ARBORIST REPORT

237 Anne St.
Niagara-on-the-Lake, ON
L0S 1J0

Created: December 12, 2022
Last revised: May 23, 2023

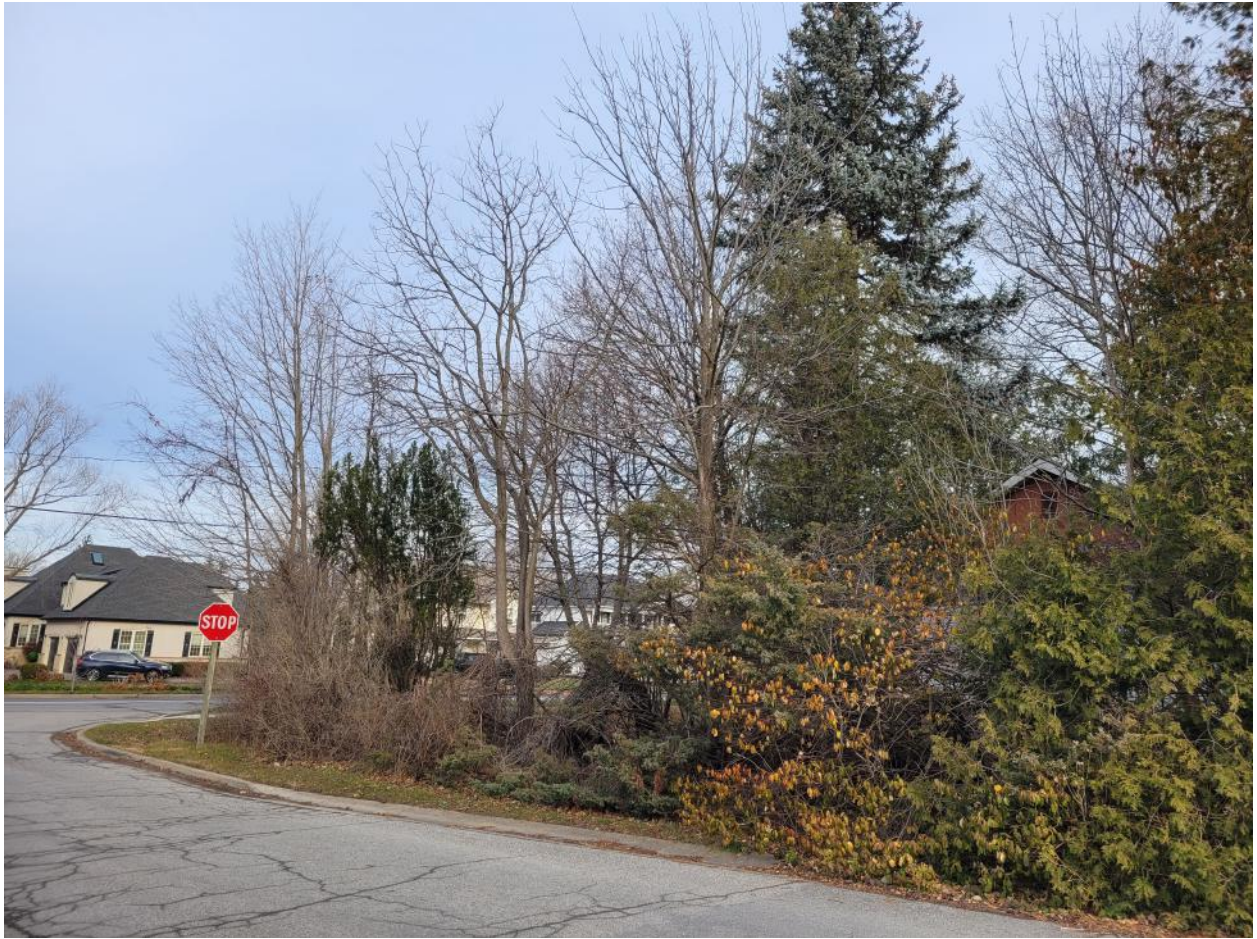
Photo 1. Proposed driveway location.

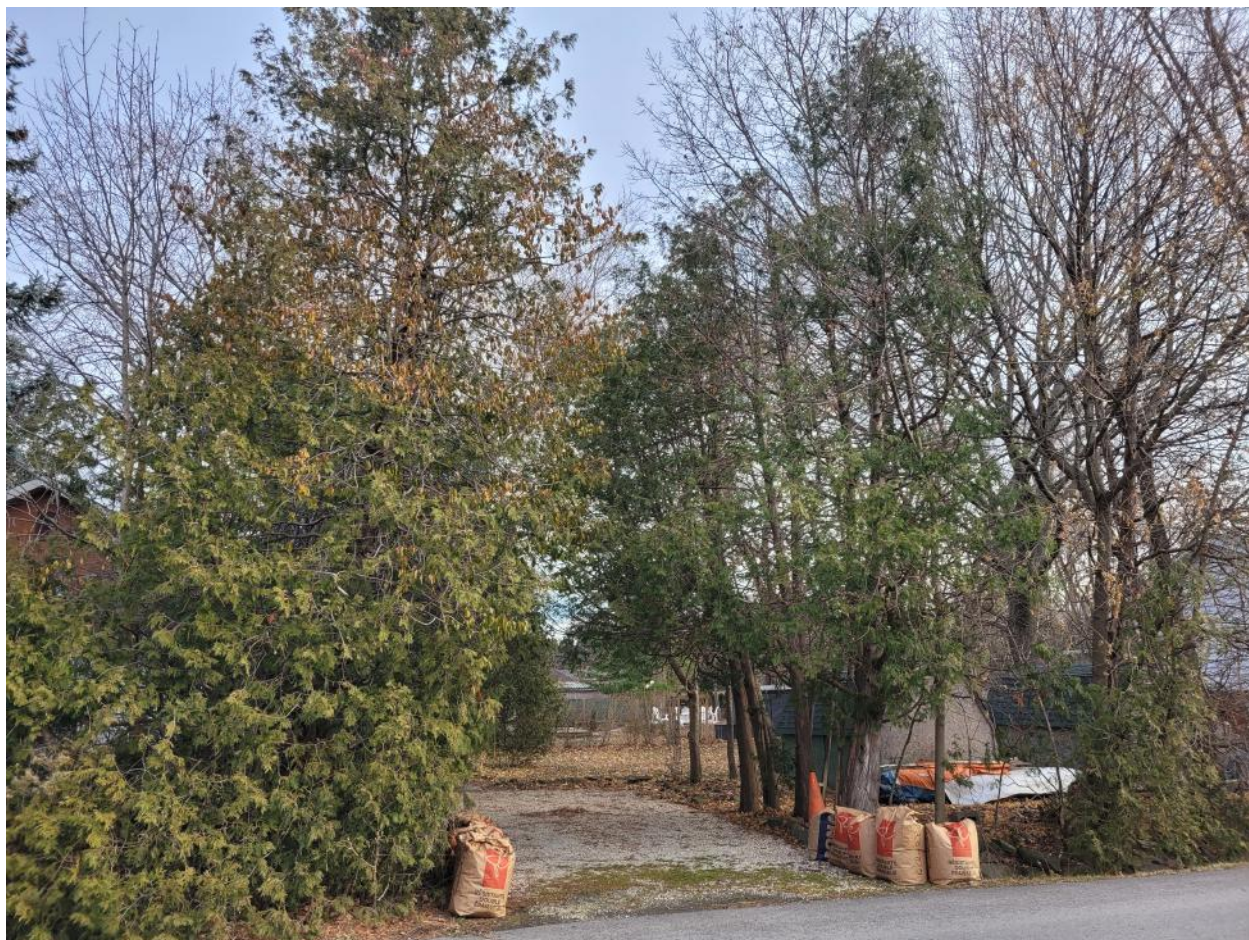
Photo 2. Existing driveway location.

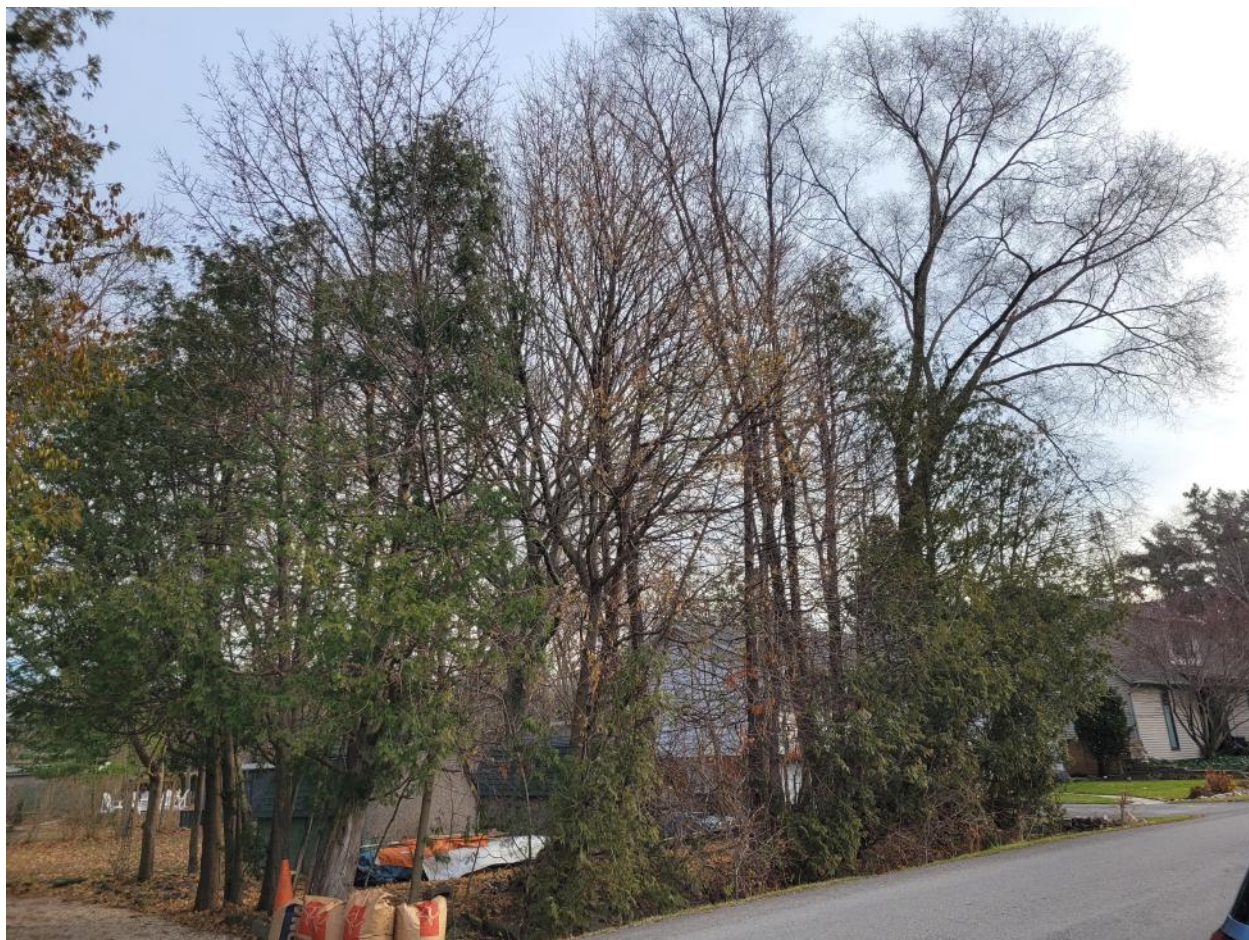
Photo 3. Second proposed driveway location.

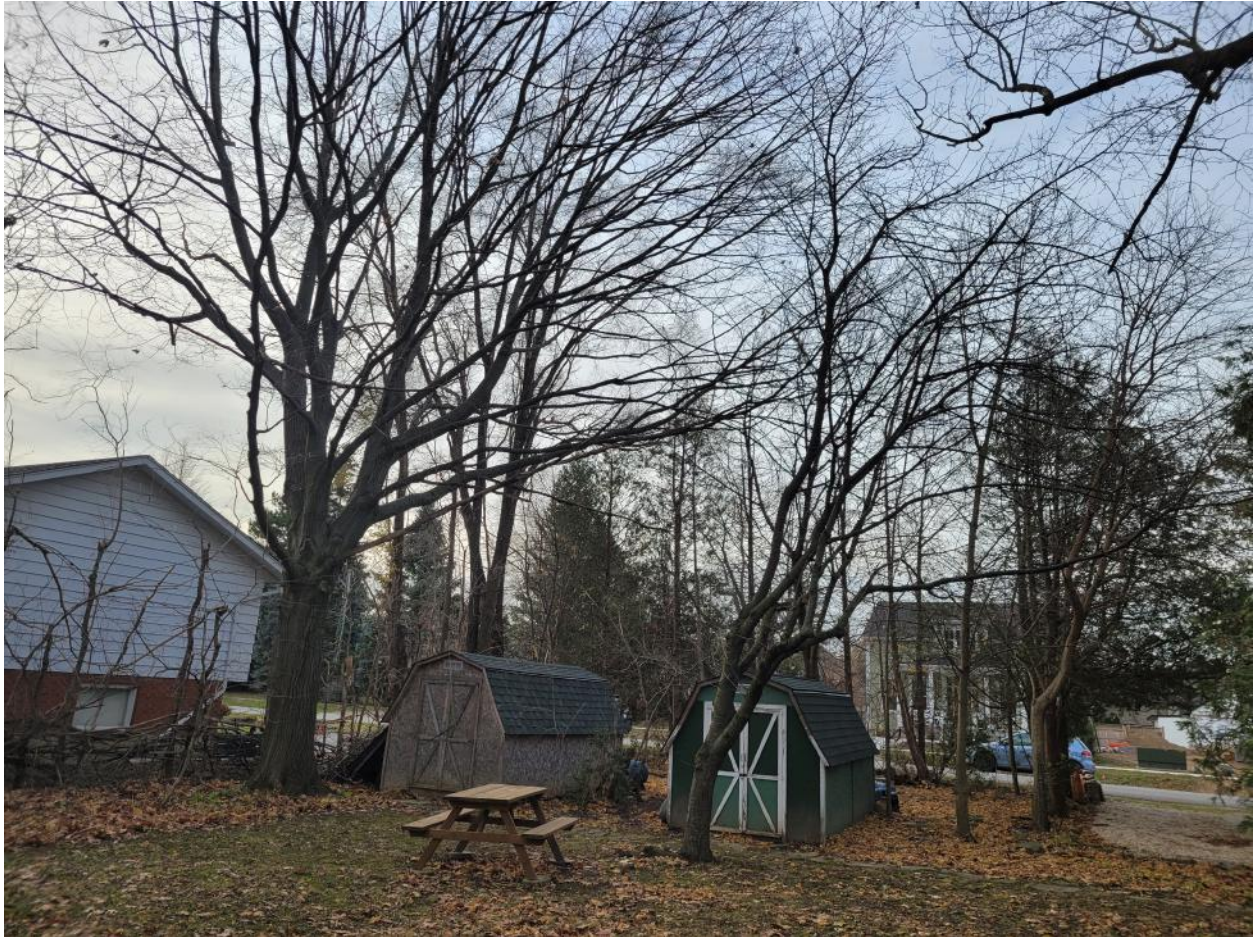
Photo 4. Existing sheds proposed for removal.

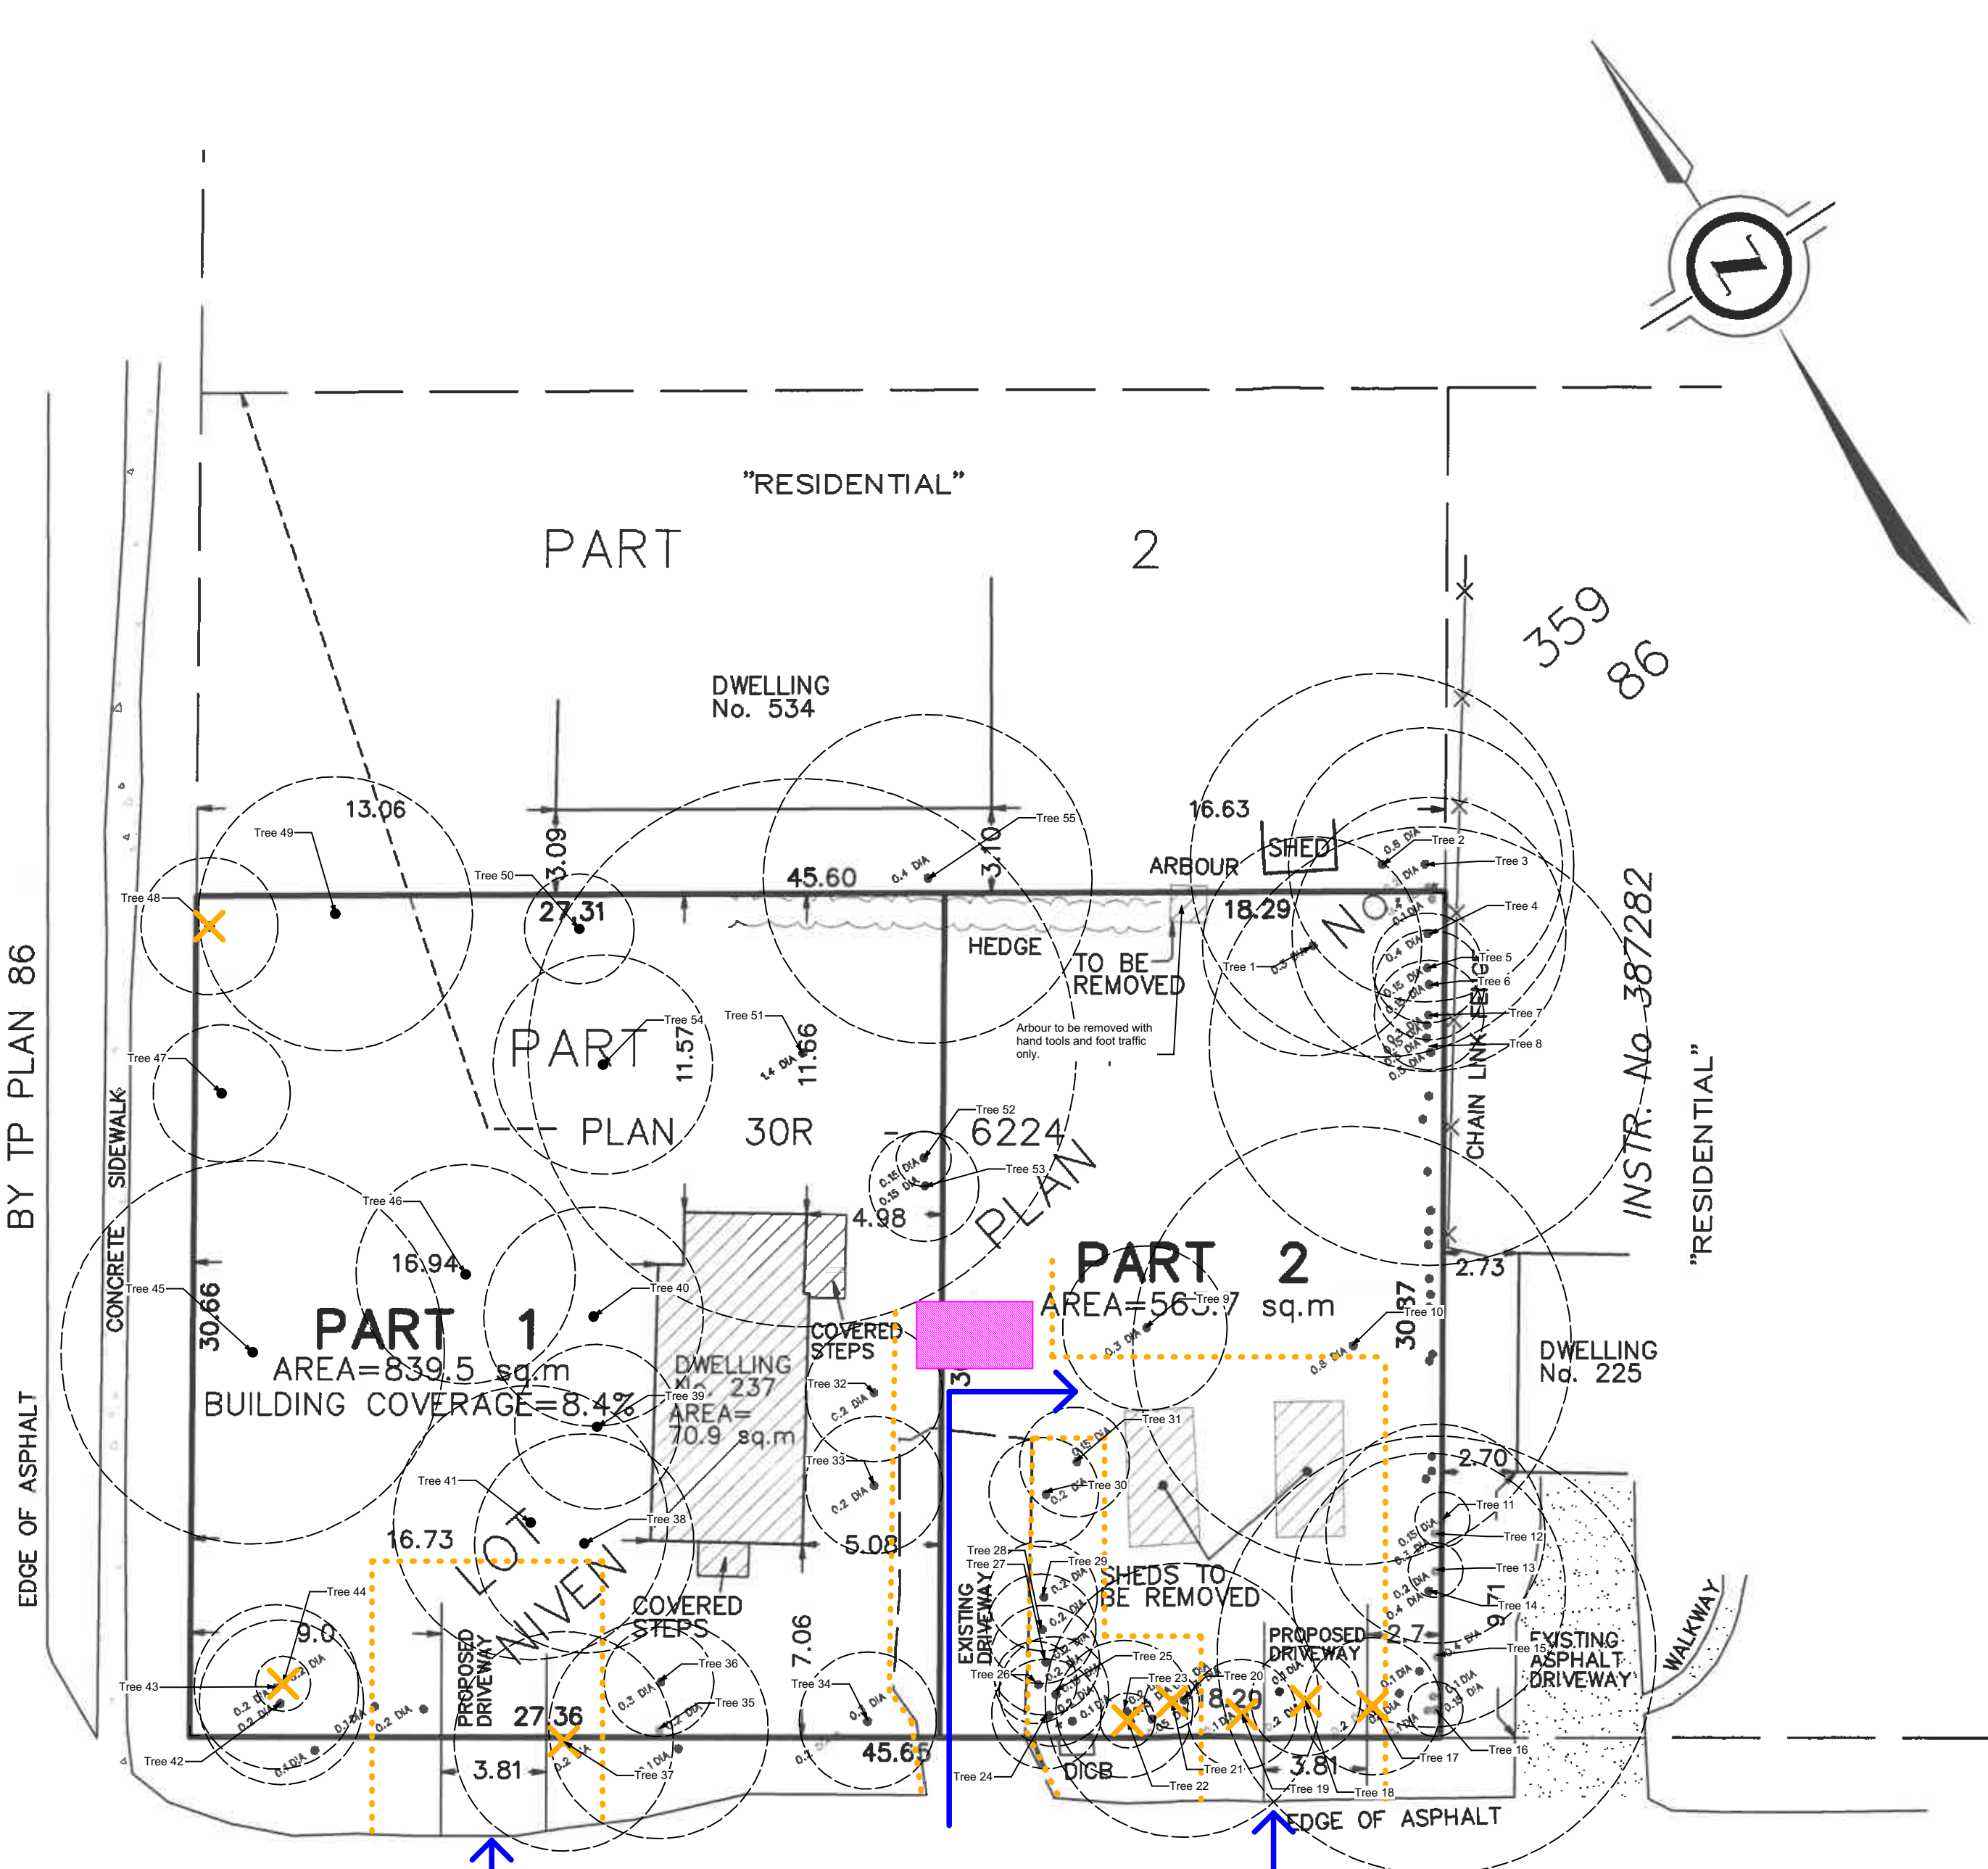
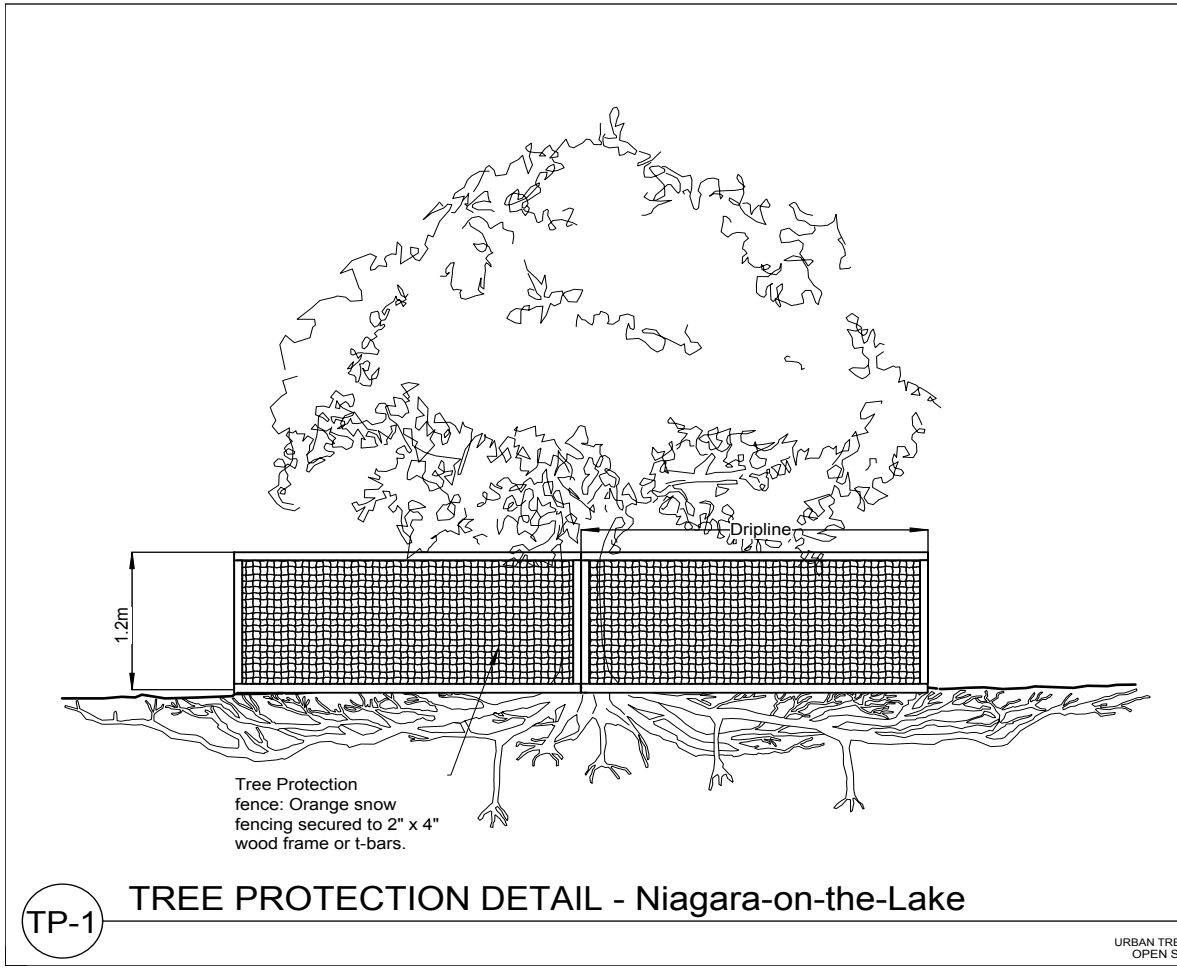
Drawing No. **TPP1**

Tree #	Species	DBH (cm)	Crown Radius (m)	Biological Condition Rating	Structural Condition Rating	Condition Comments	Min TPZ (m)	Ownership	Recommended Action
1	Acer glaberrimum (Norway maple)	27	4	Good	Fair	Fair central leader	4	Private	Preserve
2	Ulmus parviflorus (Siberian elm)	67	7	Fair	Fair	Bifurcates at base (-50 & 45cm DBH); large diameter deadwood	7	Neighbor	Preserve
3	Ulmus parviflorus (Siberian elm)	52	5	Fair	Fair	Bifurcates at base (-50 & 15cm DBH); large diameter deadwood	5	Neighbor	Preserve
4	Ulmus parviflorus (Siberian elm)	56	5	Fair	Fair	Bifurcates at -3m	5	Private	Preserve
5	Ulmus parviflorus (Siberian elm)	16	2	Fair	Fair	Suppressed crown	2	Private	Preserve
6	Ulmus parviflorus (Siberian elm)	18	2	Fair	Fair	Suppressed crown	2	Private	Preserve
7	Ulmus parviflorus (Siberian elm)	27	2	Fair	Fair	Two main stems (24 & 12cm DBH); suppressed crown; large diameter deadwood	2	Private	Preserve

8	Ulmus parviflorus (Siberian elm)	44.5	8	Fair	Fair	Two main stems (28 & 49cm DBH); asymmetrical crown; large diameter deadwood	8	Private	Preserve
9	Prunus pennsylvanica (Flowering cherry)	31	3	Fair	Fair	Bifurcates at -3m; asymmetrical crown	3	Private	Injure - Proposed work inside drip line
10	Quercus alba (red oak)	74	8	Good	Fair	Decurrent habit; minor deadwood	8	Private	Injure - Proposed work inside drip line
11	Ulmus parviflorus (Siberian elm)	22	1	Fair	Poor	Suppressed crown	1	Boundary	Preserve
12	Ulmus parviflorus (Siberian elm)	32	4	Fair	Fair	Asymmetrical due to adjacent tree	4	Boundary	Injure - Proposed work inside drip line
13	Ulmus parviflorus (Siberian elm)	21	1	Fair	Fair	Suppressed crown	1	Boundary	Preserve
14	Ulmus parviflorus (Siberian elm)	51	5	Fair	Fair	Bifurcates near ground (43 & 27cm DBH); minor deadwood	5	Potential Boundary	Injure - Proposed work inside drip line
15	Ulmus parviflorus (Siberian elm)	40	8	Fair	Fair	Bifurcates at -6m; minor deadwood	8	Boundary	Injure - Proposed work inside drip line

16	Thuja occidentalis (Larch tree)	18	1	Fair	Fair	Columnar; asymmetrical & suppressed by adjacent tree	1	Boundary	Preserve
17	Thuja occidentalis (Larch tree)	18	2.5	Good	Good	2 main stems (14 & 8cm DBH); columnar; good central leader	2.5	Private	Remove - Due to proposed driveway
18	Thuja occidentalis (Larch tree)	32	2	Good	Fair	Bifurcates at base (24 & 18cm DBH); columnar	2	Private	Remove - Due to proposed driveway
19	Thuja occidentalis (Larch tree)	24	2	Poor	Fair	Bifurcates near base (24 & 15cm DBH); 75% crown dieback	2	Private	Remove - Due to proposed driveway
20	Acer glaberrimum (Norway maple)	34	5	Fair	Fair	co-dominant crown; decurrent habit	5	Private	Injure - Proposed work inside drip line
21	Thuja occidentalis (Larch tree)	21	1	Dead	Poor	Dead	1	Private	Remove - Due to condition
22	Thuja occidentalis (Larch tree)	23	1	Dead	Poor	Dead	1	Private	Remove - Due to condition
23	Acer glaberrimum (Norway maple)	17	2.5	Fair	Fair	Asymmetrical & columnar with adjacent trees	2.5	Private	Preserve

24	Thuja occidentalis (Larch tree)	28	2	Good	Fair	Fair central leader; columnar and asymmetrical with adjacent trees	2	Private	Preserve
25	Acer glaberrimum (Norway maple)	16	2	Fair	Fair	Columnar with adjacent trees	2	Private	Preserve
26	Thuja occidentalis (Larch tree)	18	1.5	Good	Fair	Columnar and asymmetrical with adjacent trees	1.5	Private	Preserve
27	Thuja occidentalis (Larch tree)	19	2	Good	Fair	Columnar and asymmetrical with adjacent trees	2	Private	Preserve
28	Thuja occidentalis (Larch tree)	20	2	Good	Fair	Columnar and asymmetrical with adjacent trees	2	Private	Preserve
29	Thuja occidentalis (Larch tree)	23	2	Good	Fair	Columnar and asymmetrical with adjacent trees	2	Private	Preserve
30	Prunus pennsylvanica (Flowering cherry)	21	2	Good	Fair	Decurrent habit; asymmetrical with adjacent trees	2	Private	Preserve
31	Acer glaberrimum (Norway maple)	14	2	Good	Fair	Fair central leader	2	Private	Injure - Proposed work inside drip line

32	Prunus pennsylvanica (Flowering cherry)	18.5	3.5	Fair	Fair	Fair central leader; suppressed crown	2.5	Private	Injure - Proposed work inside drip line
33	Thuja occidentalis (Larch tree)	22	2.5	Good	Good	Good central leader	2.5	Private	Preserve
34	Thuja occidentalis (Larch tree)	31	2.5	Fair	Fair	Large monotypic tree in crown; codominant leaders	2.5	Private	Preserve
35	Aster sp. (black aster)	22	4	Good	Good	Fair central leader; good shoot extension	4	Private	Injure - Proposed work inside drip line
36	Thuja occidentalis (Larch tree)	22	2	Good	Good	Decurrent crown; understorey tree	2	Private	Preserve
37	Aster sp. (black aster)	24	4	Good	Poor	Five main stems at -3m	4	Boundary	Remove - Due to proposed driveway
38	Prunus pennsylvanica (Flowering cherry)	43	4	Good	Good	Good central leader; four main stems	4	Private	Injure - Proposed work inside drip line
39	Thuja occidentalis (Larch tree)	28	3	Good	Fair	Decurrent habit; four main stems	3	Private	Preserve

40	Prunus pennsylvanica (Flowering cherry)	35	4	Fair	Poor	Decurrent habit; asymmetrical with adjacent trees	4	Private	Preserve
41	Acer glaberrimum (Norway maple)	37	5	Good	Fair	Decurrent habit; codominant crown	5	Private	Injure - Proposed work inside drip line
42	Acer glaberrimum (Norway maple)	35	3	Good	Poor	Bifurcates at -1m with included union (17 & 18cm DBH)	3	Private	Preserve
43	Acer glaberrimum (Norway maple)	17	3	Good	Fair	Columnar with adjacent trees	3	Private	Preserve
44	Prunus pennsylvanica (Flowering cherry)	14	1	Dead	Poor	Dead - EAB	1	Private	Remove - Due to condition
45	Acer glaberrimum (Norway maple)	48	7	Good	Fair	Bifurcates near base (31 & 33cm DBH); decurrent habit	7	Private	Preserve
46	Thuja occidentalis (Larch tree)	32	4	Good	Good	Good central leader	4	Private	Preserve
47	Ulmus americana (American elm)	17	2.5	Good	Fair	Three from base (13, 7 & 8cm DBH)	2.5	Private	Preserve
48	Prunus pennsylvanica (Flowering cherry)	18	2.5	Poor	Poor	EAB infestation	2.5	Private	Remove - Due to condition

49	Thuja occidentalis (Larch tree)	46	5	Good	Fair	Four stems from base (30, 24, 18 & 17cm DBH)	5	Private	Preserve
50	Thuja occidentalis (Larch tree)	29	2	Good	Good	Fair central leader	2	Private	Preserve
51	Acer glaberrimum (Norway maple)	155	10	Good	Fair	50 main stems at -3.4m with included bark; good leaf set	10	Private	Preserve
52	Thuja occidentalis (Larch tree)	13	1	Good	Fair	Suppressed & columnar crown	1	Private	Preserve
53	Thuja occidentalis (Larch tree)	21	2	Good	Fair	Two main stems (14 & 13cm DBH); suppressed & columnar crown	2	Private	Preserve
54	Prunus pennsylvanica (Flowering cherry)	21	4	Fair	Fair	Multi-stem from base (14, 13 & 8cm DBH); moderate deadwood	4	Private	Preserve
55	Thuja occidentalis (Larch tree)	50	6	Good	Good	Good central leader; dominant crown	6	Neighbor	Preserve

- It is the responsibility of the site supervisor to inspect the condition of the tree protection measures outlined on the tree protection plan each morning. If disturbance to the barriers is observed, it is to be repaired prior to work commencing on site that day.

- Tree protection barriers must remain in place and in good condition during demolition, construction and/or site disturbance, including landscaping, and must not be altered, moved or removed until authorized by Urban Forestry.

- During construction, if any tree roots are exposed or disturbed outside the tree protection zone (TPZ), care is to be taken to minimize their disturbance. If roots must be removed outside the TPZ, they are to be cleanly pruned. Tearing roots hinders wound closure and can increase risk of disease and root rot.

- All landscape and construction work within the Minimum Tree Protection Zones (MTPZs) of affected trees must be completed using hand tools only.
- Trees 38-41, 45-50 & 54 were located by the arborist.

- At the completion of the project, the Forestry Department is to be notified prior to removal of the tree protection fencing on the site. With approval, the fencing may be dismantled.
