**Coastal Engineering Assessment**  
Firelane 13B, NOTL

**May 10, 2024**

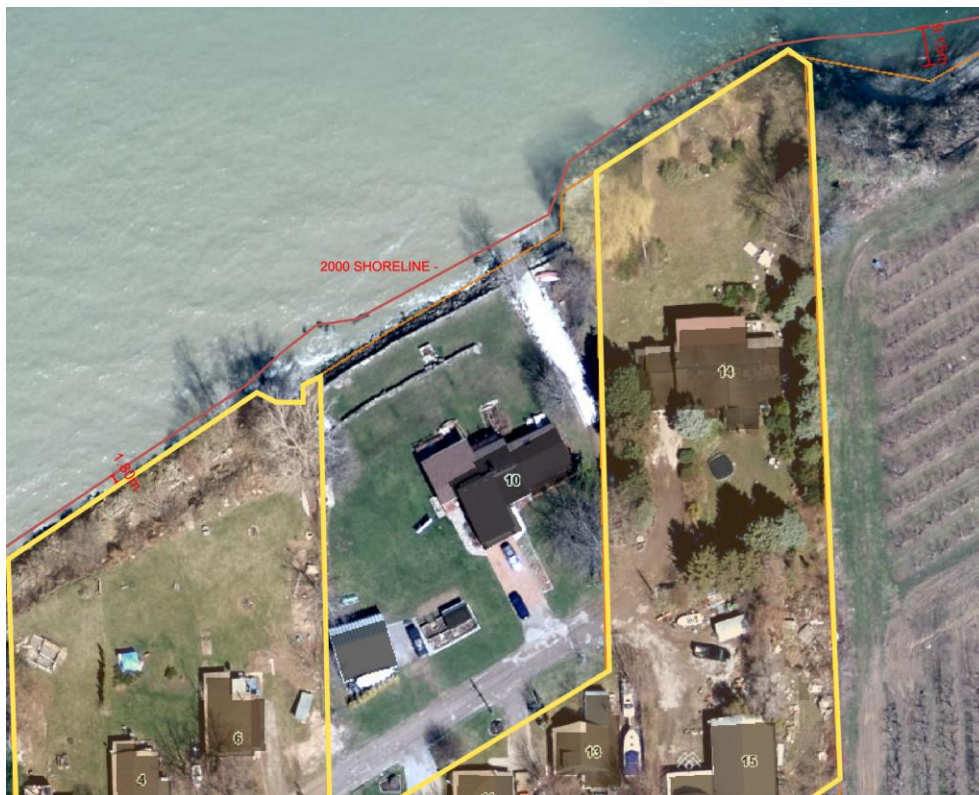
We looked at satellite imaging between 2000 and 2020 to determine how the current shoreline protection has performed over a 20-year period. As seen below the property in question has two areas fronting Lake Ontario with a separate property in between.

Based on the historical mapping from 2000-2020 we have calculated the west section has eroded 1.8-meters over the 20-year period while the east section has eroded 0-meters. To be noted the neighbouring property on the east with no shoreline protection in place has eroded 9.15-meters over this same period. Based on this information the following erosion rates are calculated:

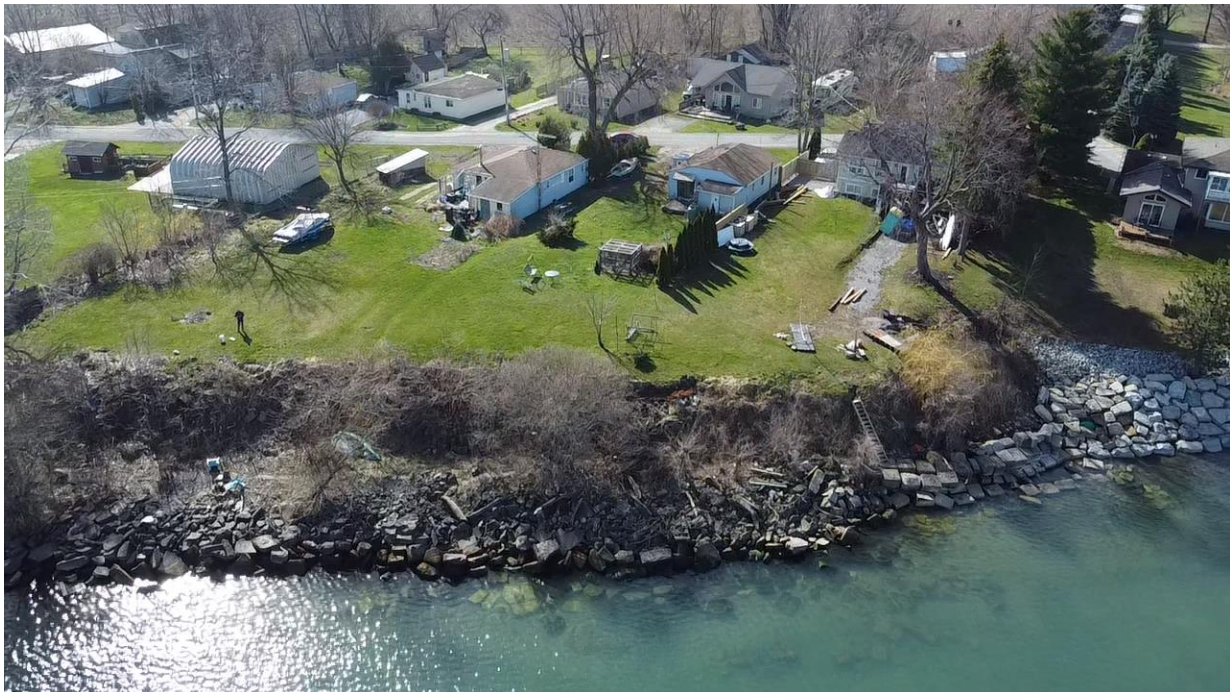
### **East Section**

During our site visit we looked at the current shoreline protection at the east and west side of the property. We observed dumped armour stone and concrete ranging from 1-3 MT.

Based on the images above and the historical erosion mapping the current shoreline protection is successfully reducing the erosion rate. The current shoreline protection was likely constructed 30-40-years ago and does not appear to be engineered. The shoreline protection on the west section extends higher into the bank than the east section. Based on this we believe the east section is more likely to experience bank erosion from overtopping waves in the future. The current shoreline protection is successfully reducing erosion at the toe of the bank.

Based on our inspection we believe the current shoreline protection has a remaining serviceable life of 15-years with proper maintenance. We recommend constructing a new breakwall in the next 15-years. The site has good access for maintenance and future construction, if any work to the property is being completed, we recommend leaving a 6-meters wide access lane from the
