Arborist Report

308 Four Mile Creek Road – Phase 2

Beacon Environmental Limited

2025-11-27

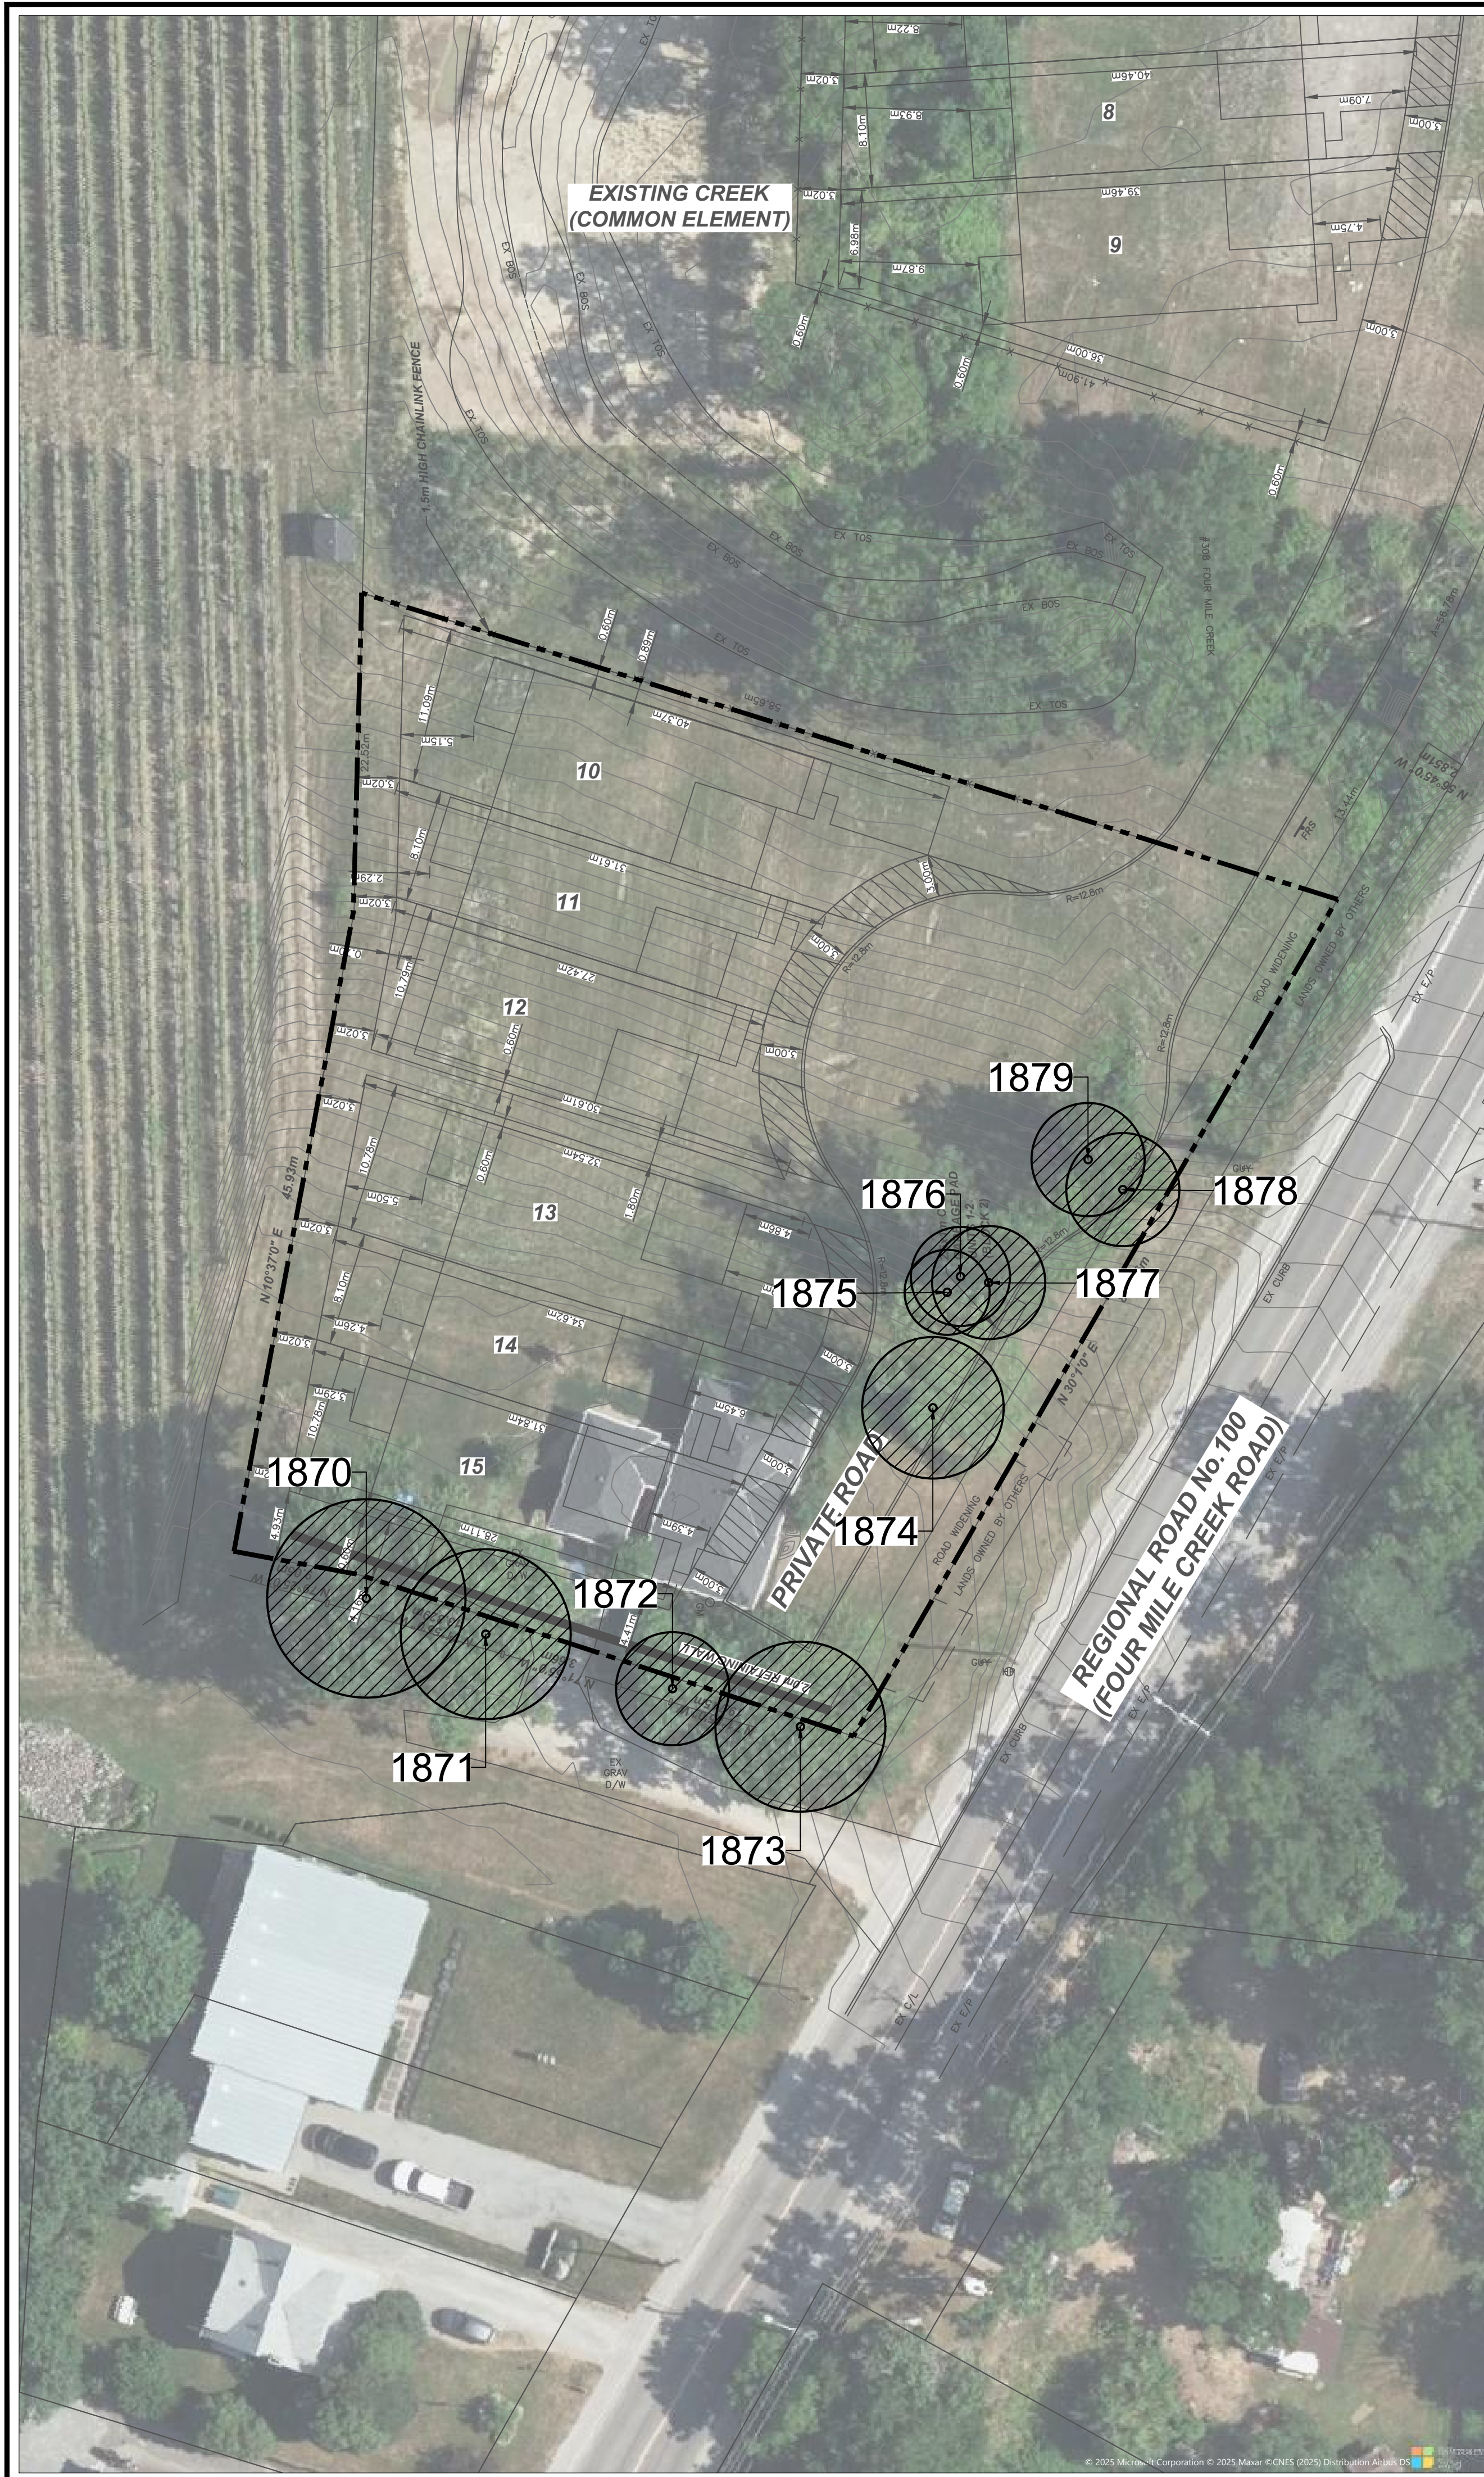
TP-1

These trees require removal due to direct conflict with the proposed private road (see **Drawing TP-1**).

These four trees are located close to the property line. Based on the proximity of these trees to a required 2 m high retaining wall along the property line, retention of these trees is not feasible due to the anticipated amount of root loss (see **Drawing TP-1**).

Tag/Tree No.	Scientific Name	Common Name	DBH (cm)	Crown Diameter (m)	Condition1	Comments	Ownership	TPZ Radius2 (m)	Tree Preservation Recommendation																													
1870	<i>Acer saccharinum</i>	Silver Maple	96	14	Good	Good form and vigour; Full healthy crown; Stems fork above great height; Included bark.	Off-site - Private	N/A	Remove Due to Development (Retaining Wall)																													
1871	<i>Acer saccharinum</i>	Silver Maple	80	12	Good	Good form and vigour; Full healthy crown; Stems fork above breast height; Good stem union; Located two metres northwest of gravel driveway.	Off-site - Private	N/A	Remove Due to Development (Retaining Wall)																													
1872	<i>Acer saccharinum</i>	Silver Maple	64	8	Fair-Good	Narrow crown; Good vigour; Calloused wounds along stem; Stems fork above breast height; Good stem unions.	Off-site - Private	N/A	Remove Due to Development (Retaining Wall)

1873	<i>Acer saccharinum</i>	Silver Maple	87	12	Good	Good form and vigour; Full healthy crown; Stems fork above breast height; Included bark.	Off-site - Private	N/A	Remove Due to Development (Retaining Wall)																													
1874	<i>Acer saccharinum</i>	Silver Maple	80	10	Poor-Fair	Moderate dieback and thinning; Approximately 35 percent of canopy dead.	Subject Property	N/A	Remove Due to Development																													
1875	<i>Picea glauca</i>	White Spruce	23	6	Good	Good form and vigour; Crown raised; Vines growing along stem.	Subject Property	N/A	Remove Due to Development																													
1876	<i>Pinus strobus</i>	Eastern White Pine	33	7	Good	Good form and vigour; Crown raised; Vines growing along stem.	Subject Property	N/A </tr <tr> <td>1877</td> <td><i>Pinus strobus</i></td> <td>Eastern White Pine</td> <td>42</td> <td>8</td> <td>Good</td> <td>Good form and vigour; Crown raised; Vines growing along stem.</td> <td>Subject Property</td> <td>N/A</td> <td>Remove Due to Development</td> </tr> <tr> <td>1878</td> <td><i>Juglans nigra</i></td> <td>Black Walnut</td> <td>27</td> <td>8</td> <td>Good</td> <td>Good form and vigour; Full healthy crown.</td> <td>Subject Property</td> <td>N/A</td> <td>Remove Due to Development</td> </tr> <tr> <td>1879</td> <td><i>Picea abies</i></td> <td>Norway Spruce</td> <td>38</td> <td>8</td> <td>Fair-Good</td> <td>Minor dieback and thinning; Vines growing along stem.</td> <td>Subject Property</td> <td>N/A</td> <td>Remove Due to Development</td> </tr>	1877	<i>Pinus strobus</i>	Eastern White Pine	42	8	Good	Good form and vigour; Crown raised; Vines growing along stem.	Subject Property	N/A	Remove Due to Development	1878	<i>Juglans nigra</i>	Black Walnut	27	8	Good	Good form and vigour; Full healthy crown.	Subject Property	N/A	Remove Due to Development	1879	<i>Picea abies</i>	Norway Spruce	38	8	Fair-Good	Minor dieback and thinning; Vines growing along stem.	Subject Property	N/A	Remove Due to Development

1877	<i>Pinus strobus</i>	Eastern White Pine	42	8	Good	Good form and vigour; Crown raised; Vines growing along stem.	Subject Property	N/A	Remove Due to Development																													
1878	<i>Juglans nigra</i>	Black Walnut	27	8	Good	Good form and vigour; Full healthy crown.	Subject Property	N/A	Remove Due to Development																													
1879	<i>Picea abies</i>	Norway Spruce	38	8	Fair-Good	Minor dieback and thinning; Vines growing along stem.	Subject Property	N/A	Remove Due to Development

Permission from adjacent landowners must be obtained prior to removing trees from adjacent lands.
