Arborist Report Tawny Ridge Estates — Phase 2 Niagara-on-the-Lake, ON

Beacon Environmental Limited

October 2022 222339

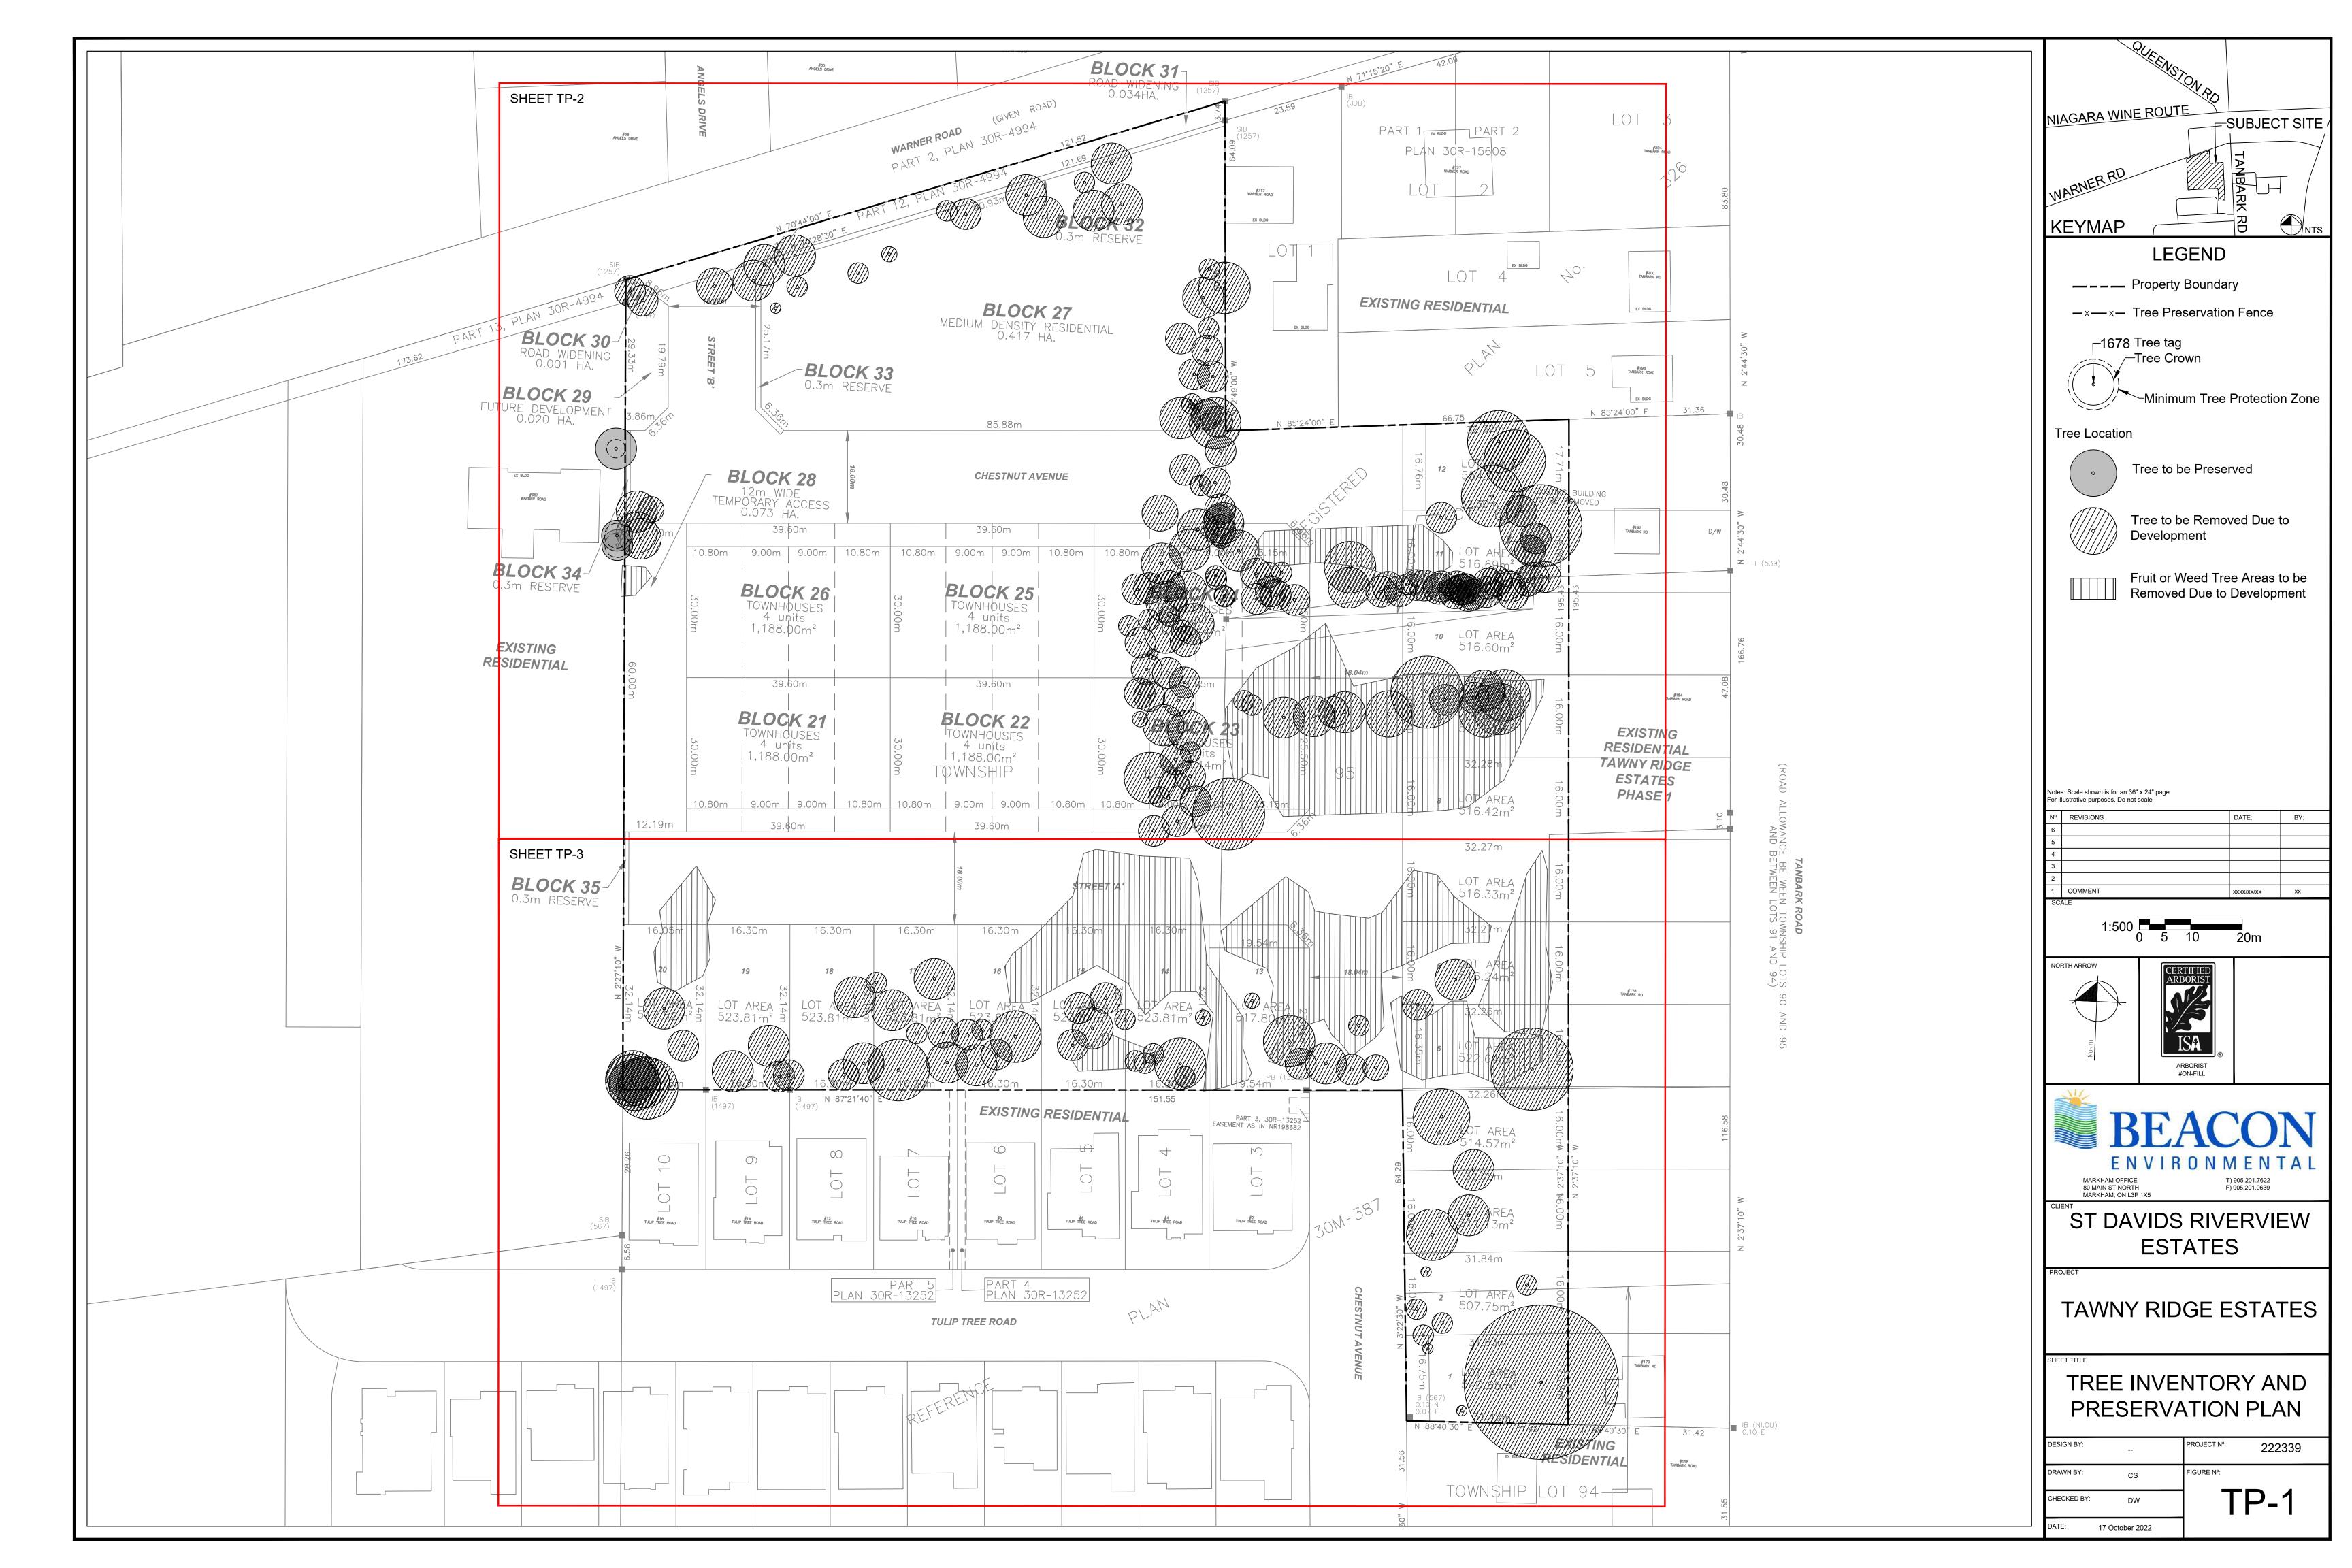
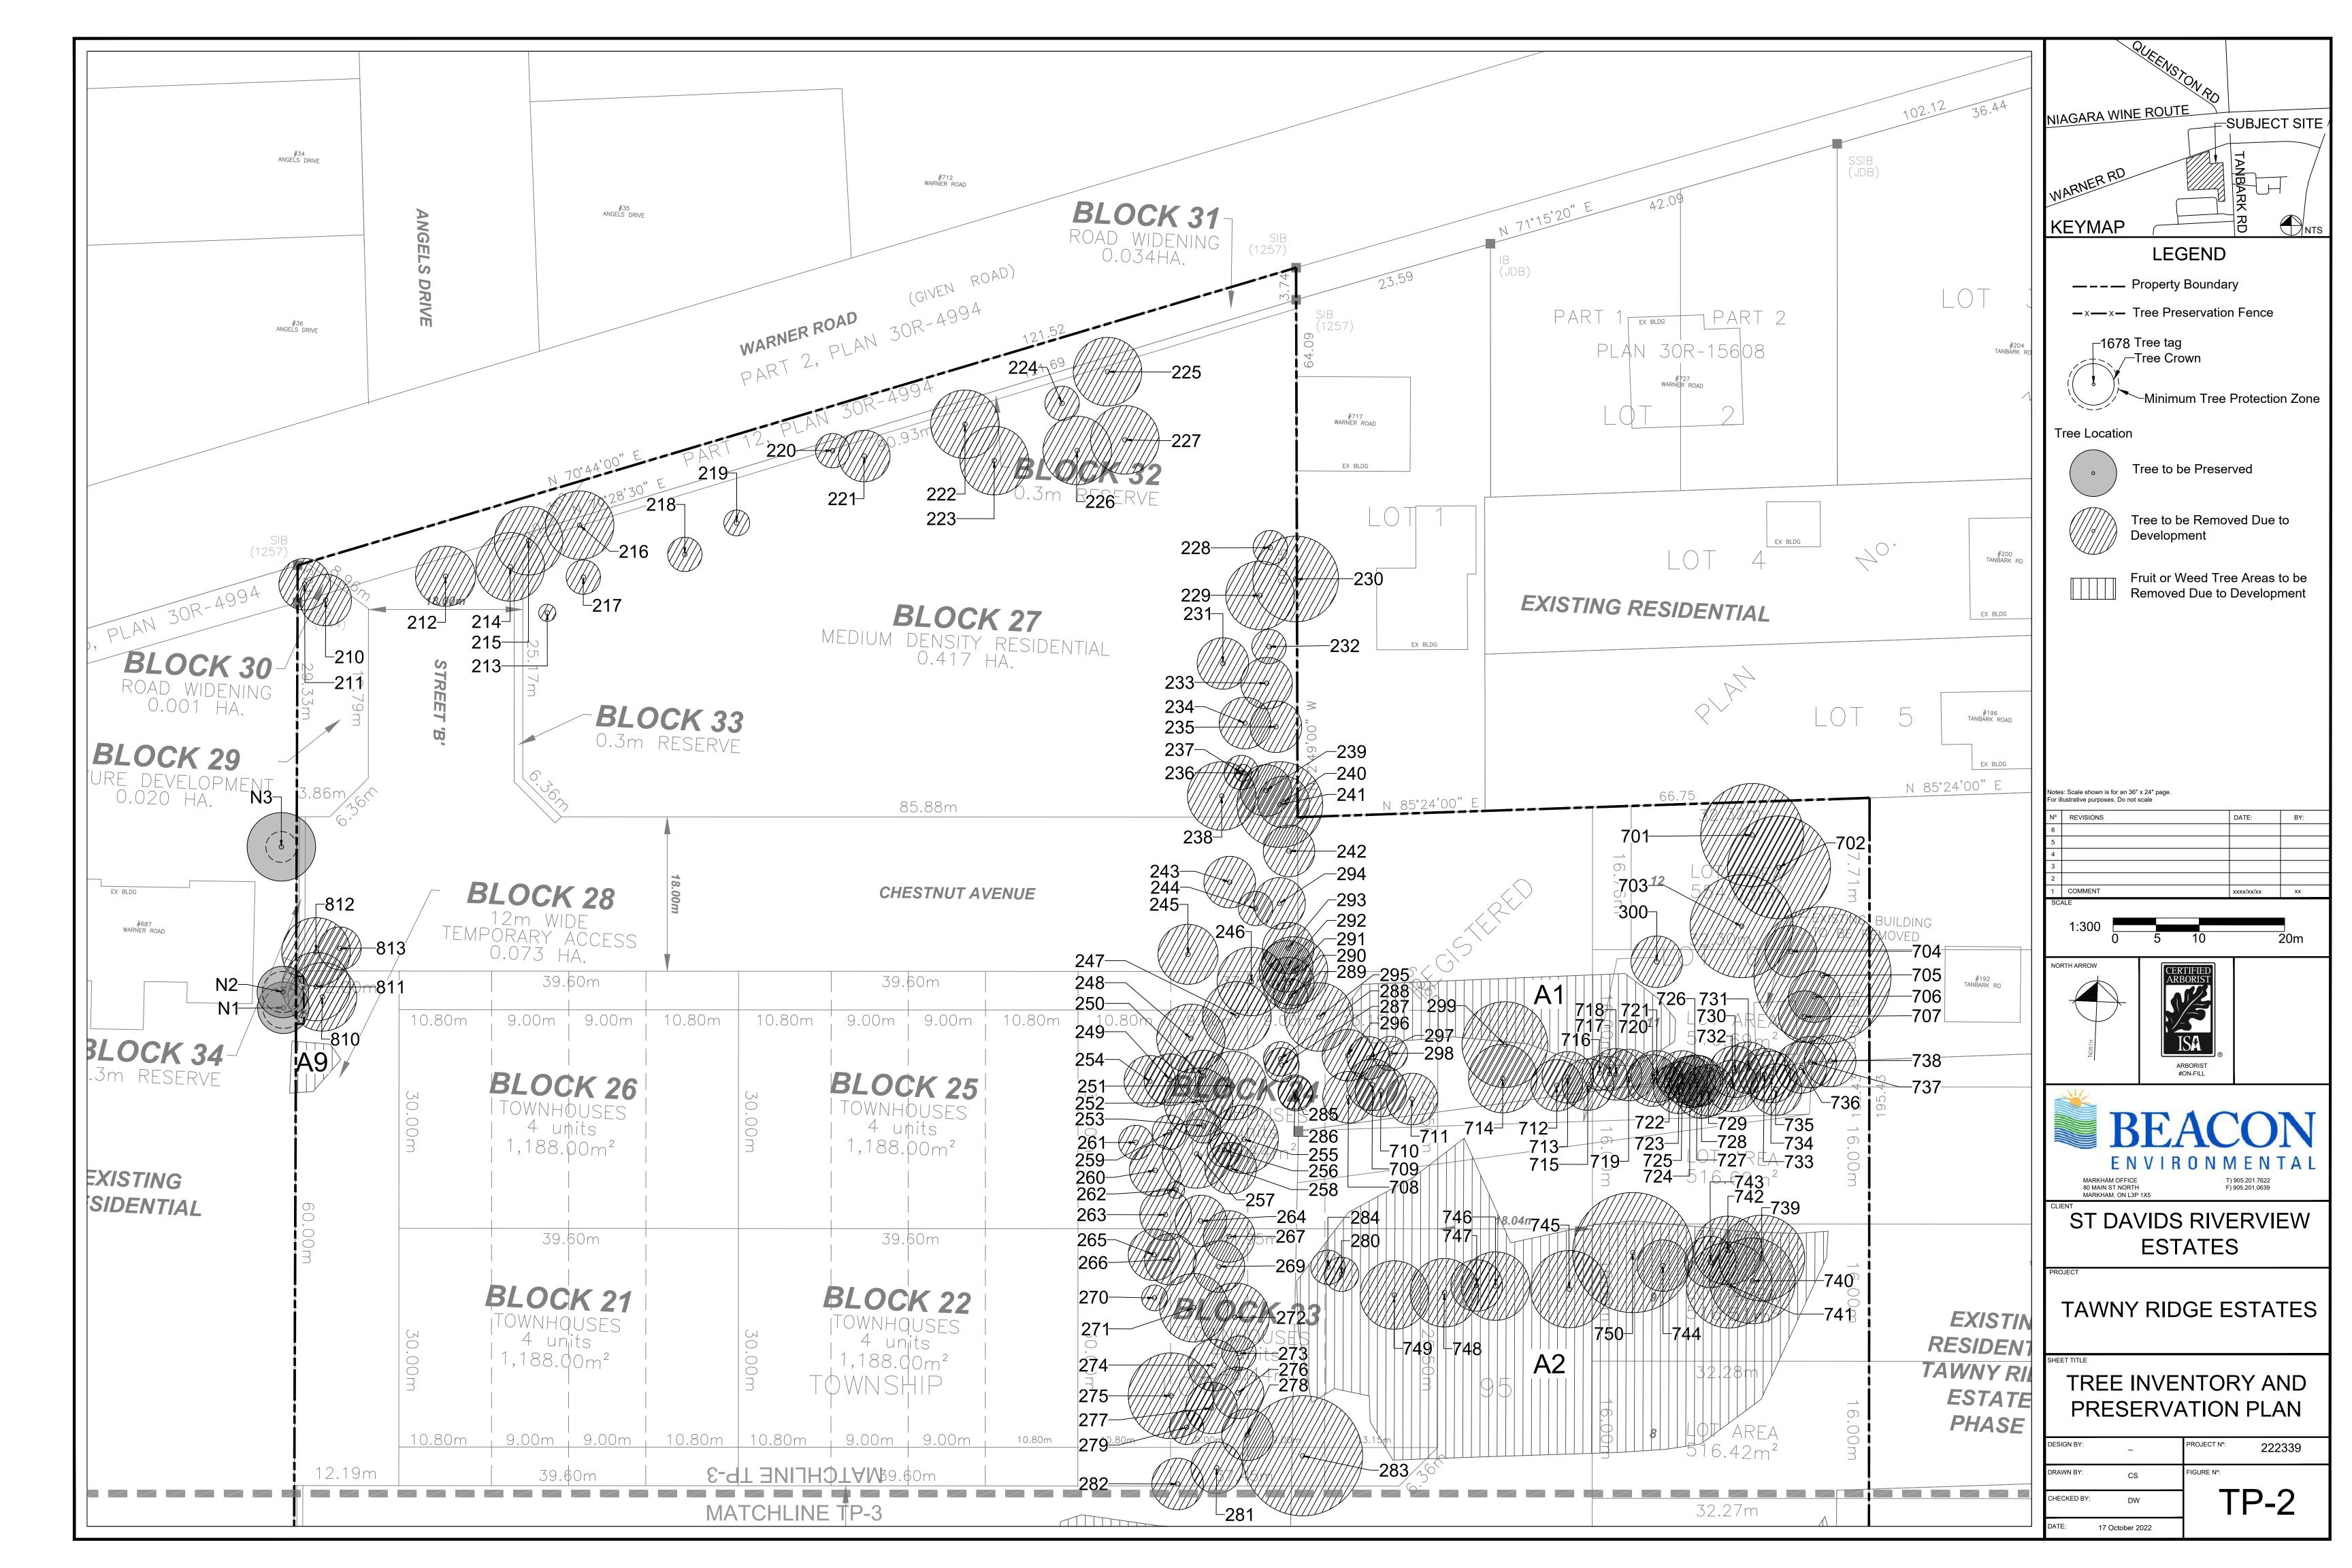
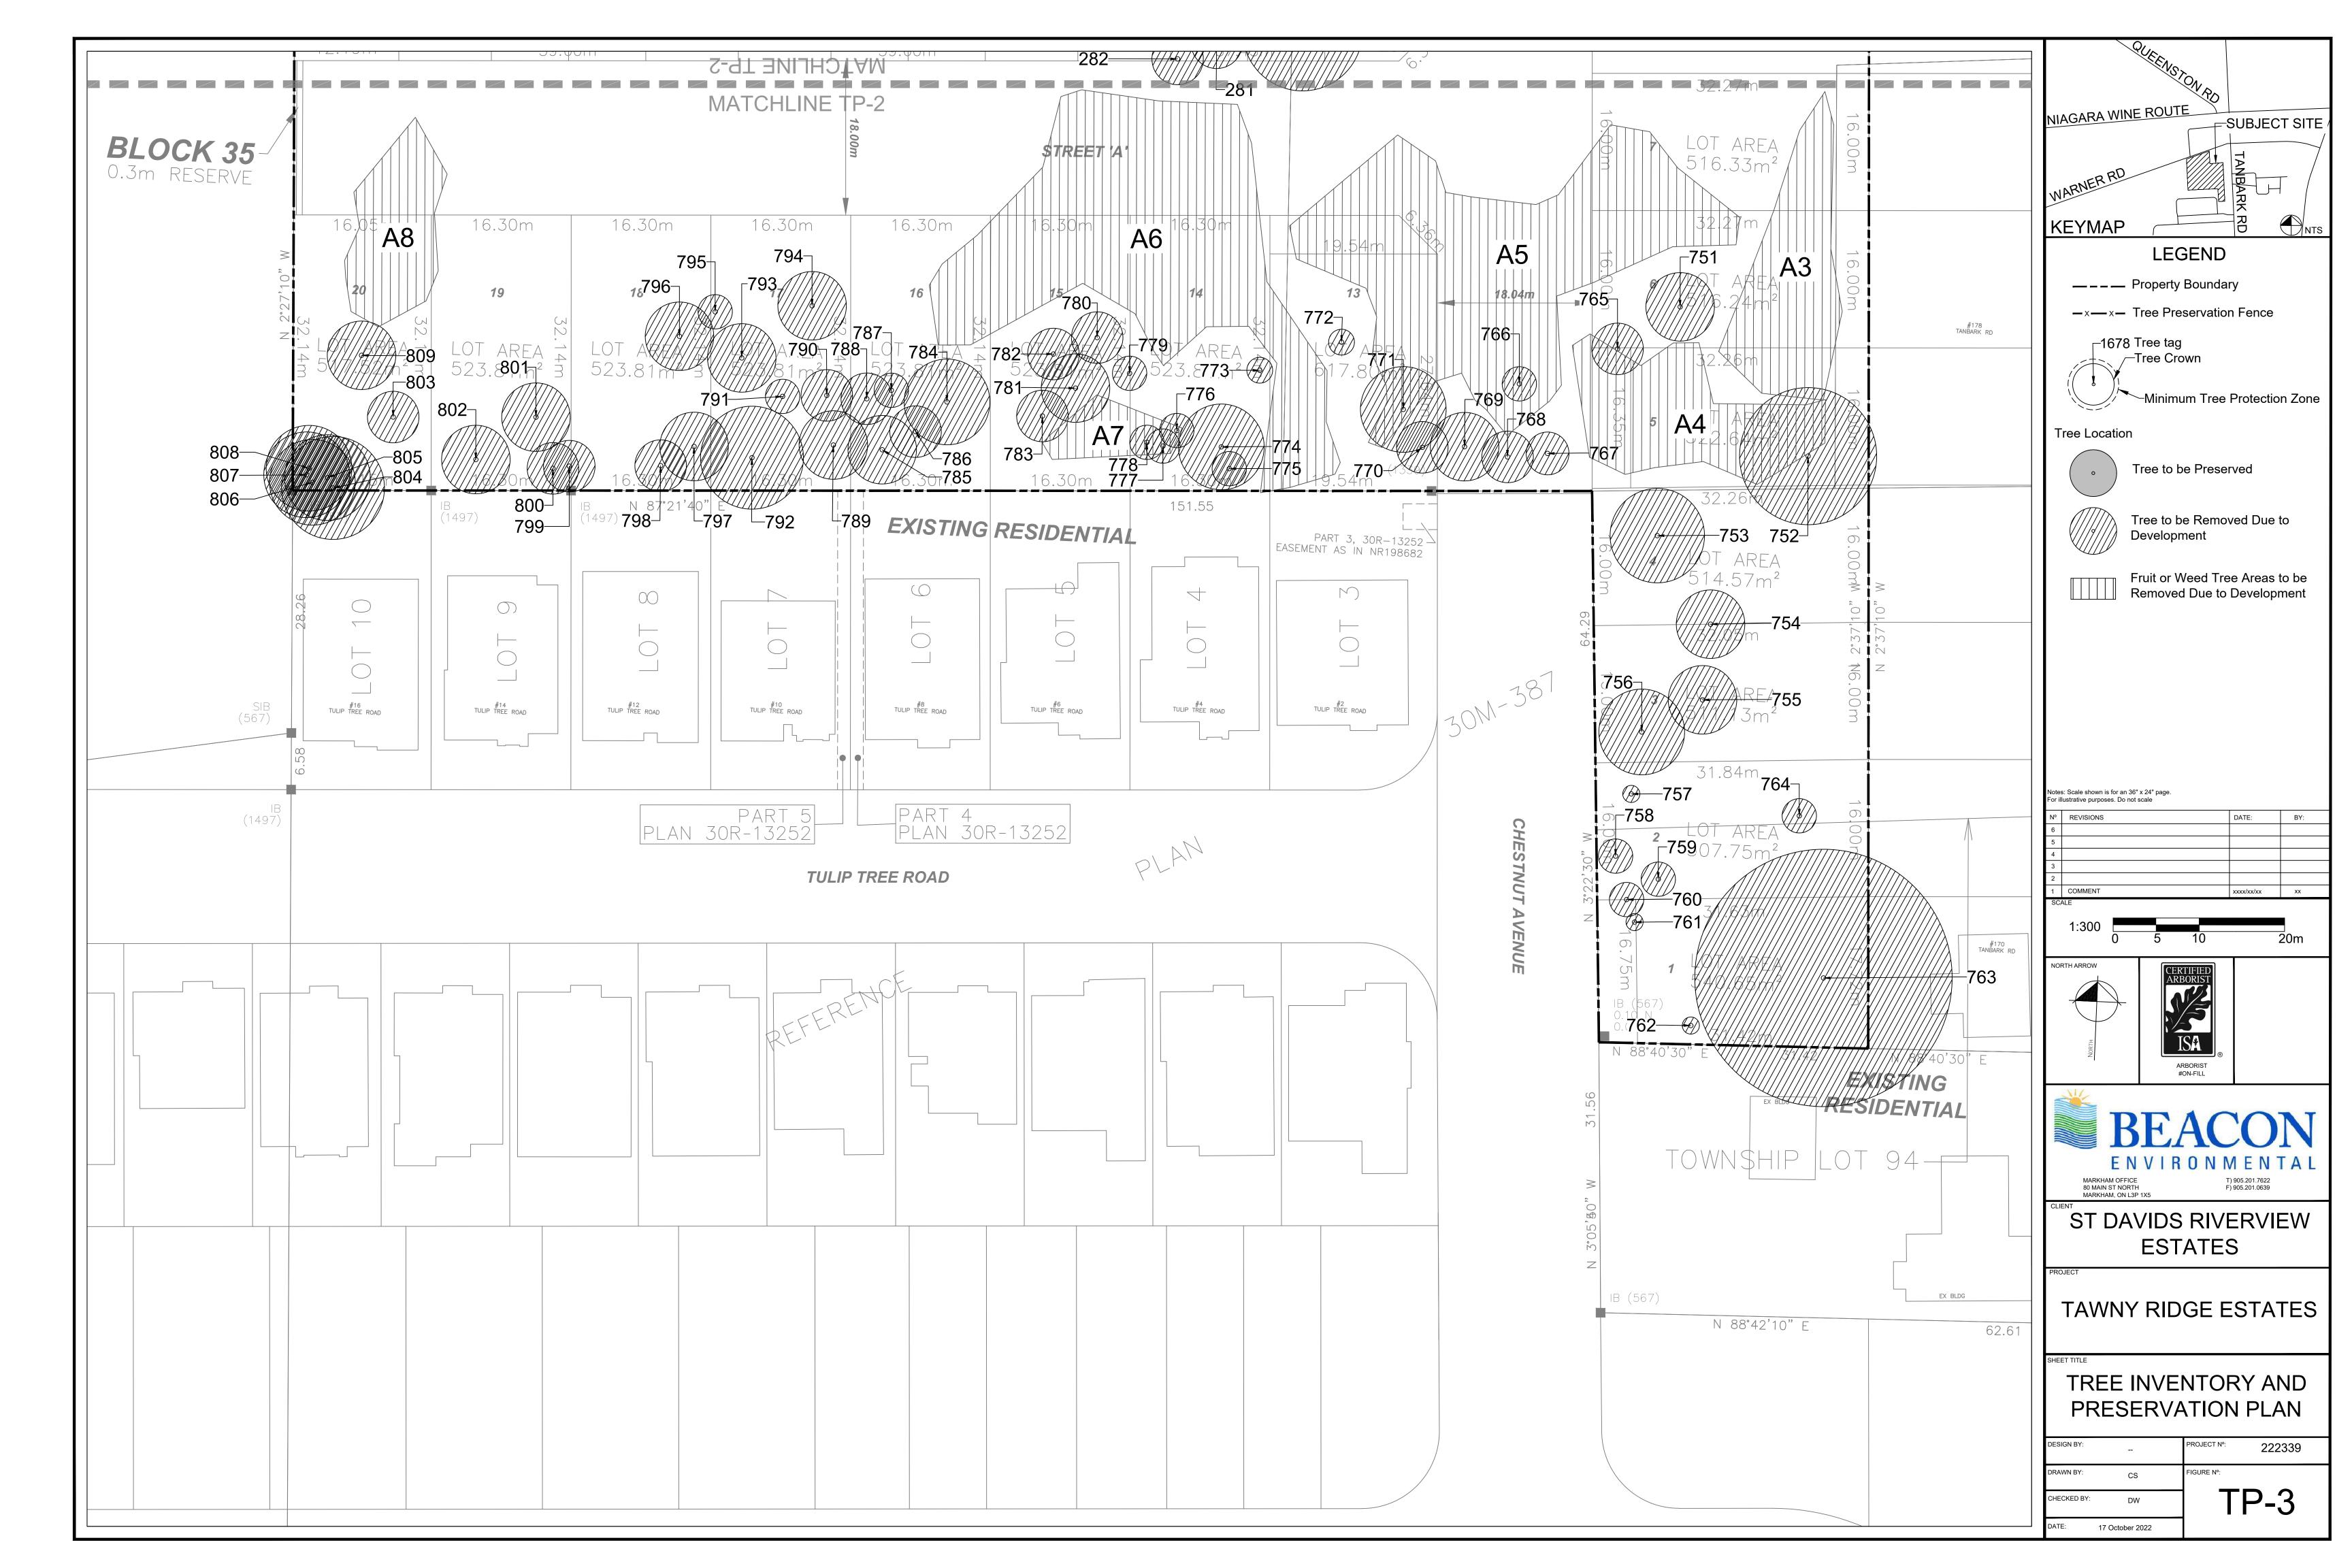
Tree Inventory and Preservation Plan

210	Species (Common Name) Norway Spruce	Species (Scientific Name) Picea abies	(cm) 28	Crown Diameter (m)	Condition Good	Comment(s) Good form and vigour	Tree Protection Zone Radius (m)		mmendatior Remove
211 212	Sugar Maple Norway Spruce	Acer saccharum Picea abies	Approx. 28 42	6 7	Fair-Good Good	Good vigour. Some unions with poor structure Good form and vigour			Remove Remove
213 214	Austrian Pine Norway Spruce	Pinus nigra Picea abies	13 33	2 8	Good Good	Good form and vigour Good form and vigour			Remove Remove
215 216	Norway Spruce Norway Spruce	Picea abies Picea abies	33 34	8	Good Good	Good form and vigour Good form and vigour	_ _		Remove Remove
217 218 219	Austrian Pine Austrian Pine Austrian Pine	Pinus nigra Pinus nigra Pinus nigra	12.6 14 13	4 4 3	Good Good Good	Good form and vigour Good form and vigour Good form and vigour	_ _ _		Remove Remove
220	Austrian Pine Austrian Pine Norway Spruce	Pinus nigra Picea abies	12.5 21	4 6	Good Good	Good form and vigour Good form and vigour	_ _ _		Remove Remove

222	Norway Spruce Norway Spruce	Picea abies Picea abies	32 31	8	Good Good	Good form and vigour Good form and vigour			Remove Remove
224 225	Austrian Pine Norway Spruce	Pinus nigra Picea abies	13.5 34	4 8	Good Good	Good form and vigour Good form and vigour			Remove Remove
226	Austrian Pine Norway Spruce	Pinus nigra Picea abies	37 42	8	Good Good	Good form and vigour Good form and vigour			Remove Remove
228	Blue Spruce Austrian Pine	Picea pungens Pinus nigra	18 43	8	Fair Good	Good form. Distal leaves yellowing throughout crown; approx 50% Good form and vigour	_ _ _		Remove Remove
230	Northern Red Oak White Ash	Quercus rubra Fraxinus americana	Approx. 60 28	10 6	Good Poor	Good form and vigour. Possible boundary tree Most of crown dead. Only lower crown and epicormics remain living at time of survey			Remove Remove
232	Blue Spruce Norway Spruce	Picea pungens Picea abies	18 24	4 6	Good Good	Good form and vigour Good form and vigour			Remove Remove

234	White Spruce Blue Spruce	Picea glauca Picea pungens	30 30	6	Good Good	Good form and vigour Good form and vigour			Remove Remove
236 237	White Spruce Northern Red Oak	Picea glauca Quercus rubra	16 18	2 4	Fair Fair	Entwined at base and growing into adjacent tree Entwined at base and growing into adjacent tree	_ 		Remove Remove
238	Scots Pine Austrian Pine	Pinus sylvestris Pinus nigra	36	8	Fair-Good Poor-Fair	Good vigour, fair form Lower canopy dead from diplodia			Remove Remove
240 241 242	Eastern White Cedar Manitoba Maple Norway Maple	Thuja occidentalis Acer negundo Acer platanoides	16, 16, 15 [27.1] 19 21	6 10 6	Fair Fair	Good vigour. Forks at base Good vigour. Strong lean			Remove
243	White Spruce Austrian Pine	Picea glauca Pinus nigra	26 32	6 4	Fair-Good Good Poor-Fair	Good form and vigour Thin crown, diplodia	_ _ _		Remove Remove Remove
245	Austrian Pine Austrian Pine	Pinus nigra Pinus nigra	40 38	7 8	Fair Fair	Good vigour. Codominant leaders in upper crown Thinning crown and codominant leaders			Remove

247 248	Austrian Pine Austrian Pine	Pinus nigra Pinus nigra	35 52 @ 0.1 m	8	Fair-Good Fair-Good	<u>-</u>			Remove Remove
249 250	Norway Spruce Norway Spruce	Picea abies Picea abies	36 32	6	Good Good	-			Remove Remove
251 252 253	Norway Spruce Austrian Pine Austrian Pine	Picea abies Pinus nigra Pinus nigra	27 31	8 8 4	Good Fair Fair	Some Diplodia Some Diplodia Some Diplodia and moderately weak unions	_ _ _		Remove Remove Remove
254 255	Scots Pine Blue Spruce	Pinus sylvestris Picea pungens	34 44 @ 0.3 m	6 8	Fair-Good Fair	Some thinning Low fork			Remove Remove
256 257	Norway Spruce Norway Spruce	Picea abies Picea abies	16 44	4 8	Good Good	——————————————————————————————————————			Remove Remove
258 259	Scots Pine Norway Spruce	Pinus sylvestris Picea abies	43 14	6	Fair Good	Low fork			Remove Remove
260 261	Scots Pine Scots Pine	Pinus sylvestris Pinus sylvestris	32 30	6 4	Fair Fair	Crown thinning and codominant leaders Crown thinning			Remove

262 263 264	Austrian Pine Eastern White Pine Austrian Pine	Pinus nigra Pinus strobus Pinus nigra	18 39 28	6	Good Good Good	- - -	_ _ _		Remove Remove
265 266	White Spruce Austrian Pine	Picea glauca Pinus nigra	29 30	6	Good Good	<u>-</u>	_ _ _		Remove Remove Remove
267 269	Norway Spruce Austrian Pine	Picea abies Pinus nigra	31 35	6	Good Fair				Remove Remove
270 271	Blue Spruce Austrian Pine	Picea pungens Pinus nigra Pinus nigra	16 28	3 8	Good Fair	Codominant leaders			Remove Remove
272 273 274	Austrian Pine White Spruce White Spruce	Pinus nigra Picea glauca Picea glauca	39 30 28	8 4 6	Good Good Good	-	_ _ _		Remove Remove
274 275 276	Austrian Pine White Spruce	Picea giauca Pinus nigra Picea glauca	42 23	10	Fair Good	Open crown with many moderately weak limbs	_ _ _		Remove Remove Remove
277 278	Norway Špruce Blue Spruce	Picea abies Picea pungens	27 30	6 6	Good Good	<u>-</u>			Remove Remove
279 280	Norway Spruce Black Walnut	Picea abies Juglans nigra	22 17	4 4	Fair-Good Good	Minor weak union			Remove Remove

281	Blue Spruce Blue Spruce Swamp Pin Oak	Picea pungens Picea pungens Quercus palustris	28 28 61	6 6 14	Good Good	Some nodes with many branches			Remove Remove
283 284 285	Black Walnut Eastern White Cedar	Juglans nigra Thuja occidentalis	13 14, 13.5, 8 [21]	4 4	Fair-Good Fair-Good Good	Some lean in upper crown	_ _ _		Remove Remove
286	Eastern White Cedar	Thuja occidentalis Thuja occidentalis	15, 10, 8 [19.7] 14.5, 11, 9.5 @ 1 m	4	Good	-	_		Remove
287	Eastern White Cedar Eastern White Cedar	Thuja occidentalis Thuja occidentalis	[20.5] 19, 15, 9 @ 1 m	4	Good Good		_		Remove Remove
289	Eastern White Cedar	Thuja occidentalis	[25.8] 15, 11 [18.6]	4	Good	-	_		Remove
290 291	Black Walnut Black Walnut	Juglans nigra Juglans nigra	22 23 19, 12, 10 @ 1.2 m	8	Good Good	_	_ _		Remove Remove
292	Eastern White Cedar Eastern White Cedar	Thuja occidentalis Thuja occidentalis	[24.6] 13, 13, 11, 11 [24.1	6	Good Good	<u>-</u>	_		Remove Remove

294 295	Eastern White Cedar Silver Maple	Thuja occidentalis Acer saccharinum	14, 13, 13, 12 [26] 42		Good Fair	Some dieback in lower crown			Remove Remove
296 297	Austrian Pine Austrian Pine	Pinus nigra Pinus nigra	28 30	6 5	Good Good	- -	_ _		Remove Remove
298 299 300	Austrian Pine Silver Maple Northern Catalpa	Pinus nigra Acer saccharinum Catalpa speciosa	19 80 @ 0.1 m 15 @ 0.8 m	10	Good Fair	Included bark in major union	_ _ _		Remove Remove
701 702	Silver Maple English Walnut	Acer saccharinum Juglans regia	54 @ 0.7 m	6 12 12	Fair-Good Good Poor-Fair	Codominant leaders Phase 1 inventory tag ID 43 Heartwood rot at base. Strong lean	_ _ _		Remove Remove
703 704	English Walnut Paper Birch	Juglans regia Betula papyrifera	38 @ 1.2 m 18.5	12	Good Fair-Good	— Some lean in canopy			Remove Remove
705 706	Silver Maple Eastern White Cedar	Acer saccharinum Thuja occidentalis	62.5 27	16 6	Fair Good	Clothes line girdling. Some weak unions —	_ _		Remove Remove

707 708	Eastern White Cedar Eastern White Cedar	Thuja occidentalis Thuja occidentalis	18, 16, 11 [26.5] 12.8, 11, 11, 11 [23 14.5, 9, 7 [18.4]	6	Fair-Good Fair-Good	- -			Remove Remove
709 710 711	Eastern White Cedar Eastern White Cedar Eastern White Cedar	Thuja occidentalis Thuja occidentalis Thuja occidentalis	13, 12, 12, 10 [23.6 12.5, 11 [16.7]	6 6 6	Fair-Good Fair-Good Fair-Good		_ _ _		Remove Remove
712	Eastern White Cedar	Thuja occidentalis Thuja occidentalis	19, 15, 14 [28] 12.5, 12, 12, 11	6	Fair-Good	_	_		Remove
713 714	Eastern White Cedar Black Walnut	Juglans nigra	[23.8] 19	8	Fair-Good Fair-Good		_	ı	Remove Remove
715 716	White Spruce White Spruce	Picea glauca Picea glauca Picea glauca	27 14	6 4	Good Good	-			Remove Remove
717 718 719	White Spruce White Spruce Eastern White Cedar	Picea giauca Picea glauca Thuja occidentalis	20 16 16	6 6	Good Good Good		_ _ _		Remove Remove
720 721	Eastern White Cedar Eastern White Cedar	Thuja occidentalis Thuja occidentalis	15 21.5	6	Good Good	<u>-</u>	_ _		Remove Remove

722 723	Eastern White Cedar Eastern White Cedar	Thuja occidentalis Thuja occidentalis	13.5 14	6	Good Good	- -			Remove Remove
724 725	Eastern White Cedar Eastern White Cedar	Thuja occidentalis Thuja occidentalis	17.5 18, 14.5 [23.1]	6	Good Good	<u>-</u>			Remove Remove
726 727 728	Eastern White Cedar Eastern White Cedar Eastern White Cedar	Thuja occidentalis Thuja occidentalis Thuja occidentalis	18 15.5 15.5	6 6 6	Good Good Good		_ _ _		Remove Remove Remove
729 730	Eastern White Cedar Eastern White Cedar	Thuja occidentalis Thuja occidentalis	21.5 19	6	Good Good	<u>-</u>			Remove Remove
731 732	Eastern White Cedar Eastern White Cedar	Thuja occidentalis Thuja occidentalis	18 15	6	Good Good	- -	_ _		Remove Remove
733 734	Eastern White Cedar Eastern White Cedar	Thuja occidentalis Thuja occidentalis Thuja occidentalis	23 17.5	6	Good Good				Remove
735 736 737	Eastern White Cedar Eastern White Cedar Black Walnut	Thuja occidentalis Thuja occidentalis Juglans nigra	17 26 14.5	6 6 6	Good Good Good	E	_ _ _		Remove Remove

737 738 739	Black Walnut Black Walnut Silver Maple	Jugians nigra Jugians nigra Acer saccharinum	18.5 58 @ 0.5 m	6 10	Good Good Good	<u>-</u>	_ _ _		Remove Remove Remove
740 741	Silver Maple Silver Maple	Acer saccharinum Acer saccharinum Acer saccharinum	29, 26, 14, 14 [43.7 30, 27, 18, 17 [47.3	7] 10 B] 10	Fair Fair	Fork at base Many limbs at base	_ _ _		Remove Remove
742 743	Silver Maple Black Walnut	Acer saccharinum Juglans nigra	29	8 6	Fair Good	Dieback at leader. Moderate lean	_ _		Remove Remove
744 745	Silver Maple White Ash	Acer saccharinum Fraxinus americana	28 20, 19.8, 14.8, 11	6 9	Good Poor-Fair	EAB damage throughout trunk but callousing. Upper 15-20% died	_ _		Remove Remove
746	Black Walnut	Juglans nigra	[33.6]	8	Good	back, incl leader. Approx 50 % keys filled —	_		Remove
747 748	Black Walnut Black Walnut	Juglans nigra Juglans nigra	15 28	6 8	Fair Fair-Good	Early senescence Some codominance			Remove Remove

749 750	Black Walnut Silver Maple	Juglans nigra Acer saccharinum	19 16	8 14	Fair Fair	Some codominance Early senescence Strong lean			Remove Remove
751 752	Eastern White Pine Silver Maple	Pinus strobus Acer saccharinum	27 Approx 58	8 16	Good Good	<u>-</u>	_ _		Remove Remove
753 754	Honey Locust Honey Locust White Ash	Gleditsia triacanthos Gleditsia triacanthos Eravinus americana	37 34.5 29.5	11 8 8	Good Good	No fruit set. North E09/ of crown dood			Remove Remove
755 756 757	White Ash Honey Locust Austrian Pine	Fraxinus americana Gleditsia triacanthos Pinus nigra	29.5 28.5 12.5 @ 1.3 m	8 10 2	Poor Good Good	No fruit set. North 50% of crown dead — — —	_ _ _		Remove Remove
758 759	Austrian Pine Austrian Pine	Pinus nigra Pinus nigra	21 25	4	Good Good	-	_ _ _		Remove Remove
760 761	Austrian Pine Blue Spruce	Pinus nigra Picea pungens	20 14	4 2	Fair-Good Good	Some dieback in lower crown			Remove Remove

762 763	Blue Spruce Silver Maple	Picea pungens Acer saccharinum Pinus sylvestris	13 89.5	30	Good Fair-Good	Some dieback in crown (10%)	_ 		Remove Remove
764 765 766	Scots Pine Austrian Pine Eastern White Pine	Pinus sylvestris Pinus nigra Pinus strobus	22 24 13	6 4	Good Poor-Fair Good	Weak major union	_ _ _		Remove Remove Remove
767 768	Austrian Pine Austrian Pine	Pinus nigra Pinus nigra	20 22	5 6	Fair-Good Fair-Good	-	_ _ _		Remove Remove
769 770	Austrian Pine Austrian Pine	Pinus nigra Pinus nigra	32 20	8 6	Fair-Good Fair-Good		_ _	-	Remove Remove
771 772	Black Walnut Balsam Fir Japanese Tree Lilac	Juglans nigra Abies balsamea Syringa reticulata	21 14, 12 [18.4]	10 3	Fair Fair Fair-Good	Moderate lean Low fork	_ _ _		Remove Remove
772 774 775	Japanese Tree Lilac Austrian Pine Eastern White Cedar	Syringa reticulata Pinus nigra Thuja occidentalis	13 @ 1 m 35 14	3 10 4	Fair-Good Fair-Good Good		_ _ _		Remove Remove Remove

776 777	Eastern White Cedar Eastern White Cedar Austrian Pine	Thuja occidentalis Thuja occidentalis Pinus nigra	14 13 18	4 4 4	Good Good Good	<u>-</u>	_ _ _		Remove Remove Remove
778 779	Eastern White Cedar Eastern White Pine	Thuja occidentalis Pinus strobus	15 16.5	4 4	Good Good	-	_ _		Remove Remove
780 781	Austrian Pine Eastern White Pine	Pinus nigra Pinus strobus	31 19	6 8	Good Good	<u> </u>			Remove Remove
782 783	Eastern White Pine Eastern White Pine	Pinus strobus Pinus strobus	16, 9, 8 [20] 20	6 6	Good Good		_ _		Remove Remove
784 785 786	Eastern White Pine Norway Spruce Ohio Buckeye	Pinus strobus Picea abies Aesculus glabra	21 49 13 @ 0.8 m	10 8 6	Good Good Good		_ _ _		Remove Remove Remove
787 788	Blue Spruce Eastern White Pine	Picea pungens Pinus strobus	13 @ 0.8 m 15 15	4 6	Good Good	<u>–</u>	_ _ _		Remove Remove Remove
789 790	Norway Spruce Austrian Pine	Picea abies Pinus nigra	35 22	8 6	Good Fair-Good	=			Remove Remove

791 792	Blue Spruce Silver Maple	Picea pungens Acer saccharinum	14 65	4 12	Good Fair-Good				Remove
793 794 795	Honey Locust White Ash Basswood	Gleditsia triacanthos Fraxinus americana Tilia americana	32 26 14	8 8 4	Good Fair Fair	No dieback. No fruit. EAB wounds Shoots at base	_ _ _		Remove Remove
796 797	Honey Locust Norway Spruce	Gleditsia triacanthos Picea abies	29 31.5	8 8	Good Good		_ _ _		Remove Remove
798	Black Walnut	Juglans nigra Juglans nigra	18 22	6	Good Good	-	_		Remove

800	Black Walnut	Juglans nigra	14	6	Good	_	_	Remove
801	Honey Locust	Gleditsia triacanthos	24	8	Fair-Good	_	_	Remove
802	Black Walnut	Juglans nigra	31	8	Good	_	_	Remove
803	White Ash	Fraxinus americana	15	6	Poor-Fair	Early senescence in upper crown	_	Remove
804	Shagbark Hickory	Carya ovata	25	12	Fair-Good	Based on fence location, not a boundary tree	_	Remove
805	Shagbark Hickory	Carya ovata	30	10	Good	_	_	Remove
806	Shagbark Hickory	Carya ovata	28	10	Good	_	_	Remove
807	Shagbark Hickory	Carya ovata	26	10	Good	_	_	Remove
808	Shagbark Hickory	Carya ovata	31	10	Good	_	_	Remove
809	Silver Maple	Acer saccharinum	41 @ 0.2 m	8	Fair	Low fork	_	Remove
810	Norway Spruce	Picea abies	28	8	Good	_	_	Remove
811	Norway Spruce	Picea abies	22	8	Good	_	_	Remove
812	Norway Spruce	Picea abies	27, 20, 13 [36]	8	Fair	Low forks	_	Remove
813	Norway Spruce	Picea abies	18	5	Good	_	_	Remove
N1	Austrian Pine	Pinus nigra	Approx 30	6	Fair	Codominant leaders in upper crown	2.4	Preserve

N2	Austrian Pine	Pinus nigra	Approx 30	6	Good	_	2.4	Preserve
N3	Eastern White Pine	Pinus strobus	18	8	Fair	Trunk edge almost at fence. Crown overhanging	1.8	Preserve

Trees to be retained are to be protected through the establishment of a minimum tree protection zone (TPZ) as per **Table 1** and illustrated in **Figure TP-1**.

It is recommended that these trees be protected by installing tree protection hoarding at the limit of the development as illustrated in **Figure TP-1**. Hoarding shall consist of 1.2 m high plastic mesh affixed to paige wire fencing supported by metal t-bar posts spaced a minimum of 2.4 m apart, with a top 2x4 wood rail for additional support as illustrated in **Figure TP-1**. Erosion and sediment control fencing may double as tree protection fencing.
