**PROJECT NO.: NT21099-S**

December 16, 2022  
Revised Date: November 6, 2023

**SLOPE STABILITY ASSESSMENT  
343 YORK ROAD  
NIAGARA-ON-THE-LAKE, ONTARIO**

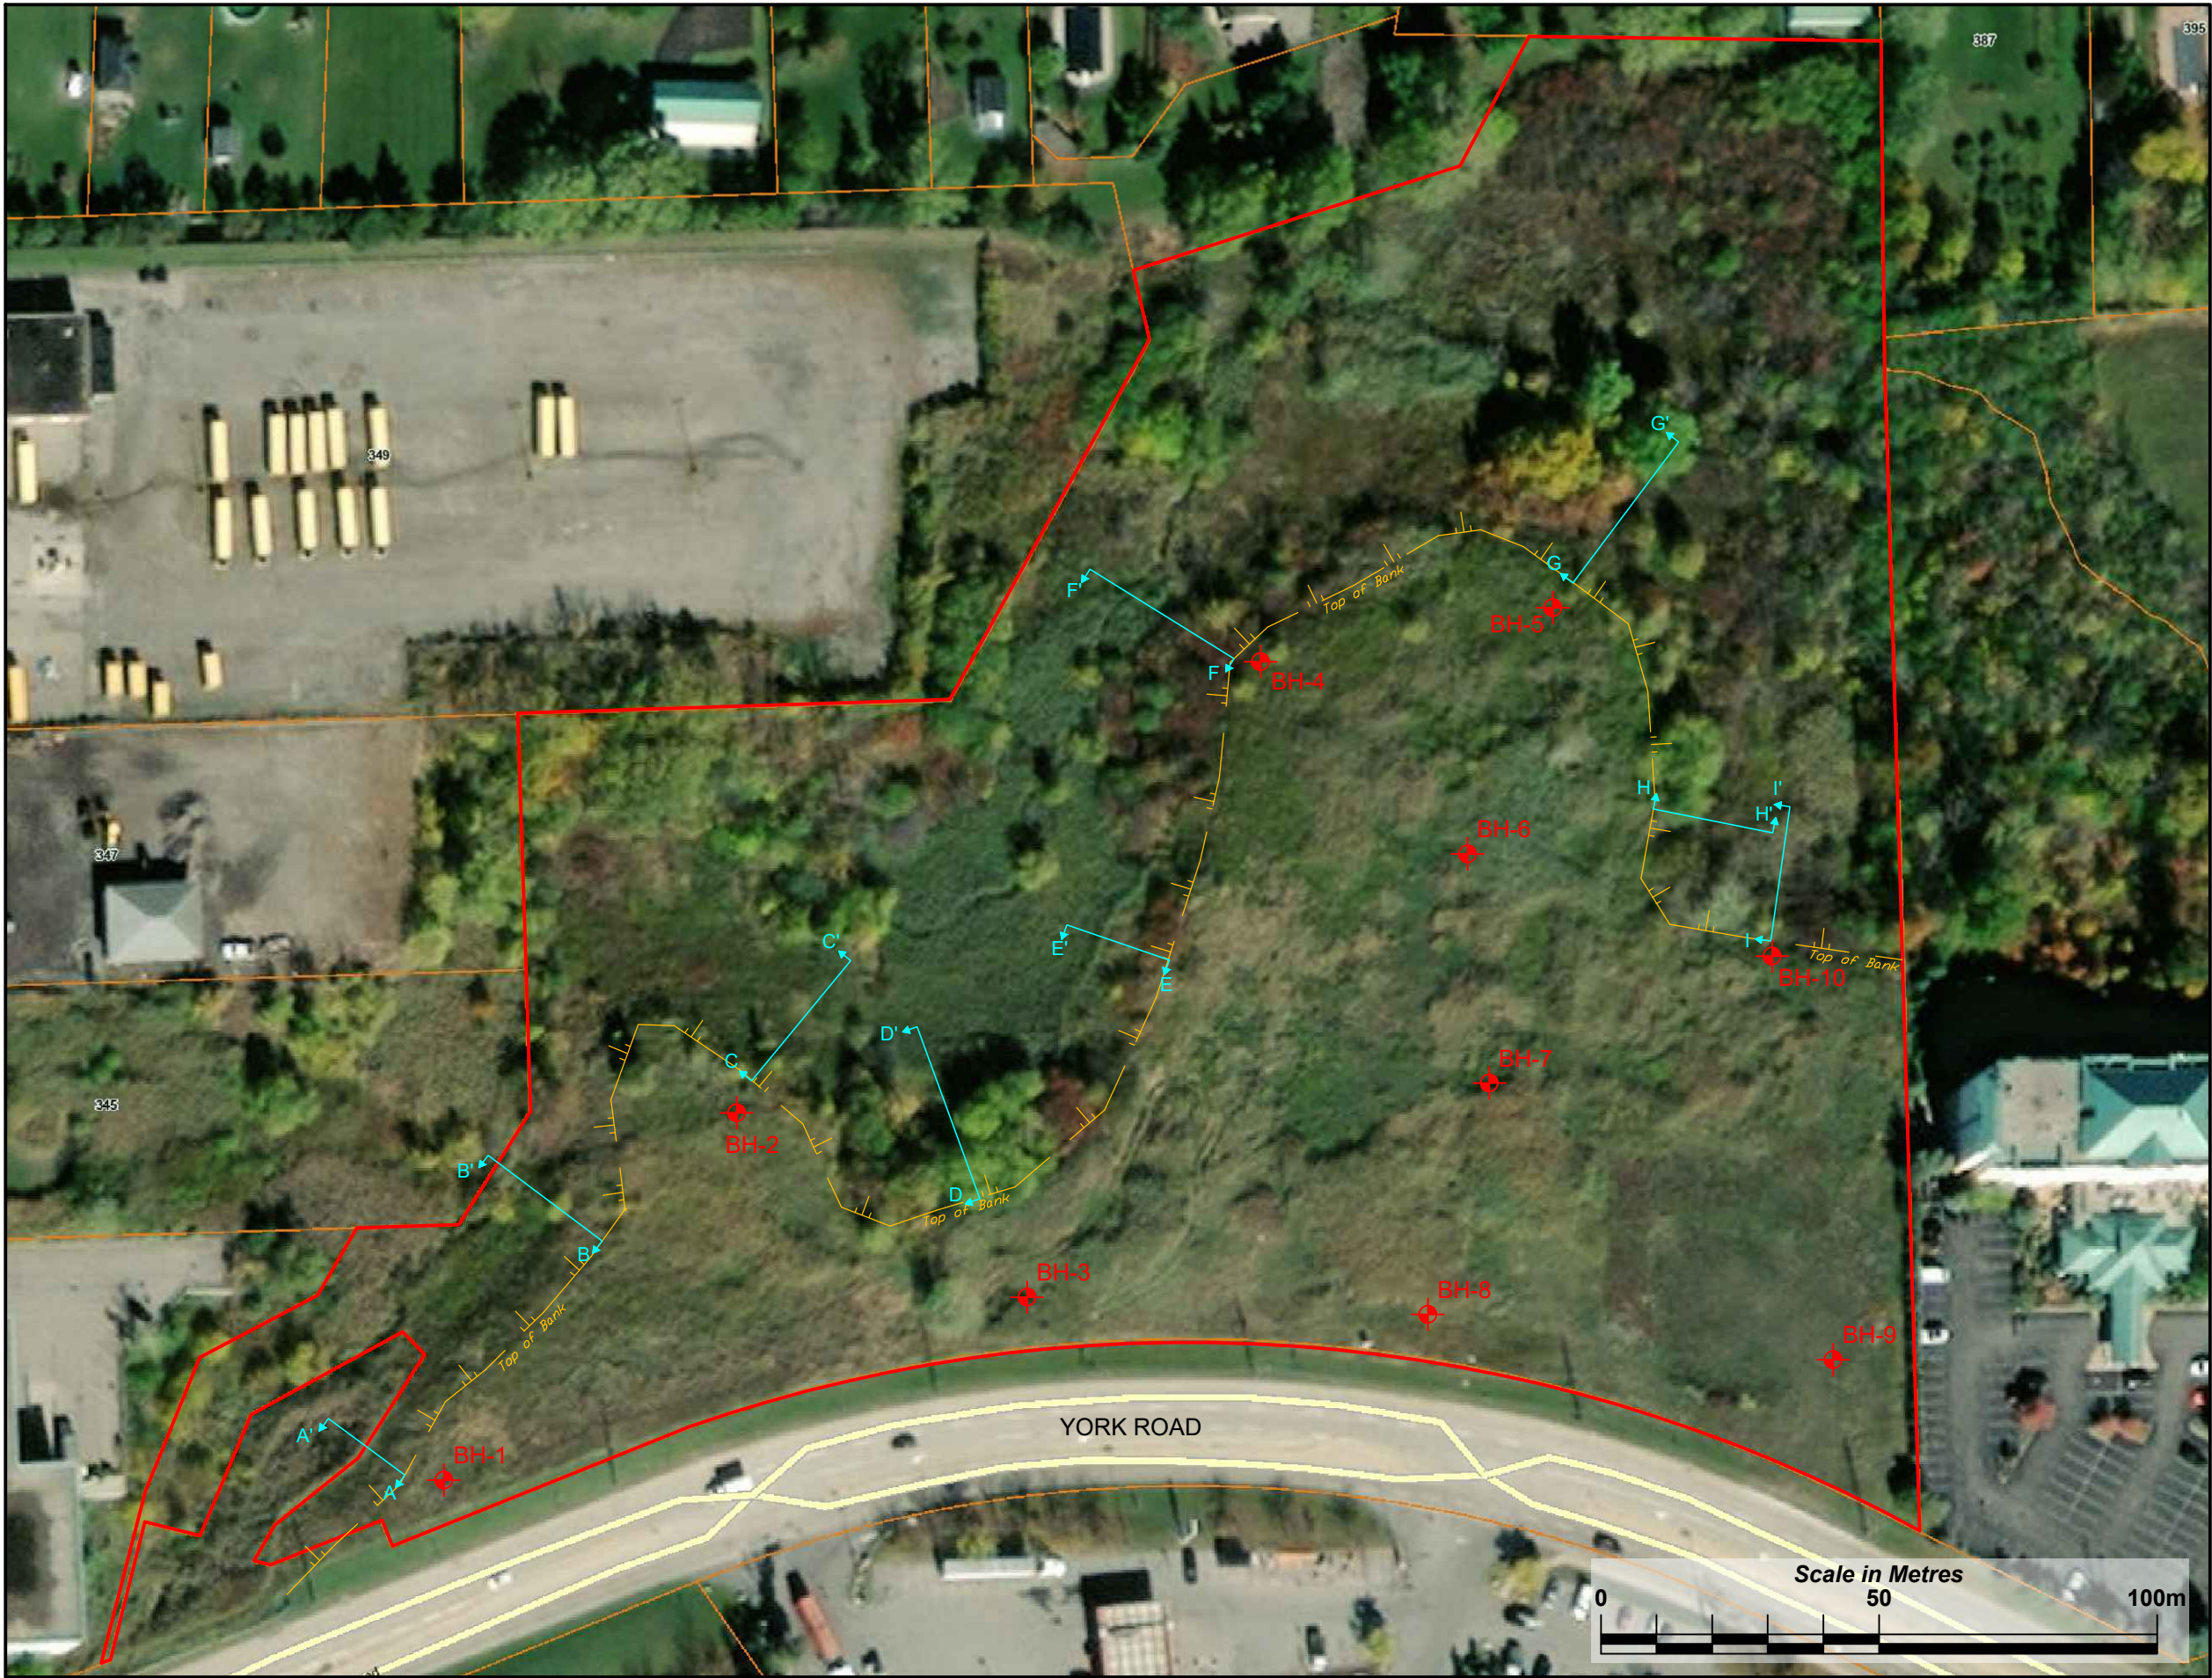
NO: **DRAWING 1**

The slope profiles were undertaken on October 14, 2021, the recorded overall angle of the subject slopes [between slope 'toe' and physical top of slope] and slope profile heights for each slope profile are summarized in the table below. The area beyond [south] of the Physical Top of Slope is a relatively flat grass covered field extending well past the Top of Stable Slope.

There were no significant slope failure 'scars' observed across the subject slopes and there were no 'tension' cracks observed near the 'crest' of the slopes. The subject slope has evidently remained stable for a very long period of time with only slow flattening of the slope, associated with natural weathering process, freeze-thaw, wetting-drying, etc. of the exposed silty clay material. This degeneration of the slope is a very slow process spanning multiple years to decades. Deep-seated stability is not a concern in this case. The subject slope is covered with scrub vegetation, as well as some other surficial vegetation.

- Drainage over the slope should not be altered.
- We would recommend that a Silt fence be installed along the northern limit of the construction area to control access and damage to the subject slope.
- Vegetation must be maintained on the slope both during and post construction to limit/minimise erosion from surface runoff.
- Should any surficial damage to the 'face' of the slope be caused during construction it should be repaired with vegetation native to the area and approved by the Niagara Peninsula Conservation Authority. This requirement is best assessed in the field and following comments/recommendations from NPCA.
- The construction staging area [stockpiling of construction materials] should be designated away from the subject slope.
- Construction should be undertaken to limit damage to the existing slope.

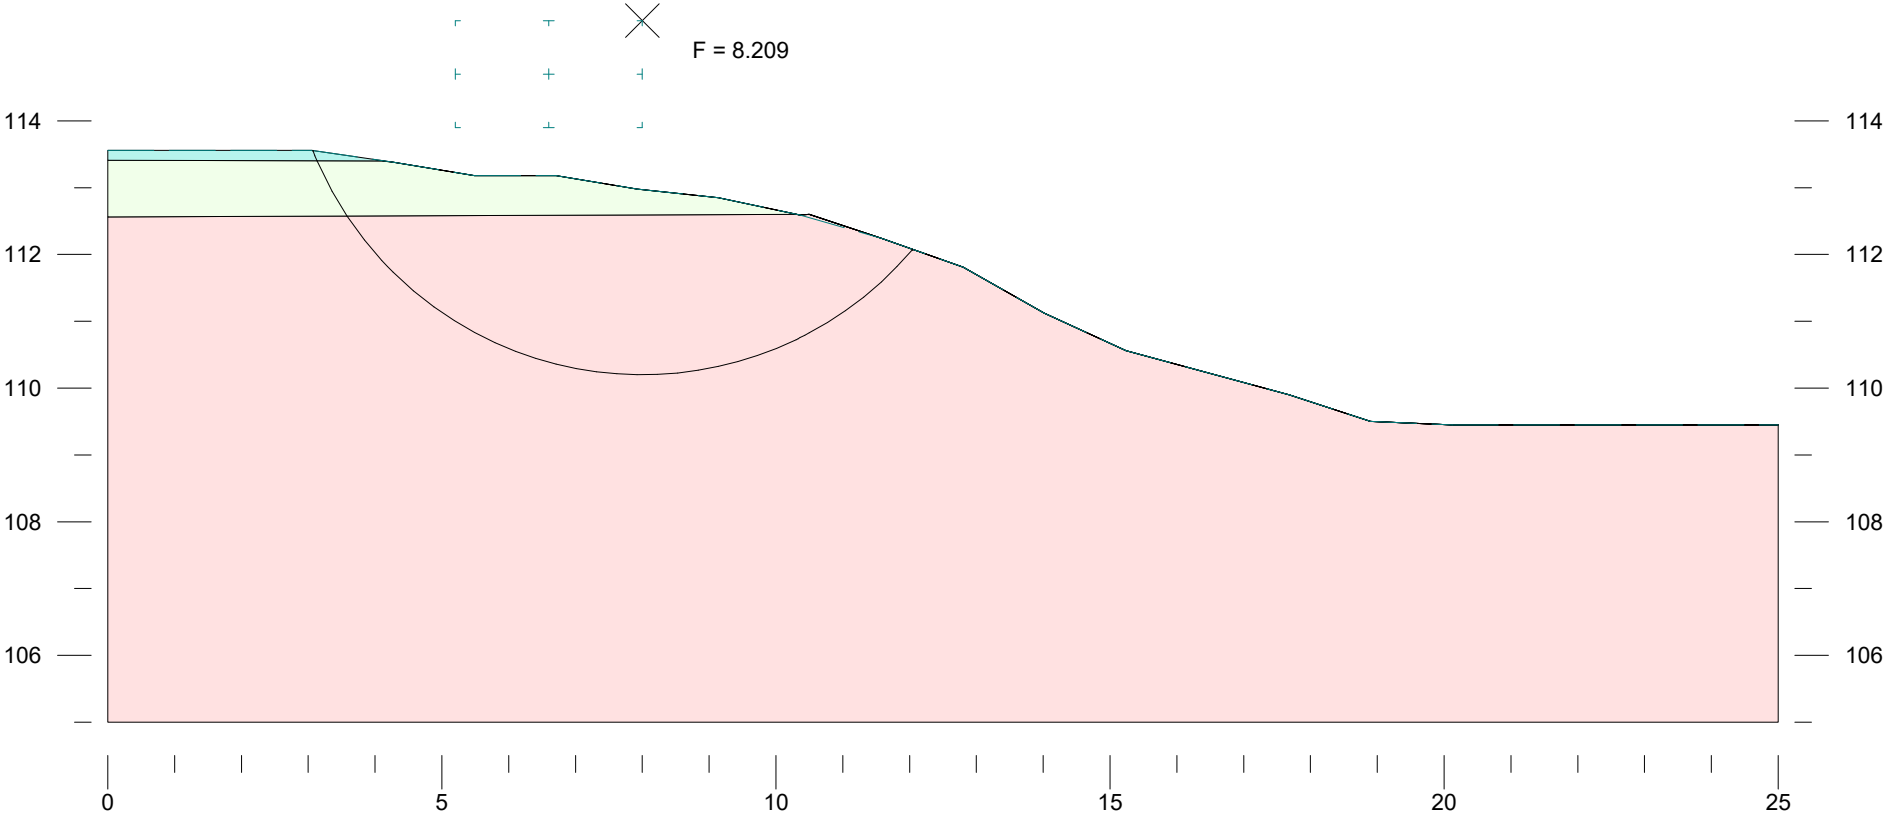
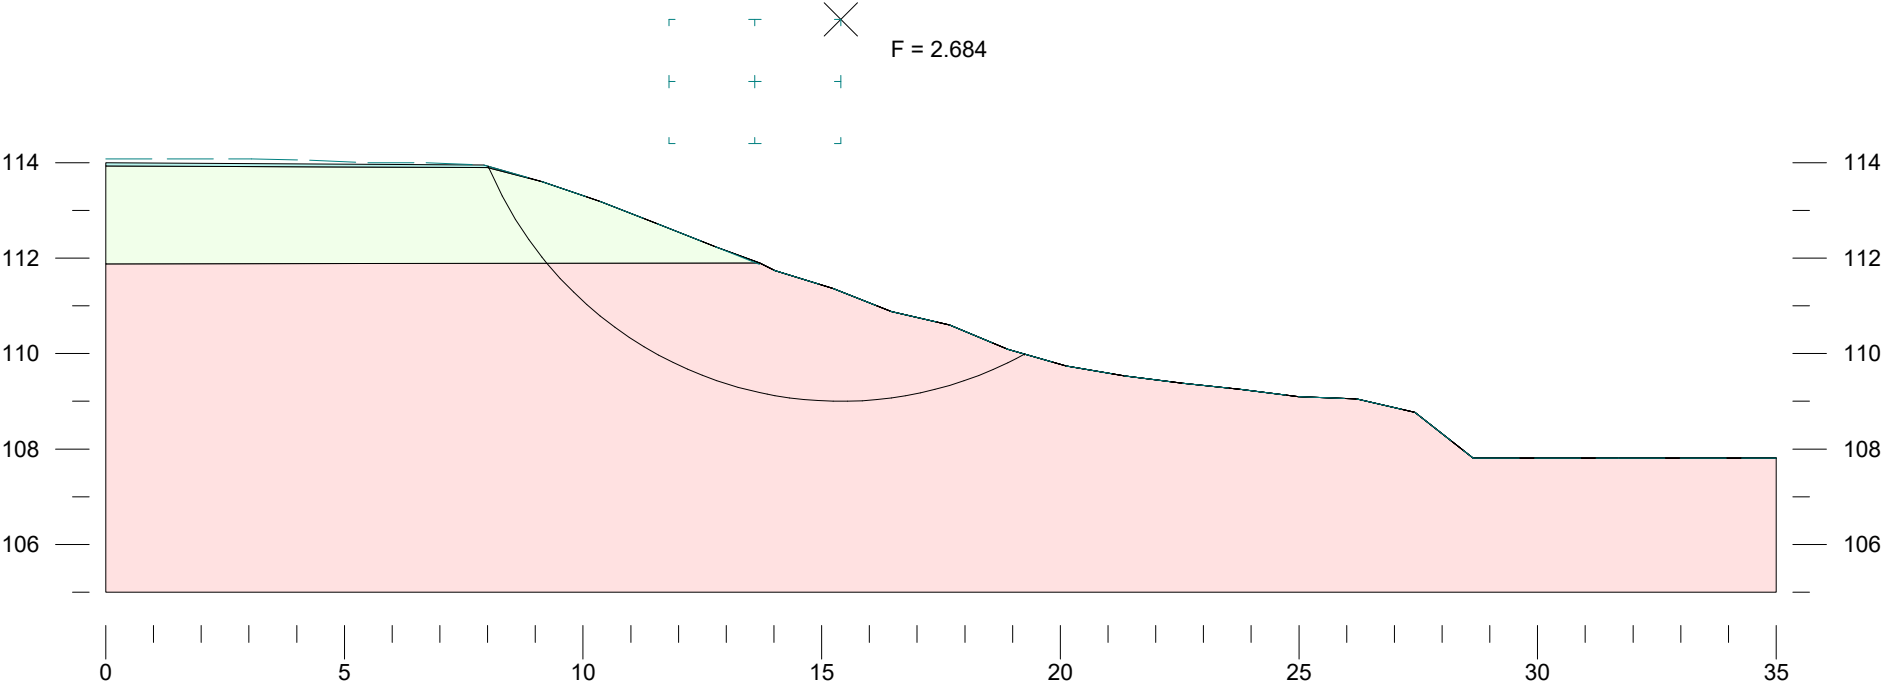
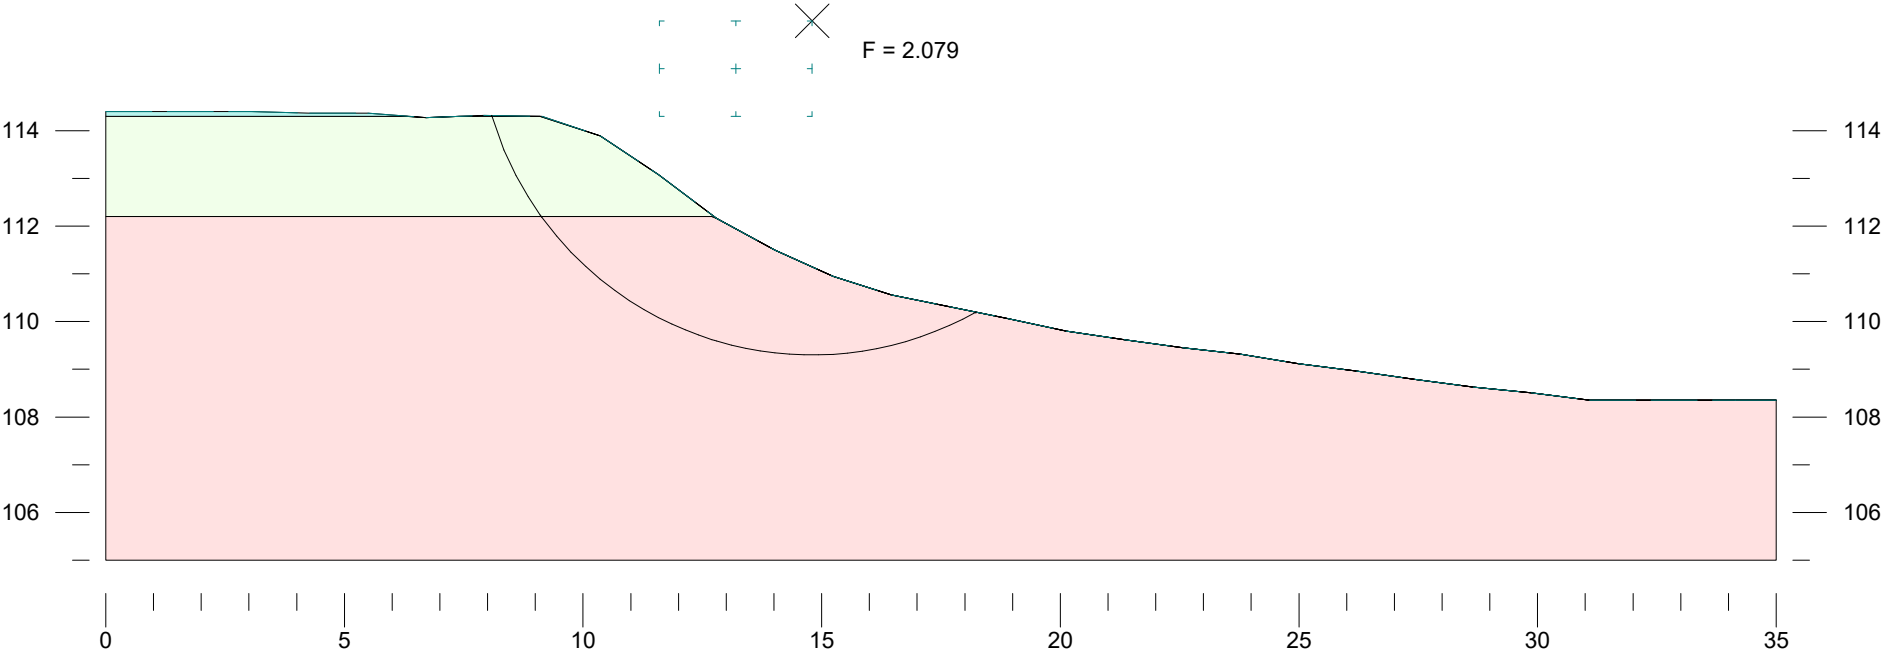
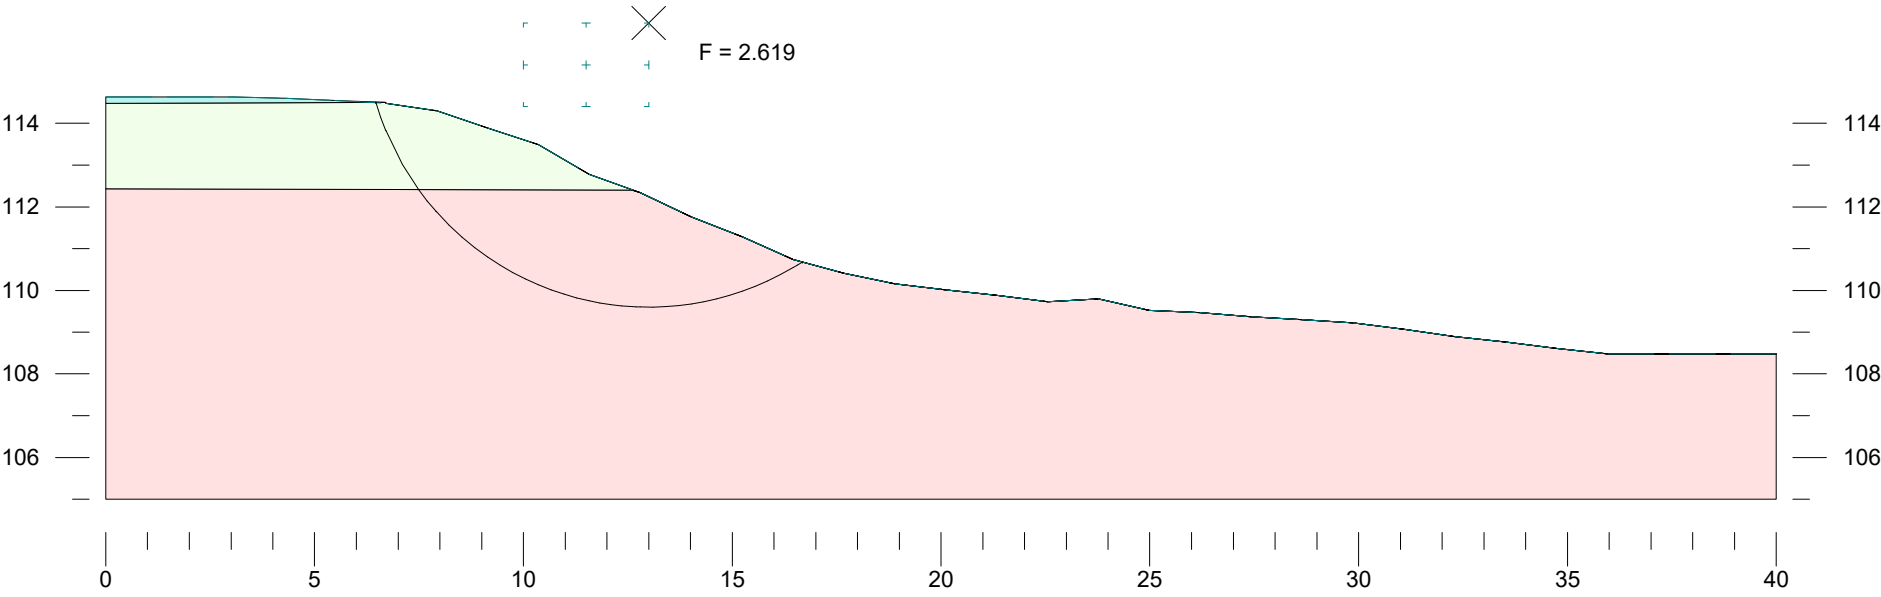
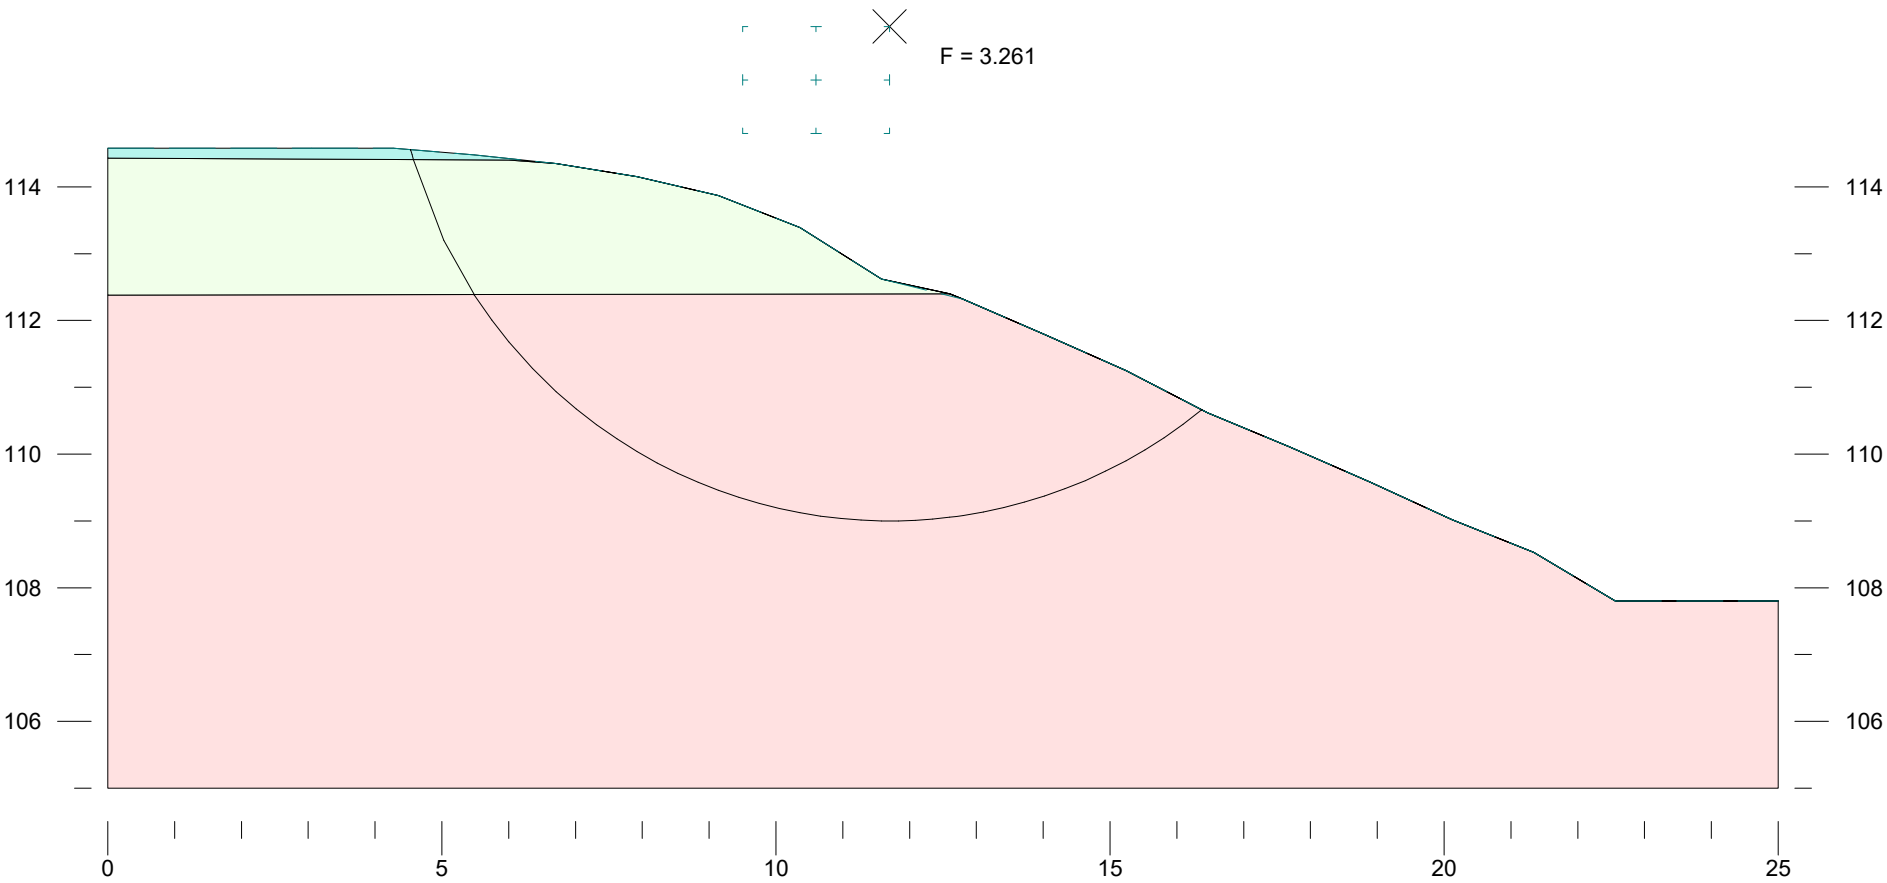
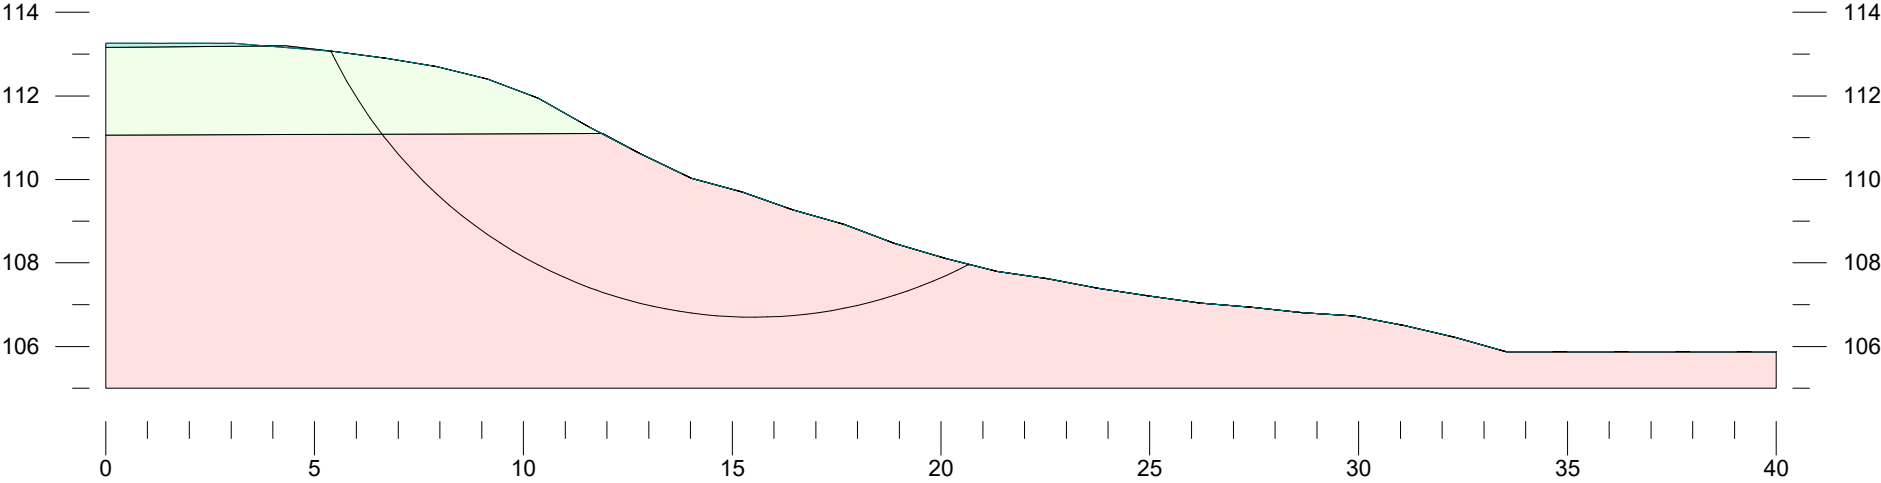
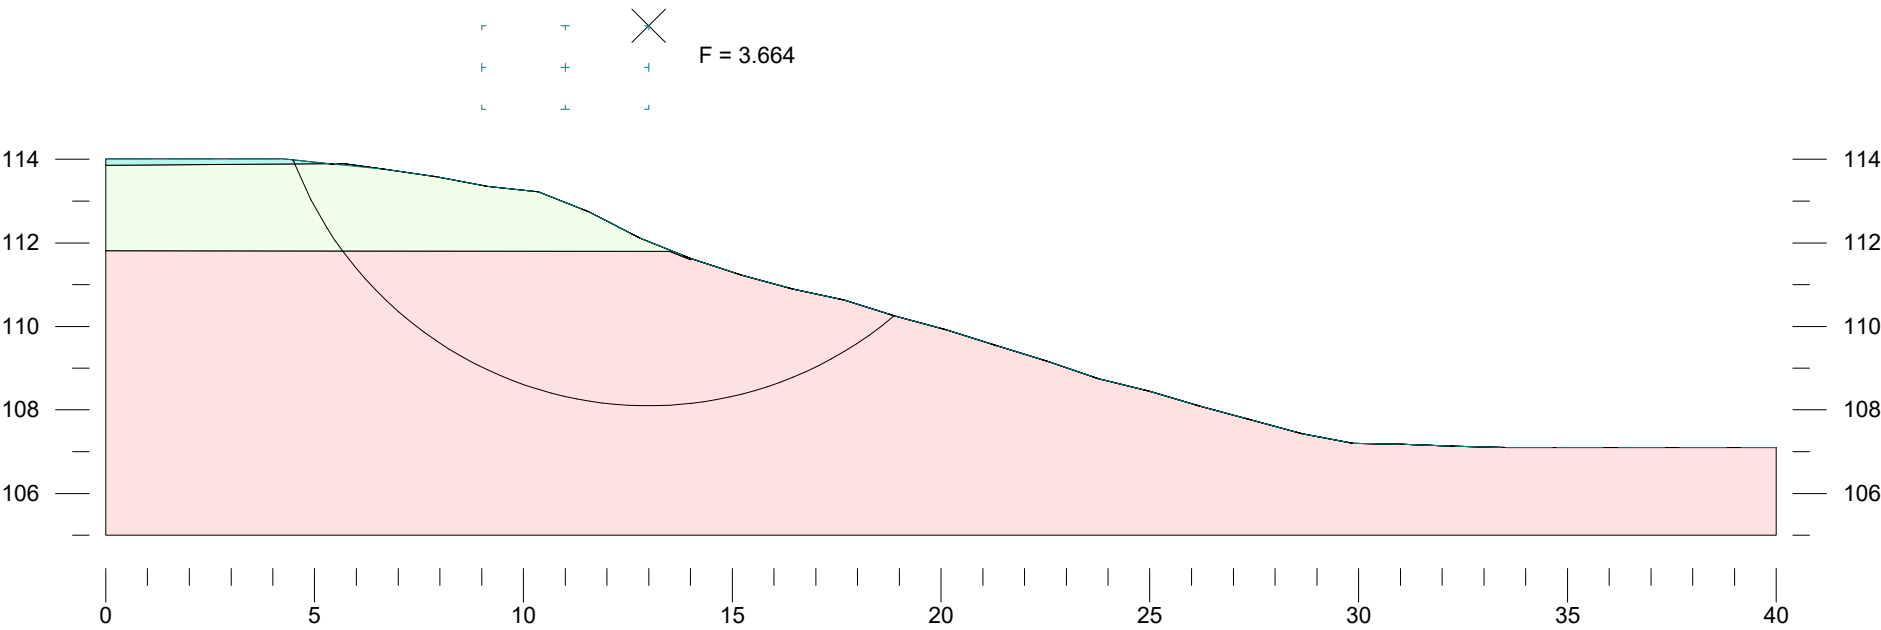
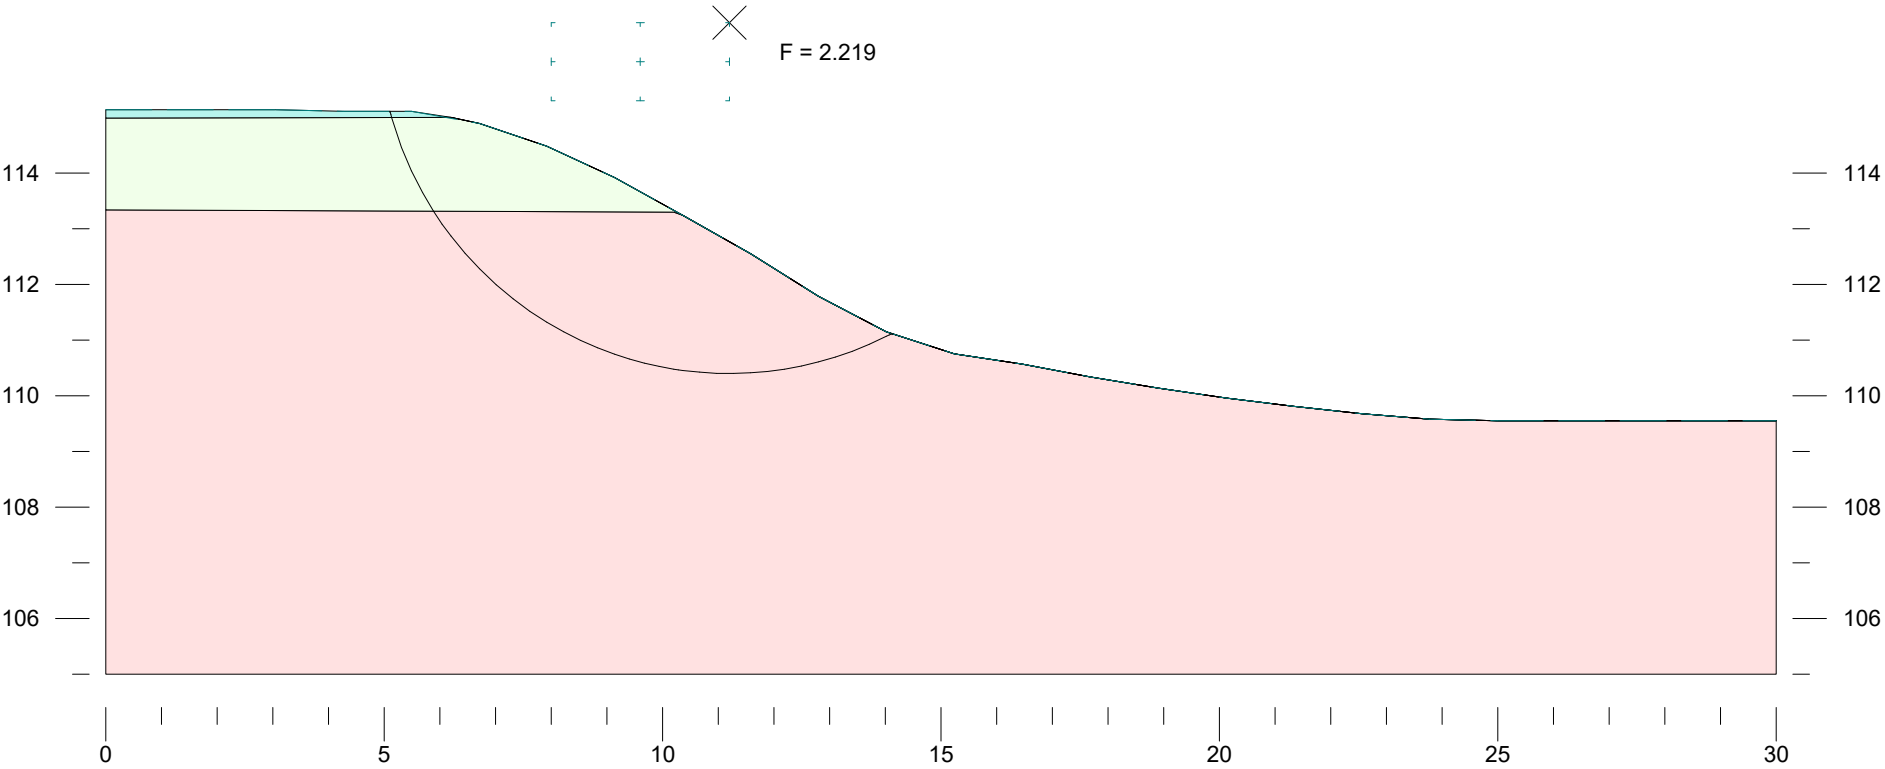
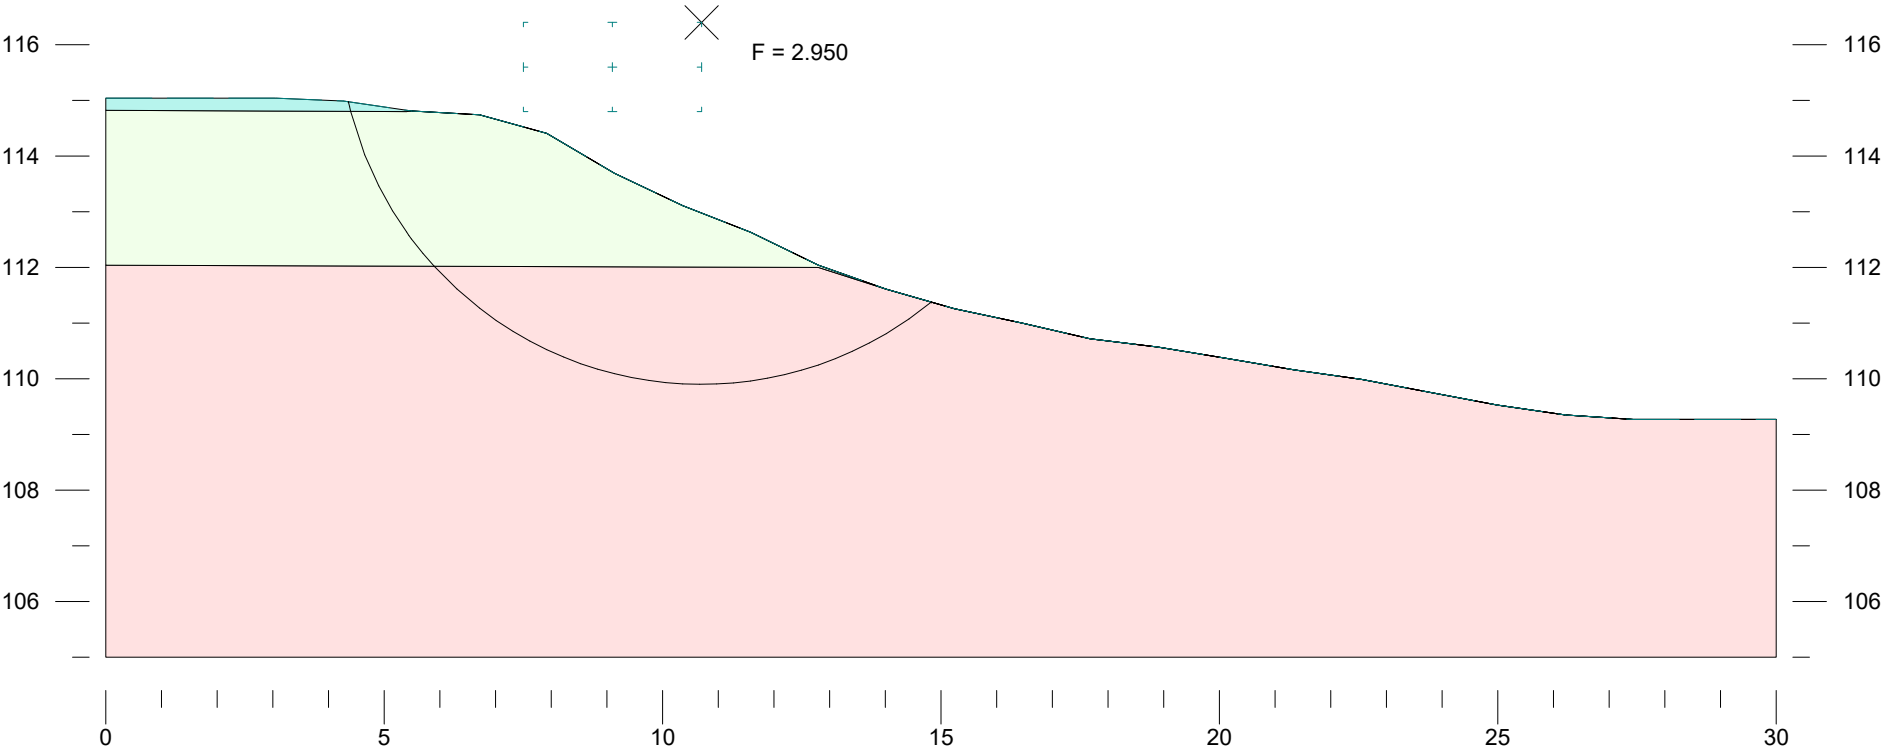
Stability analyses of the subject slope was performed with a computerized modeling program [GSlope 2021] for the nine slope profiles. Analyses were conducted considering multiple failure planes, ultimately through the designated Top of Stable Slope. The material parameters assigned to the topsoil were Unit Weight of 15.0 kN/m<sup>3</sup>, Friction Angle of 30 degrees and Cohesion of 0 kPa, the material parameters assigned to the silty clay fill were Unit Weight of 17.0 kN/m<sup>3</sup>, Friction Angle of 30 degrees and Cohesion of 0 kPa, and the material parameters assigned to the native silty clay / clayey silt were Unit Weight of 19.0 kN/m<sup>3</sup>, Friction Angle of 32 degrees and Cohesion of 2 kPa.

<b>Profile I.D.</b>	<b>Calculated Factor of Safety</b>
<b>A-A</b>	8.209
<b>B-B</b>	2.684
<b>C-C</b>	2.079
<b>D-D</b>	2.619
<b>E-E</b>	3.261
<b>F-F</b>	2.466
<b>G-G</b>	3.664
<b>H-H</b>	2.219
<b>I-I</b>	2.950

The results of these analyses are attached to this report [Figure Nos. 1 to 9, inclusive]. It is noted that theoretical surficial failure planes would exist with marginally lower calculated factors of safety, however these models do not account for the stabilizing effect of surface vegetation. Further any such shallow surficial movements would not impact the global stability of the slope.
