228 Queen Street
Niagara-on-the-Lake, ON

Van Riesen Hotel Group Inc.
PO Box 612
St. Davids, ON L0S 1P0

Tree Preservation Plan

JACKSON ARBORICULTURE INC.

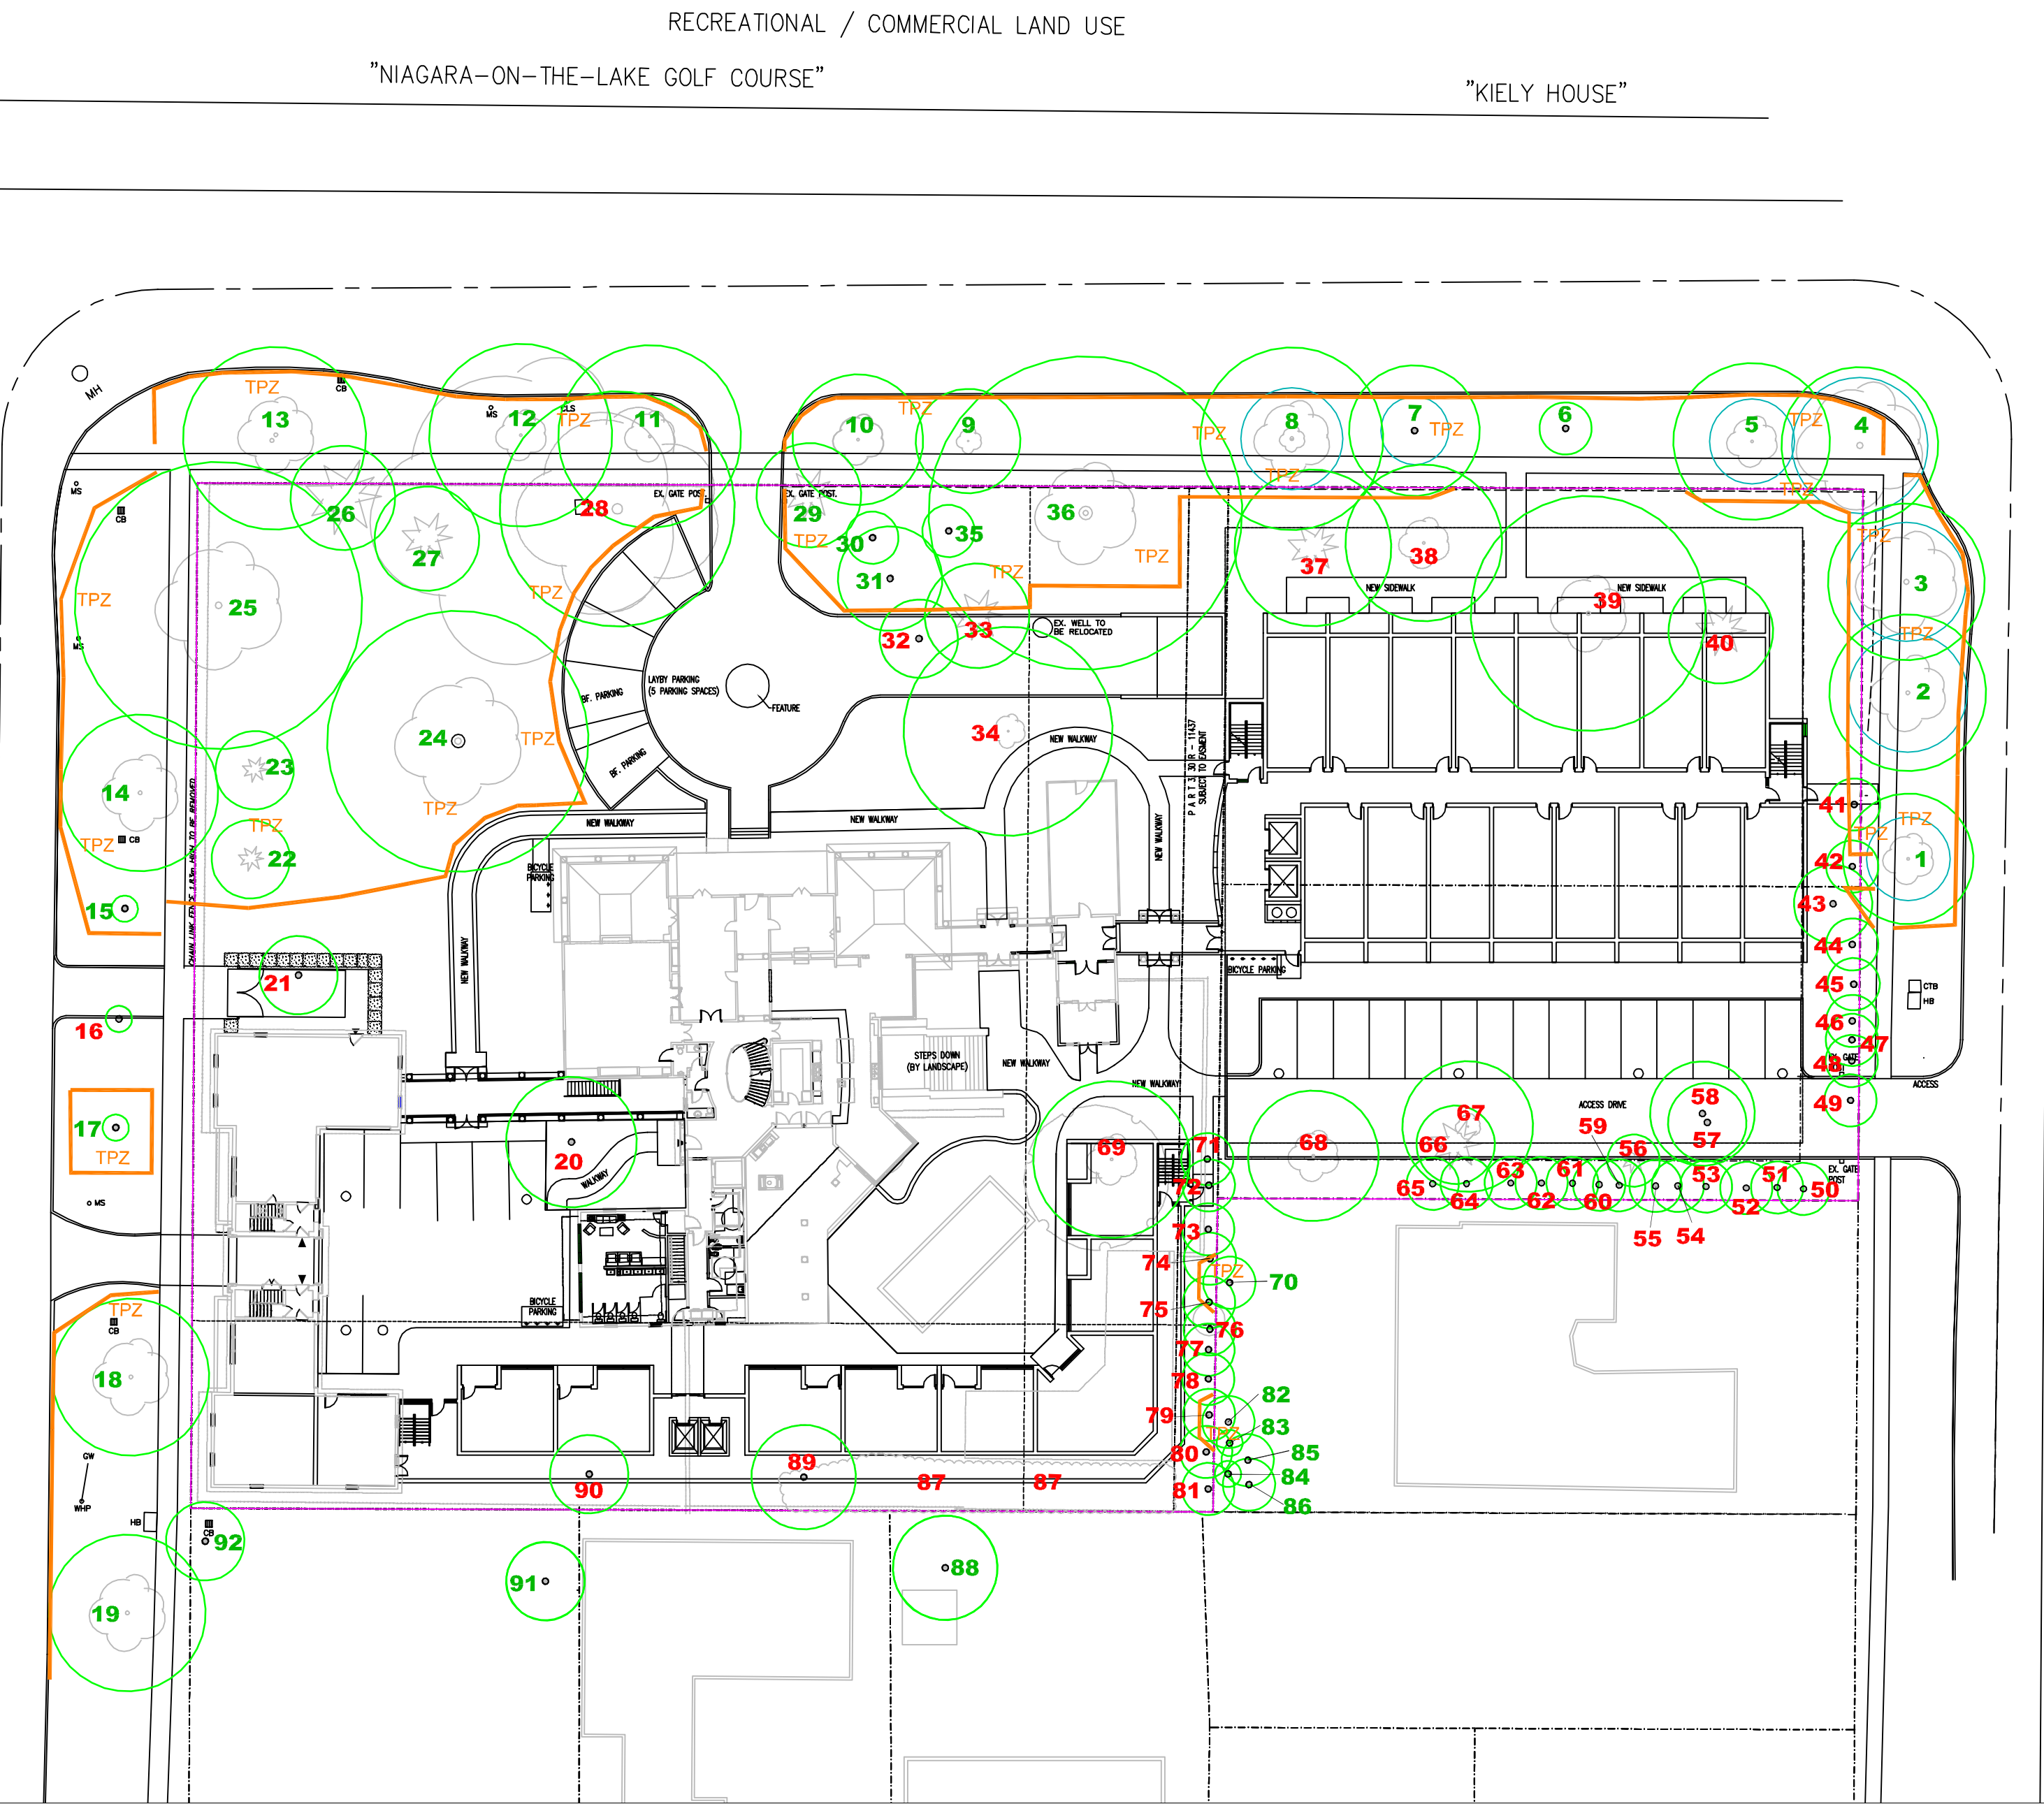
Sheet # 1

Note:
Encroachment within the driplines of Trees 10, 11 and 29 will be required to accommodate the proposed concrete driveway. A gravel driveway already exists adjacent to tree 29 and it is anticipated that few tree roots reside below the existing driveway. Where the curb is proposed within the driplines of Trees 10 and 11, air spade excavation will be required to excavate the limit of the proposed curb to gently expose any tree roots that reside within the area of encroachment. If any roots are exposed they must be pruned by a Certified Arborist in accordance with good arboricultural practice to ensure that the root systems are not damaged by construction.

Note:
Encroachment within the dripline of tree 24 will be required to accommodate the proposed patio stone walkway and parking spaces. If any roots are exposed by construction they must be pruned by a Certified Arborist in accordance with good arboricultural practice to ensure that the root system is not damaged. It is recommended that tree 24 be watered during construction and for 1 growing season after construction is complete to ensure that it responds well to the impacts from development. Approximately 100 gallons of water should be applied during each watering event. The tree should be watered once per week during weeks where there is no significant rainfall. The water should be applied gently and slowly to the ground surface to ensure that it does not run away from the root system overland.

- The proposed encroachment area within the dripline of trees 10 and 11 must be excavated using air spade excavation to gently expose any roots that may conflict with development.

- Trees 24 and 36 will require watering as outlined in the note on this drawing.
 - Tree protection fencing should be inspected by a Certified Arborist prior to and during construction to ensure that the fencing remains intact and in good repair throughout the stages of development.
