PROJECT NO.: 2020-161-G

February 12, 2021

**PRELIMINARY SLOPE STABILITY ASSESSMENT
PROPOSED COMMERCIAL DEVELOPMENT
353 TOWNLINE ROAD, NIAGARA-ON-THE-LAKE, ONTARIO**

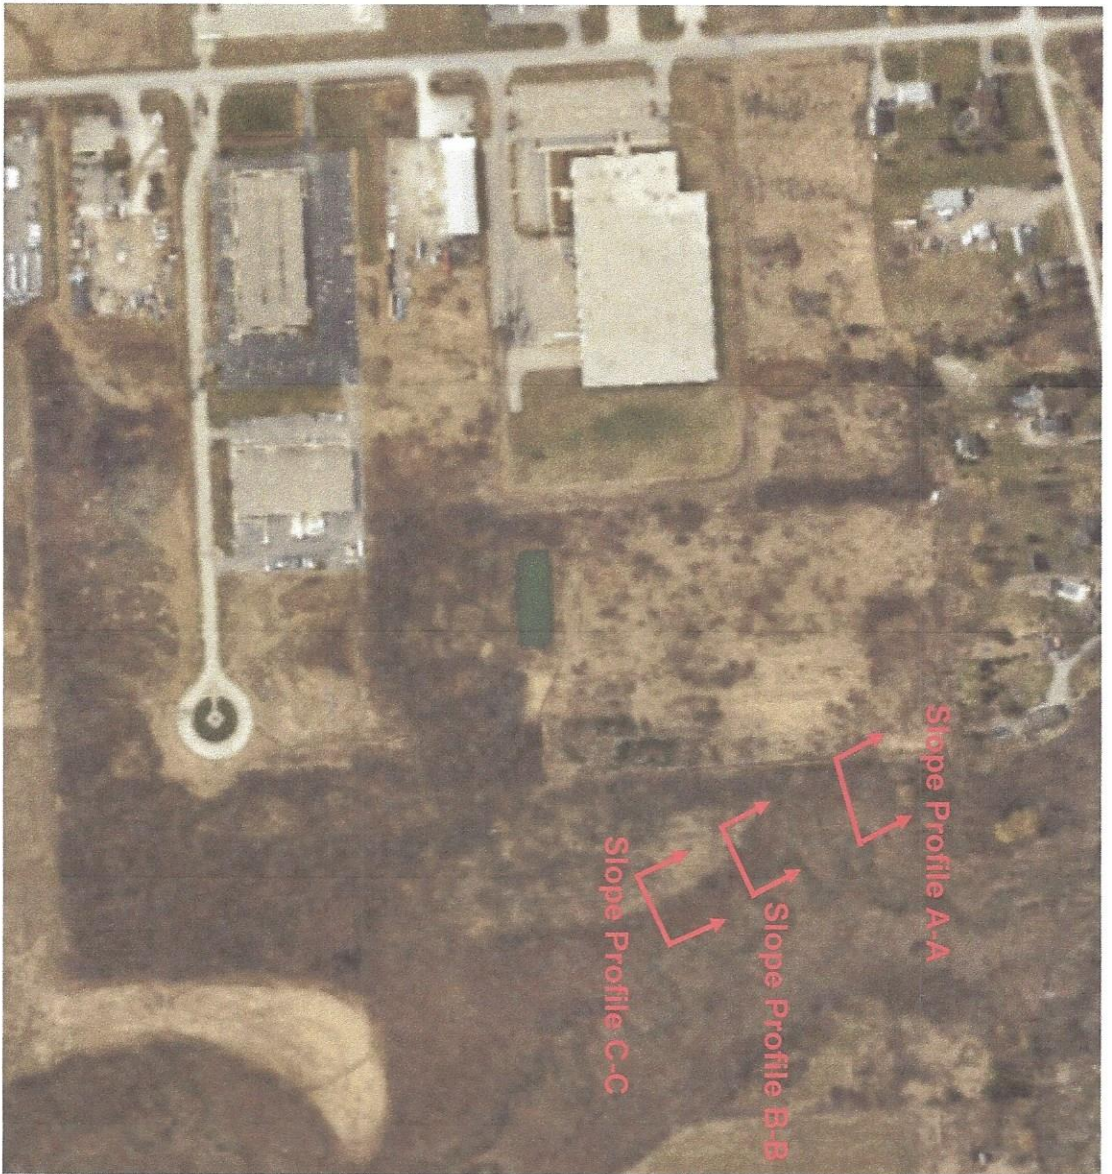
rating of 27, which indicates a slight potential and therefore the need for a site inspection, surveying, preliminary study and a report letter. Three slope profiles were measured across the property at the locations illustrated in Drawing No. 1 Slope Profile Location Plan and presented in Drawing Nos. 2, 3 and 4, Slope Profile Sections A-A, B-B and C-C, respectively.

All surveying associated with determining the ground surface elevations for Slope Profiles A-A [north end], B-B [centre section] and C-C [south end] was carried out by Bendigo Consulting Inc. personnel. The ground surface elevations at the three selected physical top of slopes were referenced to geodetic datum by representatives of J.D. Barnes Limited [Reference No. 20-16-376-00 dated plotted January 11, 2021].

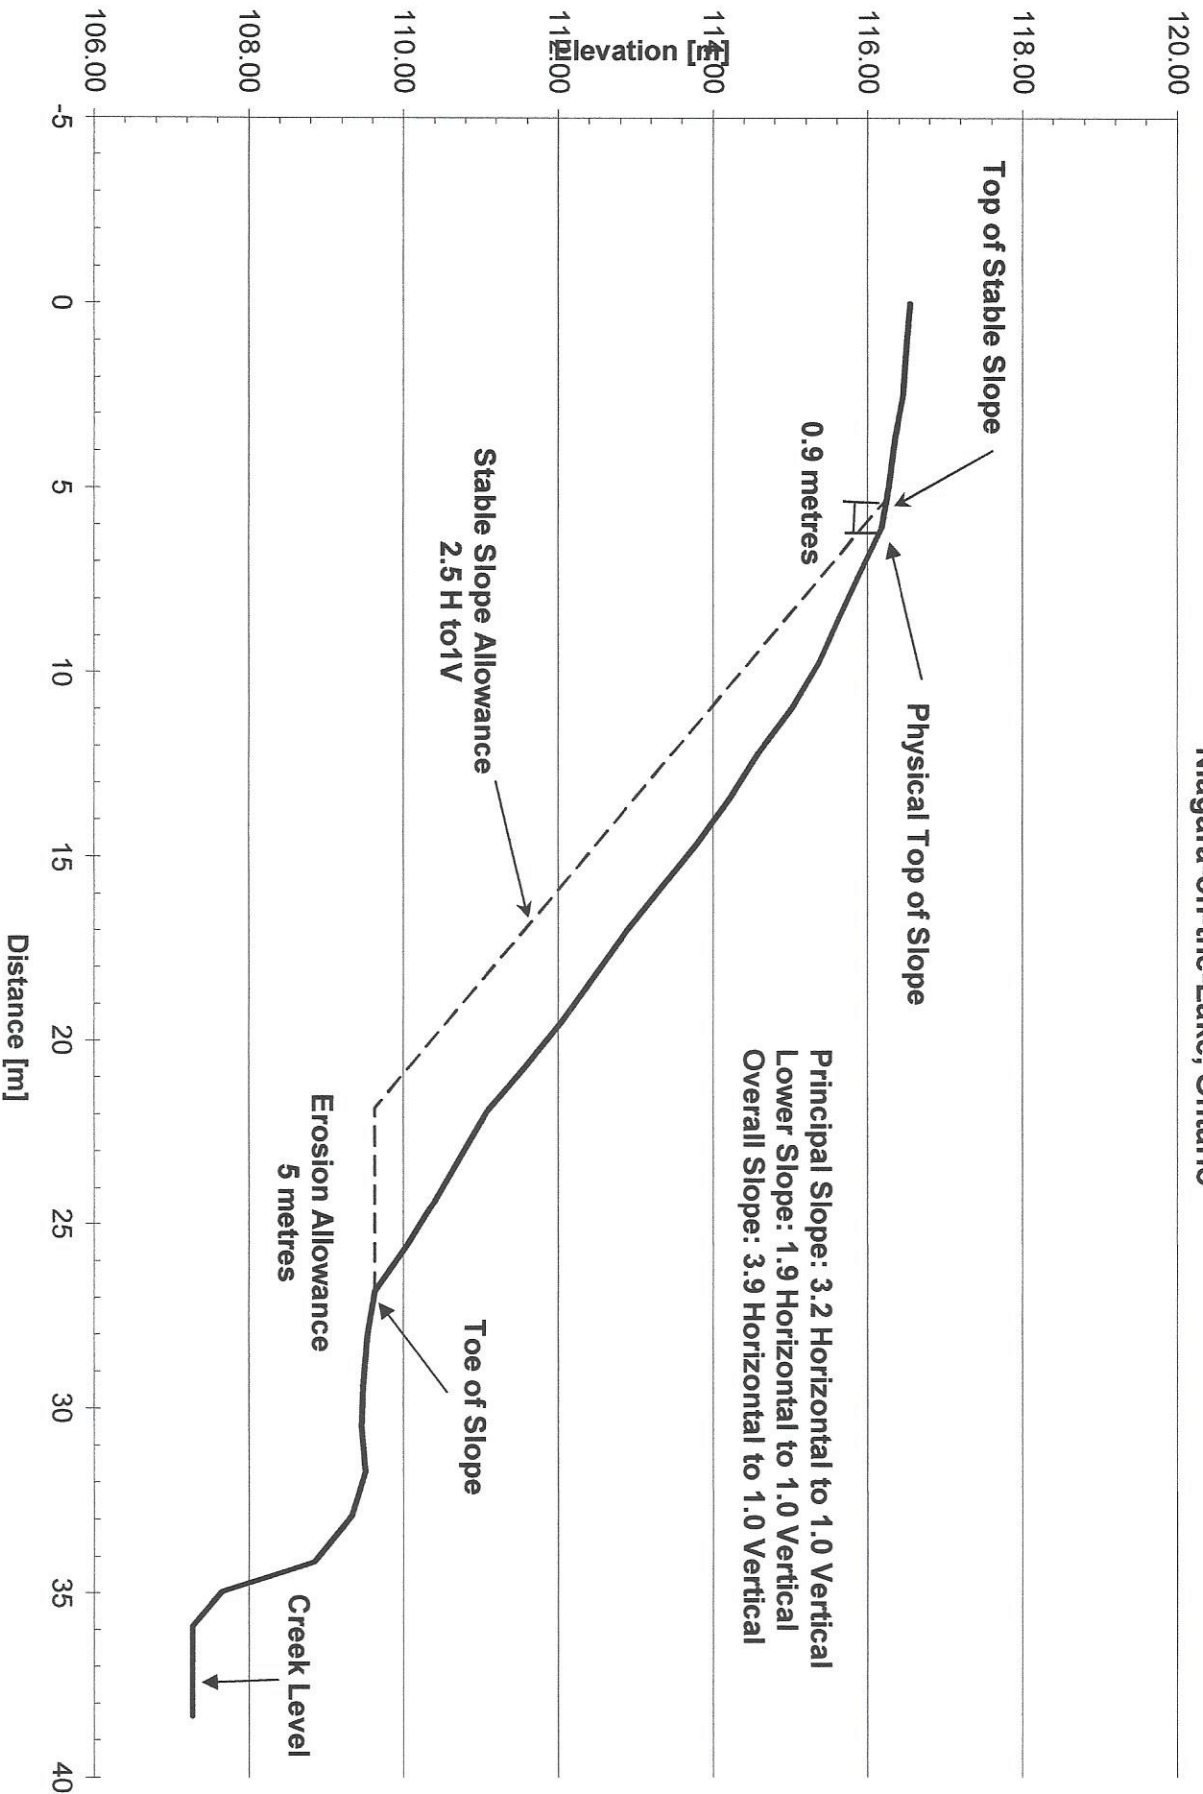
Slope Profile Section A-A
Townline Road
Niagara-on-the-Lake, Ontario

The slope profiles, undertaken on November 6, 2020, found that the overall angle of the subject slopes [between slope 'toe' and top of physical slope] are about 3.2, 2.2 and 2.3 Horizontal to 1 Vertical for Slope Profiles A-A, B-B and C-C, respectively. The upper slope sections [physical top of slope to the western surveyed limit] were found to be about 16.5, 16.8 and 20.0 Horizontal to 1 Vertical for Slope Profiles A-A, B-B and C-C, respectively. There were no significant erosion issues found over the crest the subject slope. In addition, there was found to be some erosion issues at the 'toe' of the subject slope at the bank of the creek.

The Stable Top of Slopes were evaluated following the guidelines in the referenced MNR documents. Specifically this involves applying an allowance for toe erosion, and a long-term stable slope inclination. In this case the toe of the slope is in the very stiff to hard silty clay, which is considered to be rather competent in terms of its strength properties and resistance to erosion. A conservative toe erosion allowance of 5.0 metres has been applied in this case. The selected slope inclination was assessed from observation methodology [assessment of the subject slope from visual observations and surveying measurements] and geotechnical analysis. Based on the current slope profiles and the presence of the native very stiff silty clay, Halton Till material, in the subject slope an inclination of 2.3 Horizontal to 1 Vertical has been used in Slope Profiles B-B and C-C. A slope inclination of 2.5 Horizontal to 1 Vertical has been used for Slope Profile A-A so that it does not 'daylight' into the existing slope. Applying the erosion allowance and stable slope allowances from the existing toe of the slope profiles provides the locations for the long-term Stable Top of Slopes at about 0.9 metres, 12.4 metres and 5.3 metres west of the Physical Top of Slope for Profiles A-A, B-B and C-C, respectively.
