Parliament Oak Hotel, Niagara-On-The-Lake, Ontario, Arborist Report

August 28, 2024

PARLIAMENT OAK HOTEL, NIAGARA-ON-THE-LAKE, ONTARIO, ARBORIST REPORT

Tree Management Plan

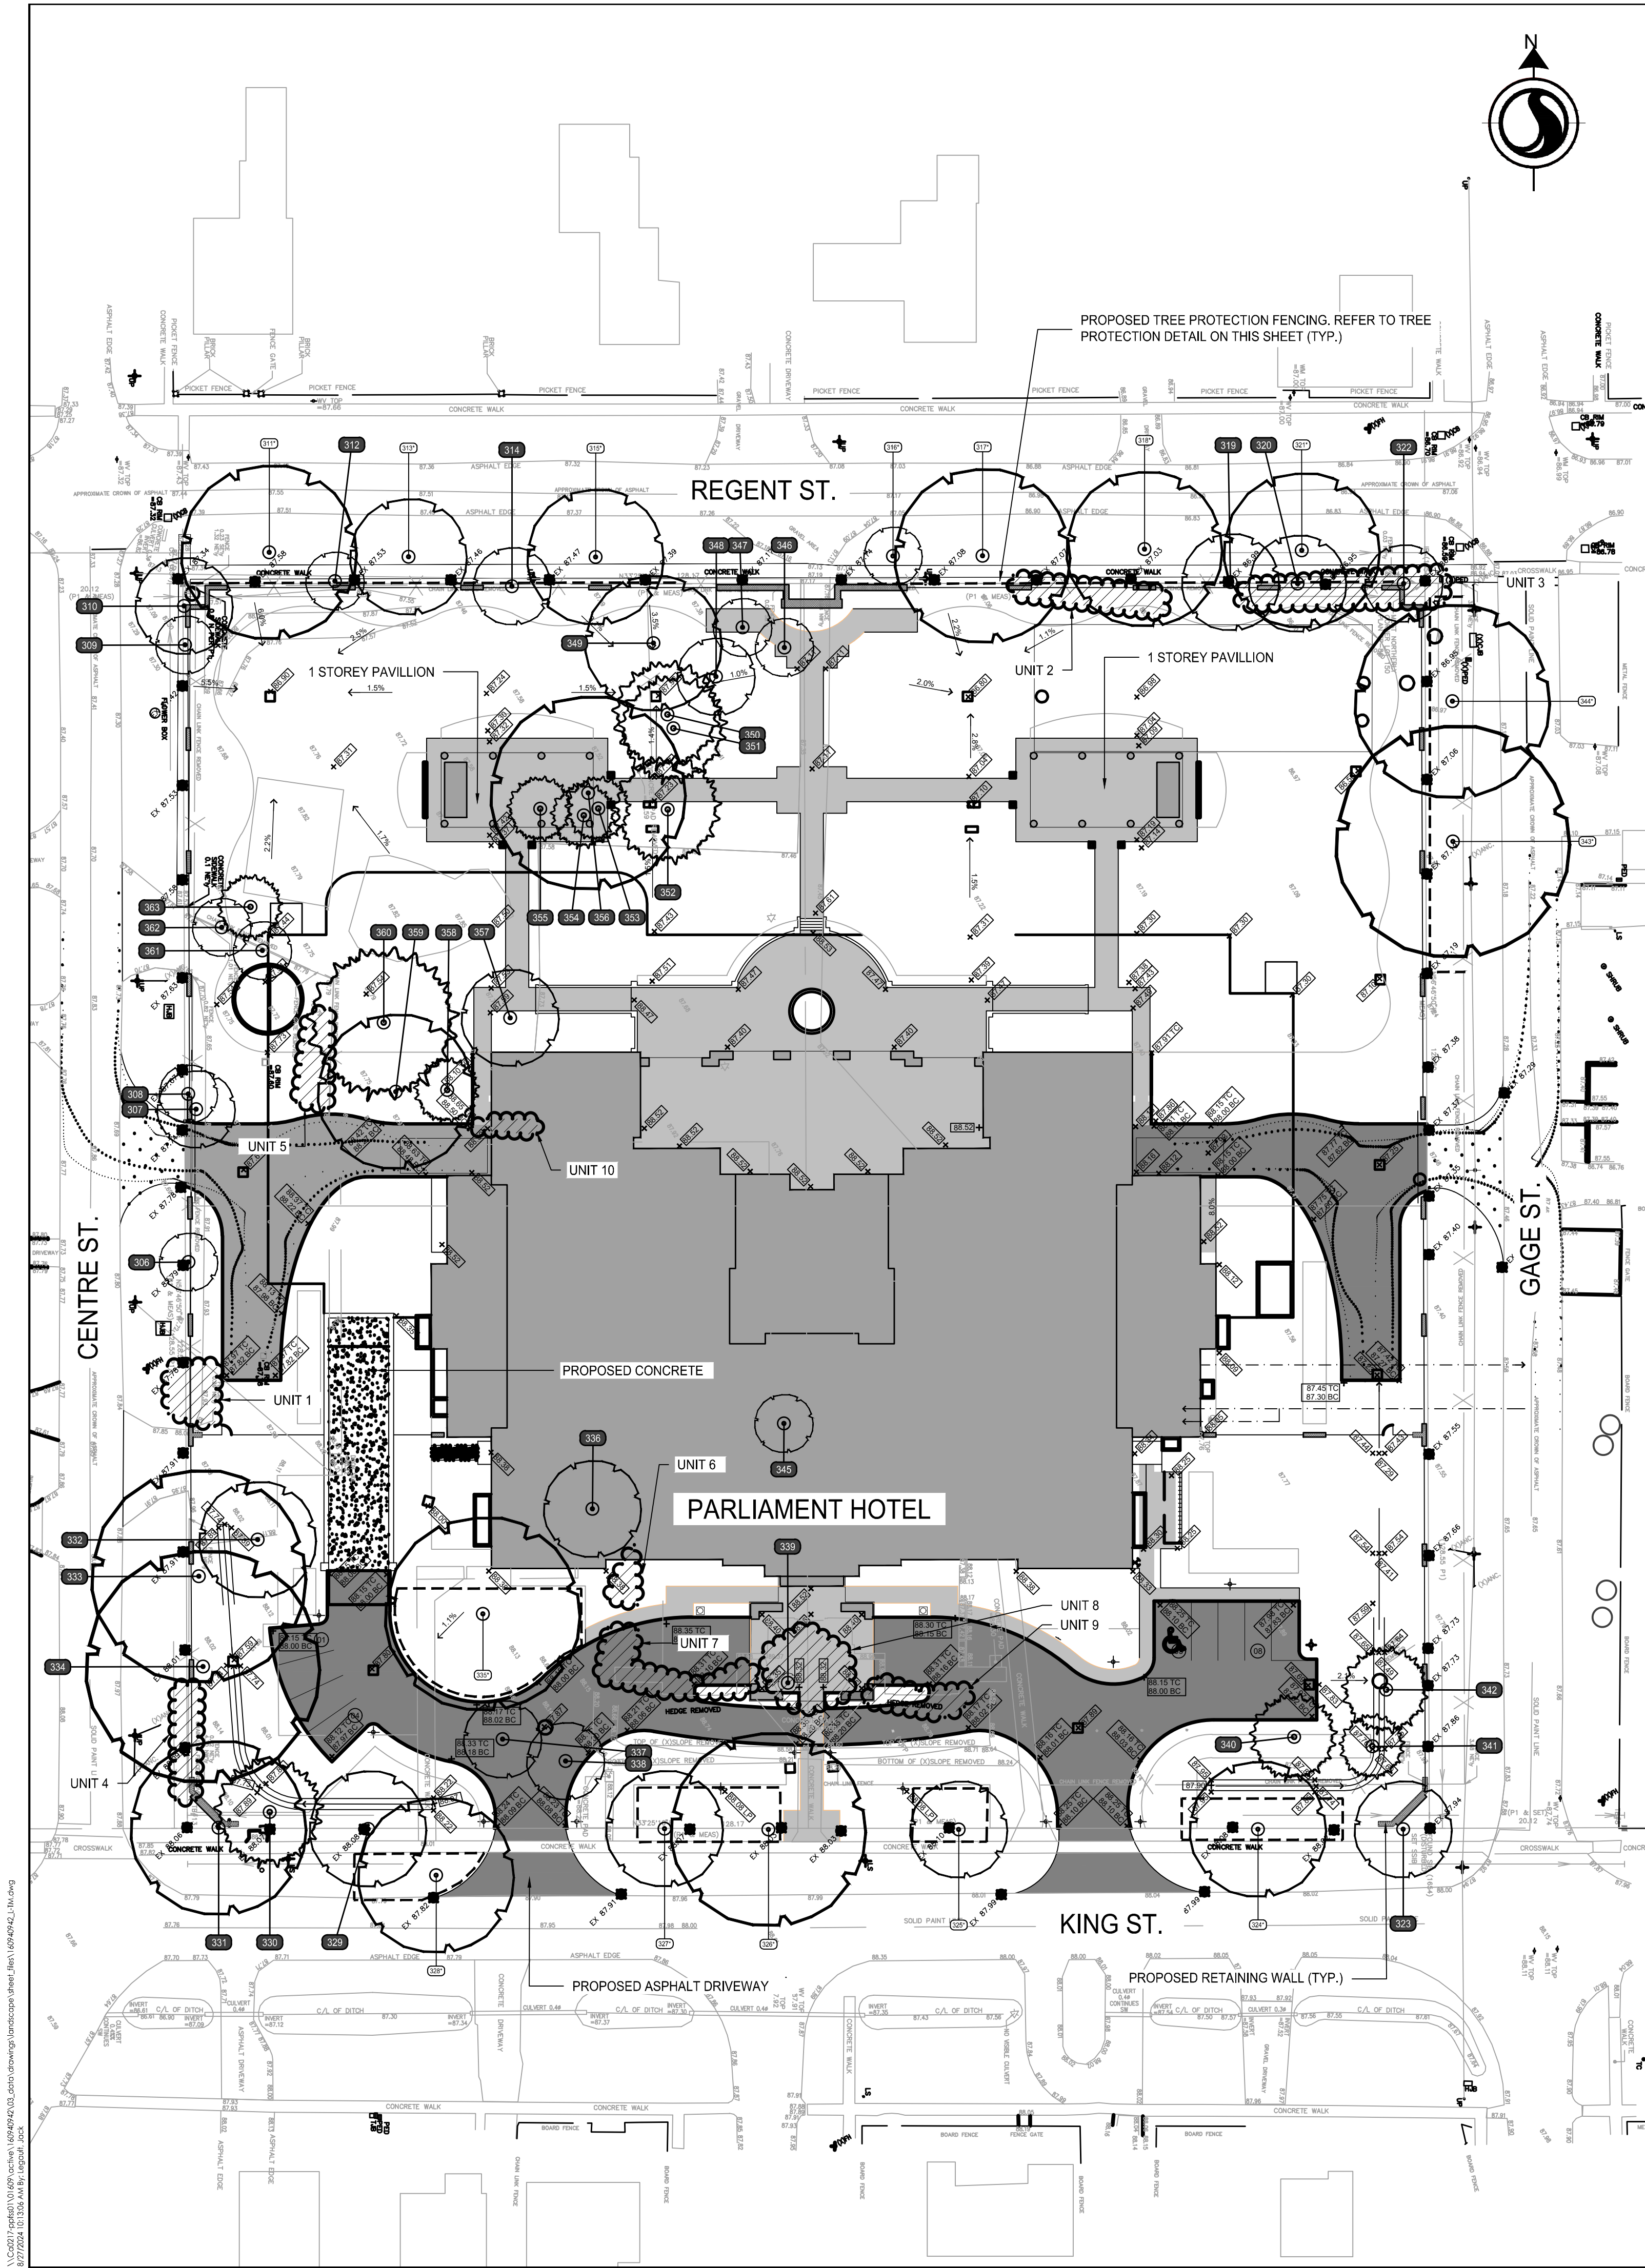
L-900

- **Protect - Reduced TPZ:** Fifteen (15) trees (#311, #313, #315-318, #321, #324-328, #335, #343-344) from the DTI will be preserved but protection hoarding will be installed on one side that is reduced from the minimum standard.

Forty-three (43) trees within the DTI and 139 stems within the GTI conflict with the demolition, proposed grading and construction of the Parliament Oak Hotel and will require removal.

A total of 197 trees have been observed on Site. Fifty-eight (58) trees from the DTI and 139 stems from the GTI. Forty-three (43) trees from the DTI and all 139 stems from the 10 vegetation units conflict with the demolition, proposed grading and construction of the new hotel and will require removal. A total of 15 trees will be protected with a reduced TPZ and will require root pruning prior to demolition and grading.

There are 15 trees in which roots may be encountered through the demolition, grading and excavating process. The proper arboriculture management technique in this case would be root pruning. Roots should be cleanly severed at the limits of grading and not pulled in order to mitigate damage to any trees to remain. All root pruning shall be completed prior to demolition and proposed grading under the direct supervision of a Certified Arborist to limit any damage to the trees.

1. Tree Preservation Hoarding shall be installed to protect trees identified for preservation. Tree Preservation Hoarding must be installed as per the detail identified on Drawing L-100. Upon installation of the Tree Preservation Hoarding, the Contractor shall contact the Environmental Inspector to review and approve the fencing and its location prior to commencement of any site work. This shall be coordinated with City staff for final approval (as required). The protection fencing shall remain intact throughout the entire project. The fencing will be inspected weekly, and if required, repaired. The fencing shall be removed at the completion of all site works.
