**Tree Inventory and Preservation Plan
524 York Road (Phase 2)
Niagara-on-the-Lake, Ontario**

**Niagara York Road Inc.
366 King Street West
Hamilton, Ontario
L8P 1B3**

23 January 2025

KUNTZ FORESTRY CONSULTING INC. Project P4333

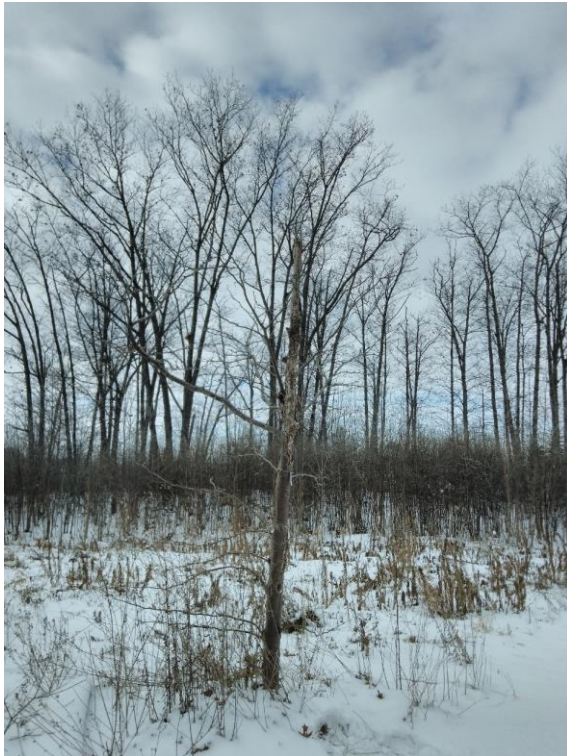
Image 1. Tree 1426

Tree #	Common Name	Scientific Name	DBH	Multistem DBH	TI	CS	CV	CDB	DL	mTPZ	Comments	Owner	Action	Rep.
1426	Thornless Honey Locust	<i>Gleditsia triacanthos</i> var. <i>inermis</i>	9	-	P	PF	P	60	2.0	1.2	Stem wounds (H), top dead, decay (H) in trunk	Subject	Remove	0
1427	Thornless Honey Locust	<i>Gleditsia triacanthos</i> var. <i>inermis</i>	8.5	-	FG	G	FG		2.0	1.2	Stem wounds (L)	Subject	Remove	0
1428	Japanese Flowering Lilac	<i>Syringa reticulata</i>	8.5	-	F	G	F		1.0	1.2	Stem wounds (M)	Subject	Remove	0
1429	Japanese Flowering Lilac	<i>Syringa reticulata</i>	9	-	F	G	F		1.0	1.2	Stem wounds (M)	Subject	Remove	0
1430	Japanese Flowering Lilac	<i>Syringa reticulata</i>	8.5	-	F	G	FG		1.0	1.2	Bulge at base	Subject	Remove	0
1431	White Elm	<i>Ulmus americana</i>	12.5, 12	17.5	F	F	F		3.0	1.8	V-union at 0.1m with included bark, one large stem cut at 0.1m, epicormic branching (L)	Subject	Preserve	-
1432	Shagbark Hickory	<i>Carya ovata</i>	14.5, 9.5	17.5	F	FG	FG		4.0	1.8	Previously tagged: #517, v-union at base with included bark	Subject	Remove	2

The removal of 12 trees and one polygon, identified as Trees 1426 – 1430, 1432 – 1434, 1437, and A – C, and Polygon P-1, will be required to accommodate the proposed development. These trees and polygon either conflict directly with the proposed development or the level of encroachment into their minimum tree protection zones (mTPZs) resulting from the proposed work would be at an intolerable level such that they would not be expected to overcome the injury.

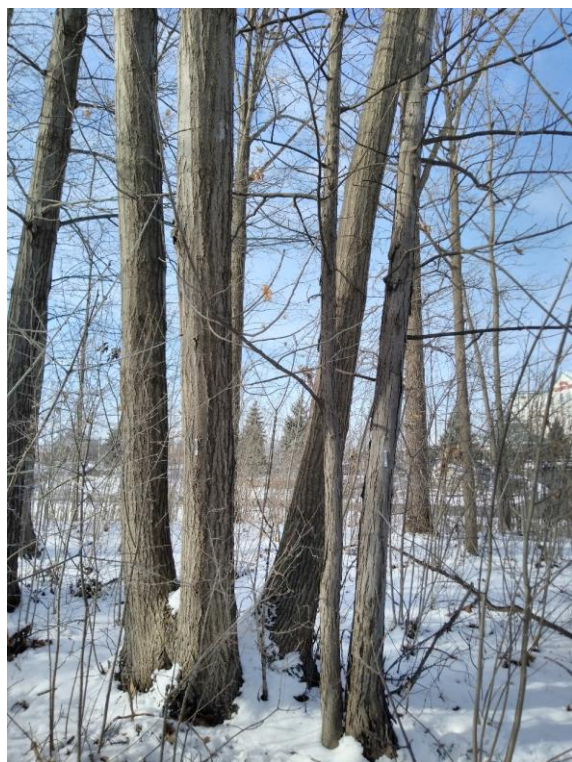
Image 7. Tree 1432 (right) and 1433 (left)

1433	Red Oak	<i>Quercus rubra</i>	30, 29.5, 29	51.1	F	F	F	10	10.0	3.6	Union at 0.1m, lean (L), asymmetrical crown (M), broken branches (L)	Subject	Remove	5
1434	Red Oak	<i>Quercus rubra</i>	33, 32	46	F	PF	PF	10	6.0	3.0	Previously tagged: #519, v-union at 0.3m with included bark and one stem dead, epicormic branching (M), broken branches (L)	Subject	Remove	5
1435	Red Oak	<i>Quercus rubra</i>	26	-	FG	F	F	10	4.0	1.8	Crook (L), epicormic branching (M)	Subject	Preserve	-
1436	Red Oak	<i>Quercus rubra</i>	32	-	F	PF	PF	20	3.0	2.4	Lean (L), epicormic branching (M), one stem lost at base	Subject	Preserve	-
1437	Red Oak	<i>Quercus rubra</i>	37	-	P	PF	PF	20	5.0	2.4	Lean (L), broken branches (M), epicormic branching (M), cavities (H) at base, decay (M) in trunk	Subject	Remove	4
1438	Red Oak	<i>Quercus rubra</i>	33	-	F	PF	PF	20	6.0	2.4	Broken branches (M), lean (L), bulge at base, epicormic branching (M)	Subject	Preserve	-

Trees 1432 – 1434 and 1437 are located within the boundaries of the subject property and measure 12.5cm DBH or greater. Polygon P-1 is located within the boundaries of the subject property and within this polygon, a total of 42 trees measure 12.5cm DBH or greater. Permits will be required prior to the removal of these trees.

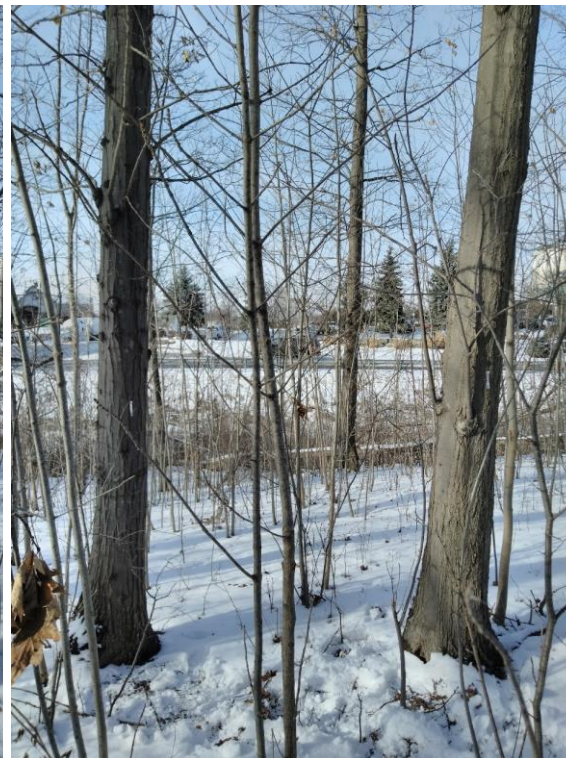
Image 12. Tree 1439 (right) and 1440 (left)

1439	Red Oak	<i>Quercus rubra</i>	29.5	-	F	PF	PF	30	6.0	1.8	Cavities (L) at base, growth deficit (M), epicormic branching (L), broken branches (M)	Subject	Preserve	-
1440	Red Oak	<i>Quercus rubra</i>	27	-	FG	PF	PF	30	6.0	1.8	Bow (L), epicormic branching (H)	Subject	Preserve	-
1441	Sugar Maple	<i>Acer saccharum</i>	39	-	F	PF	PF	30	8.0	2.4	Growth deficit (M), broken branches (M), epicormic branching (L)	Subject	Preserve	-
1442	Red Oak	<i>Quercus rubra</i>	44	-	FG	PF	PF	30	8.0	3.0	Broken branches (M), epicormic branching (L), lean (L)	Subject	Preserve	-
1443	Sugar Maple	<i>Acer saccharum</i>	25	-	P	P	PF	60	4.0	1.8	Cavities (H), top lost, broken branches (H)	Subject	Preserve	-
1444	Green Ash	<i>Fraxinus pennsylvanica</i>	14	-	F	G	F		2.0	1.8	Lean (L), Emerald Ash Borer damage (L)	Subject	Preserve	-

The preservation of the remaining ten trees, identified as Trees 1431, 1435, 1436, and 1438 – 1444, will be possible with the use of appropriate tree protection measures as indicated on Figure 1. Tree protection measures must be implemented prior to the commencement of the proposed works to ensure tree resources designated for preservation are not impacted.

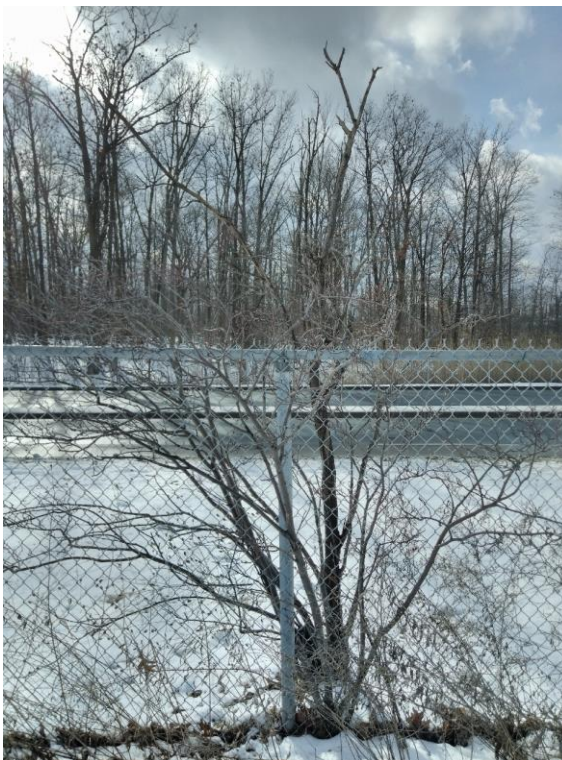
Image 17. Tree A

A	Serviceberry species	<i>Amelanchier</i> sp.	~4	-	P	P	P	80	1.0	1.2	Main stem dead, only shoots at base alive, decay (H) in trunk, growing through fence	Town	Remove	-
B	Serviceberry species	<i>Amelanchier</i> sp.	~5	-	P	P	P	70	1.0	1.2	Top-down dieback, shoots at base, decay (H) in trunk, growing through fence	Town	Remove	-
C	Serviceberry species	<i>Amelanchier</i> sp.	~1-2	-	F	F	F		1.0	1.2	Multistem at base, stem wounds (M), growing through fence	Town	Remove	-
P-1	See Table 2											Subject	Remove	139

Trees A – C are located within the road right-of-way adjacent to the subject area and as such, are considered Town-owned trees. Permission from the Town of Niagara-on-the-Lake will be required prior to the removal of these trees.
