Arborist Report

308 Four Mile Creek Road

Niagara-on-the-Lake

Project

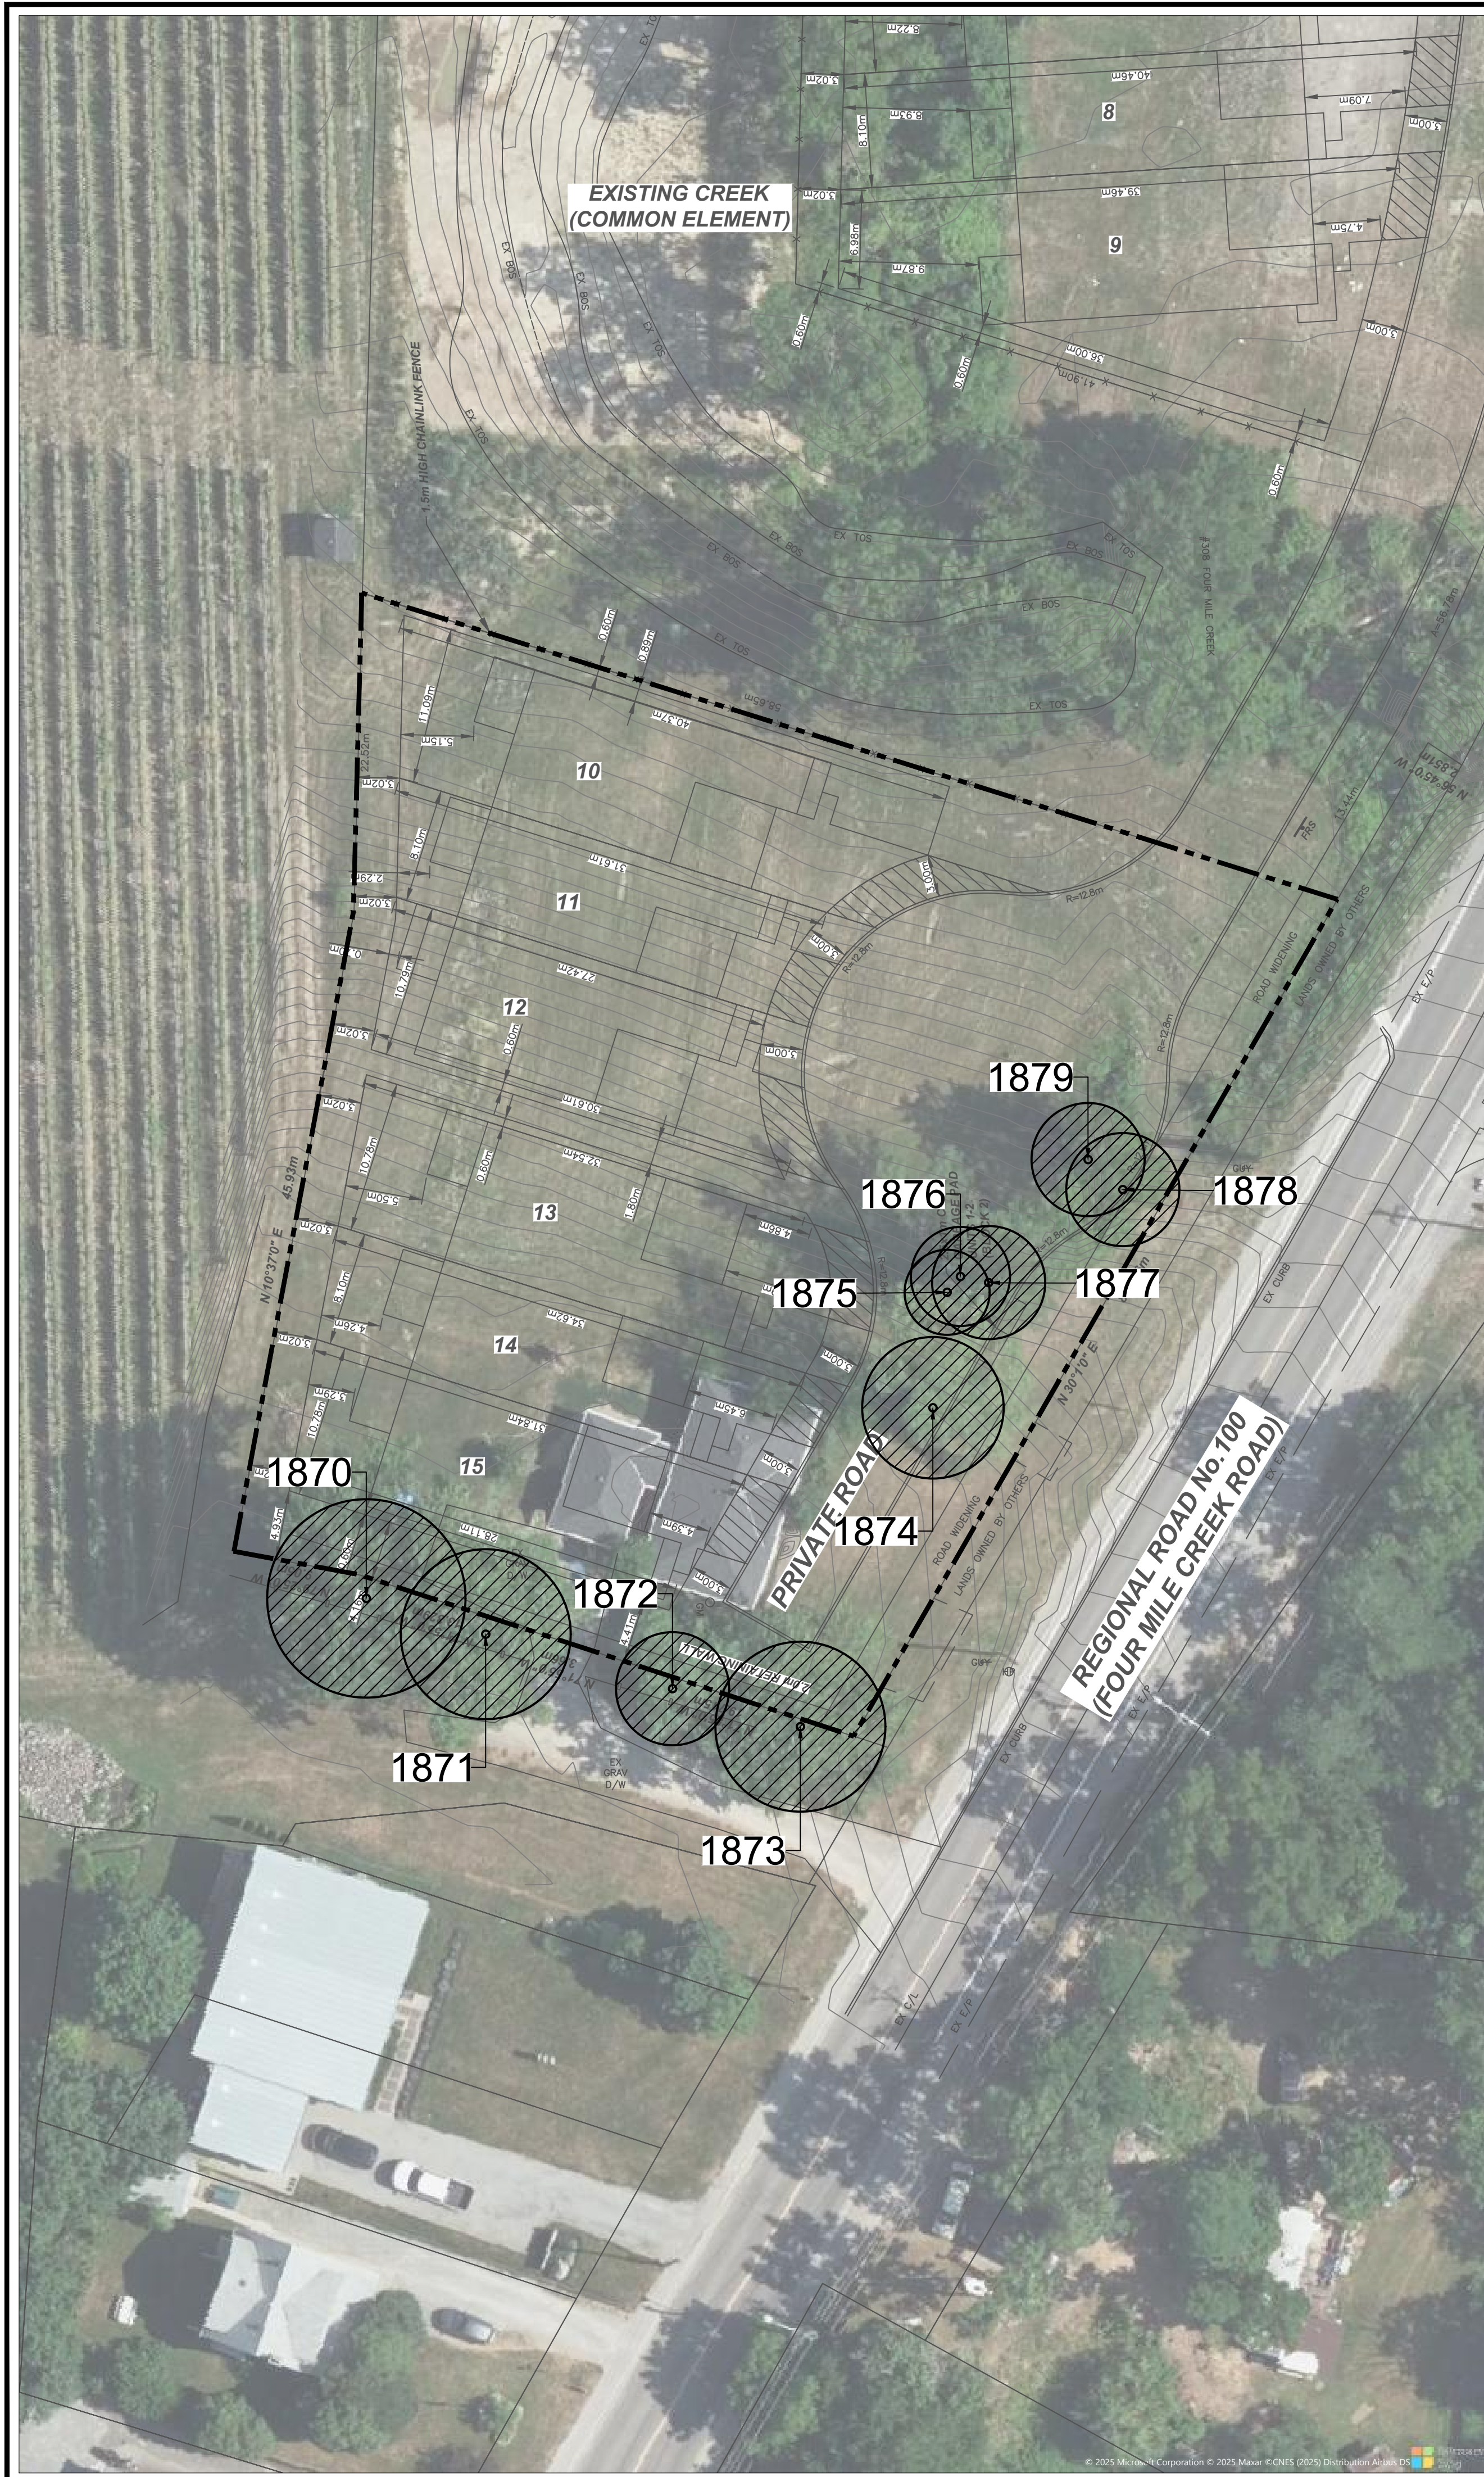
SHEET TITLE: TREE INVENTORY AND PRESERVATION PLAN

Based on a review of the development plans, all 10 inventoried trees will require removal. Of these, six (6) are located within the subject property and four (4) are located on the adjacent private property to the south.

- Two (2) Eastern White Pine, Tree Nos. 1876 and 1877;
- One (1) Norway Spruce, Tree No. 1879;
- One (1) Silver Maple, Tree No. 1874;
- One (1) White Spruce, Tree No. 1875; and
- One (1) Black Walnut, Tree No. 1878.

- Four (4) Silver Maple, Tree Nos. 1870-1873.

Permission from adjacent landowners must be obtained prior to removing trees from adjacent lands.
