**Tree Inventory and Preservation Plan
524 York Road (Phase 2)
Niagara-on-the-Lake, Ontario**

23 January 2025; revised 18 December 2025

KUNTZ FORESTRY CONSULTING INC. Project P4333

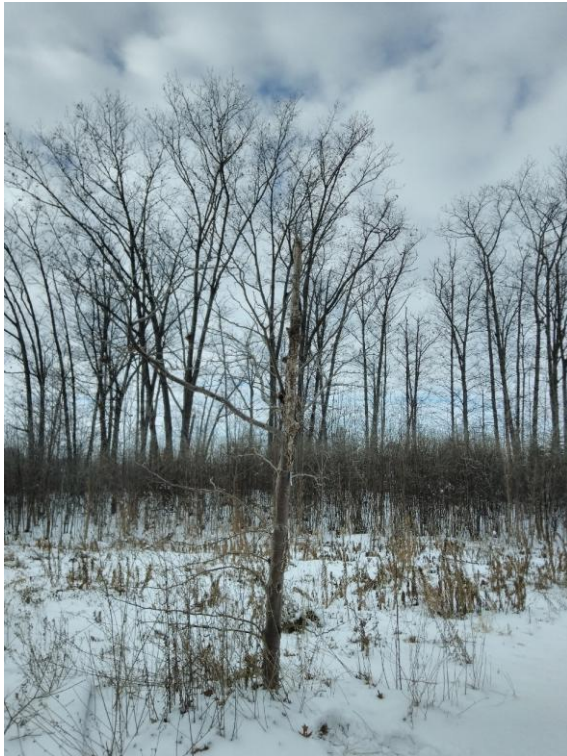
Image 1. Tree 1426

Tree #	Common Name	Scientific Name	DBH	Multistem DBH	TI	CS	CV	CDB	DL	mTPZ	Comments	Owner	Action	Rep.
1426	Thornless Honey Locust	<i>Gleditsia triacanthos</i> var. <i>inermis</i>	9	-	P	PF	P	60	2.0	1.2	Stem wounds (H), top dead, decay (H) in trunk	Subject	Remove	0
1427	Thornless Honey Locust	<i>Gleditsia triacanthos</i> var. <i>inermis</i>	8.5	-	FG	G	FG		2.0	1.2	Stem wounds (L)	Subject	Remove	0
1428	Japanese Flowering Lilac	<i>Syringa reticulata</i>	8.5	-	F	G	F		1.0	1.2	Stem wounds (M)	Subject	Remove	0
1429	Japanese Flowering Lilac	<i>Syringa reticulata</i>	9	-	F	G	F		1.0	1.2	Stem wounds (M)	Subject	Remove	0
1430	Japanese Flowering Lilac	<i>Syringa reticulata</i>	8.5	-	F	G	FG		1.0	1.2	Bulge at base	Subject	Remove	0
1431	White Elm	<i>Ulmus americana</i>	12.5, 12	17.5	F	F	F		3.0	1.8	V-union at 0.1m with included bark, one large stem cut at 0.1m, epicormic branching (L)	Subject	Preserve	-
1432	Shagbark Hickory	<i>Carya ovata</i>	14.5, 9.5	17.5	F	FG	FG		4.0	1.8	Previously tagged: #517, v-union at base with included bark	Subject	Preserve	-

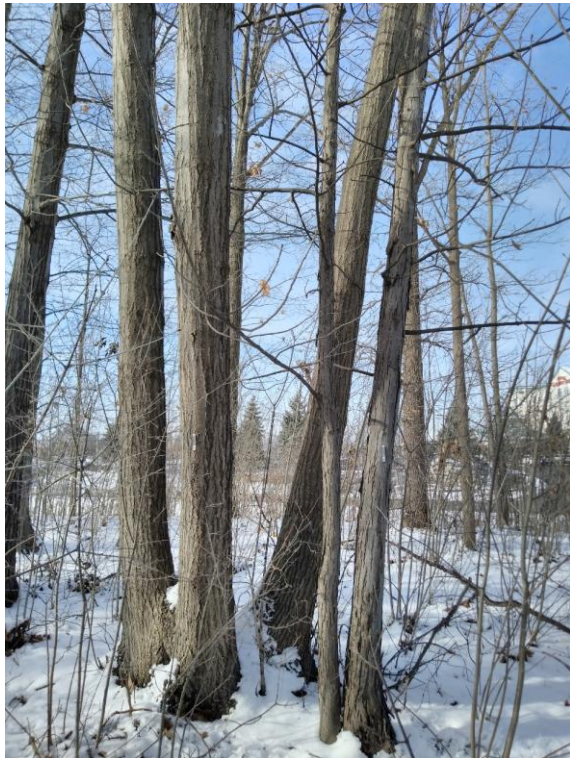
Image 7. Tree 1432 (right) and 1433 (left)

Encroachment into the mTPZs of Trees 1433, 1434, and 1437 will be required to accommodate the construction of a proposed retaining wall or associated regrading works. Tree preservation fencing has been prescribed at the anticipated limit of encroachment within the mTPZs of these trees. If the following mitigation measures are employed, long-term adverse impacts are not anticipated for these trees.

1433	Red Oak	<i>Quercus rubra</i>	30, 29.5, 29	51.1	F	F	F	10	10.0	3.6	Union at 0.1m, lean (L), asymmetrical crown (M), broken branches (L)	Subject	Preserve (Injure)	-
1434	Red Oak	<i>Quercus rubra</i>	33, 32	46	F	PF	PF	10	6.0	3.0	Previously tagged: #519, v-union at 0.3m with included bark and one stem dead, epicormic branching (M), broken branches (L)	Subject	Preserve (Injure)	-
1435	Red Oak	<i>Quercus rubra</i>	26	-	FG	F	F	10	4.0	1.8	Crook (L), epicormic branching (M)	Subject	Preserve	-
1436	Red Oak	<i>Quercus rubra</i>	32	-	F	PF	PF	20	3.0	2.4	Lean (L), epicormic branching (M), one stem lost at base	Subject	Preserve	-
1437	Red Oak	<i>Quercus rubra</i>	37	-	P	PF	PF	20	5.0	2.4	Lean (L), broken branches (M), epicormic branching (M), cavities (H) at base, decay (M) in trunk	Subject	Preserve (Injure)	-
1438	Red Oak	<i>Quercus rubra</i>	33	-	F	PF	PF	20	6.0	2.4	Broken branches (M), lean (L), bulge at base, epicormic branching (M)	Subject	Preserve	-

1. Prior to the commencement of the proposed works, tree preservation fencing should be installed as indicated on Figure 1 and maintained throughout the duration of the proposed development.
2. Where excavation for the proposed retaining wall or regrading works is required within the mTPZ of a tree, it should occur under the direct supervision of a Certified Arborist.
3. Any roots encountered within the excavated mTPZ areas that require pruning are to be pruned by a Certified Arborist in accordance with Good Arboricultural Standards.
4. Any branches that require pruning should be pruned by a Certified Arborist or other tree professional in accordance with Good Arboricultural Standards.

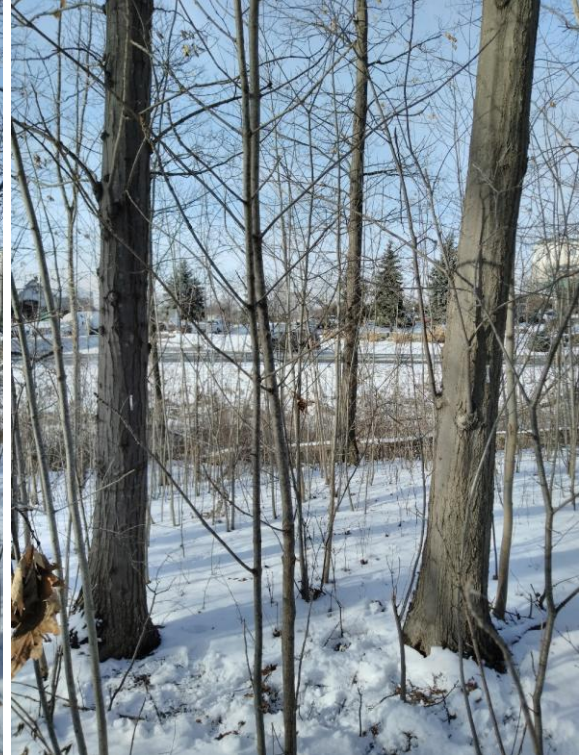
Image 12. Tree 1439 (right) and 1440 (left)

1439	Red Oak	<i>Quercus rubra</i>	29.5	-	F	PF	PF	30	6.0	1.8	Cavities (L) at base, growth deficit (M), epicormic branching (L), broken branches (M)	Subject	Preserve	-
1440	Red Oak	<i>Quercus rubra</i>	27	-	FG	PF	PF	30	6.0	1.8	Bow (L), epicormic branching (H)	Subject	Preserve	-
1441	Sugar Maple	<i>Acer saccharum</i>	39	-	F	PF	PF	30	8.0	2.4	Growth deficit (M), broken branches (M), epicormic branching (L)	Subject	Preserve	-
1442	Red Oak	<i>Quercus rubra</i>	44	-	FG	PF	PF	30	8.0	3.0	Broken branches (M), epicormic branching (L), lean (L)	Subject	Preserve	-
1443	Sugar Maple	<i>Acer saccharum</i>	25	-	P	P	PF	60	4.0	1.8	Cavities (H), top lost, broken branches (H)	Subject	Preserve	-
1444	Green Ash	<i>Fraxinus pennsylvanica</i>	14	-	F	G	F		2.0	1.8	Lean (L), Emerald Ash Borer damage (L)	Subject	Preserve	-

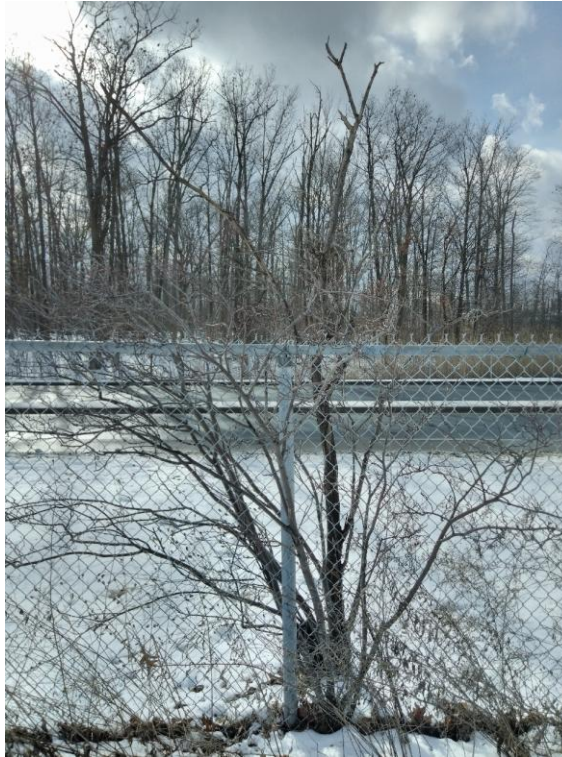
Image 17. Tree A

A	Serviceberry species	<i>Amelanchier sp.</i>	~4	-	P	P	P	80	1.0	1.2	Main stem dead, only shoots at base alive, decay (H) in trunk, growing through fence	Town	Remove	-
B	Serviceberry species	<i>Amelanchier sp.</i>	~5	-	P	P	P	70	1.0	1.2	Top-down dieback, shoots at base, decay (H) in trunk, growing through fence	Town	Remove	-
C	Serviceberry species	<i>Amelanchier sp.</i>	~1-2	-	F	F	F		1.0	1.2	Multistem at base, stem wounds (M), growing through fence	Town	Remove	-
P-1	See Table 2											Subject	Remove	139

Trees A – C are located within the road right-of-way adjacent to the subject area and as such, are considered Town-owned trees. Permission from the Town of Niagara-on-the-Lake will be required prior to the removal of these trees.
