TITLE:
43 Castlereagh St,
Niagara-on-the-Lake, ON

Pre-Construction Assessment

CLIENT:
Niagara-on-the-Lake Museum
c/o Sarah Kaufman

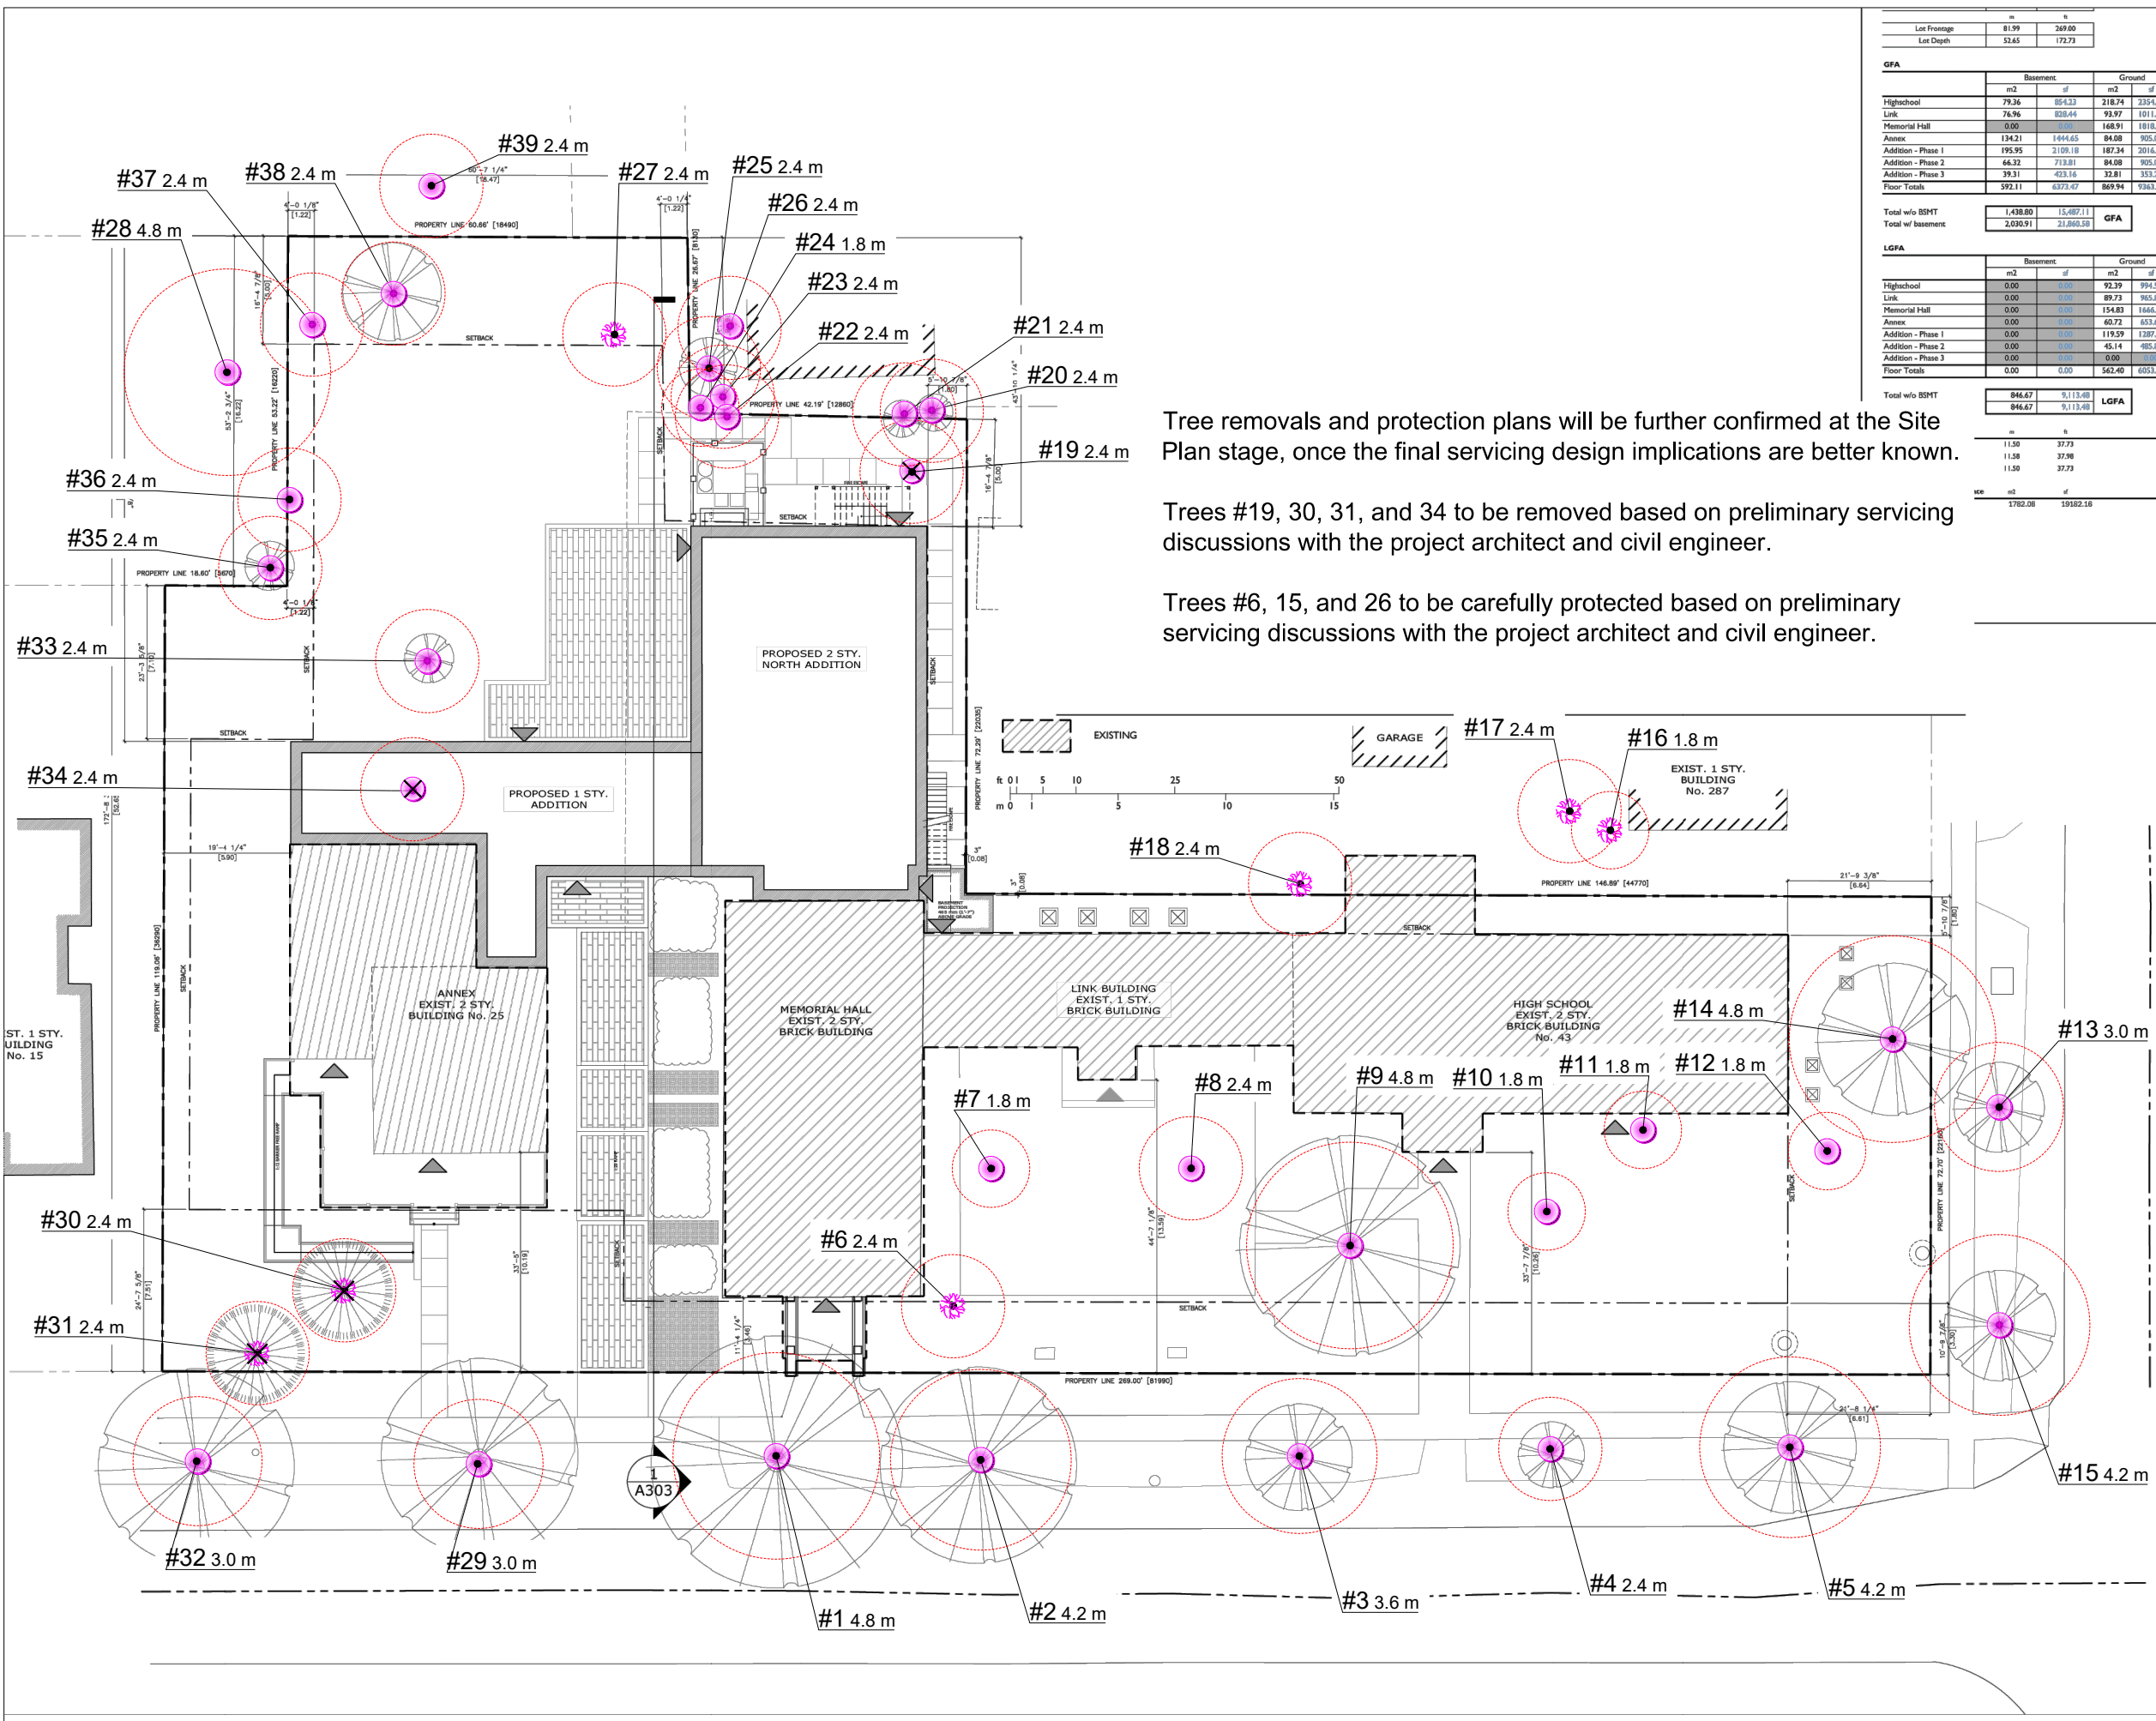
Tree removals and protection plans will be further confirmed at the Site Plan stage, once the final servicing design implications are better known.

Trees #19, 30, 31, and 34 to be removed based on preliminary servicing discussions with the project architect and civil engineer.

Trees #6, 15, and 26 to be carefully protected based on preliminary servicing discussions with the project architect and civil engineer.
