December 13, 2023 (Revision of report dated September 12, 2023)

Reference No. 2308-S165 Page 1 of 4

Re: **Slope Stability Assessment Proposed Stormwater Management Pond 353 Townline Road** Town of Niagara-on-the-lake

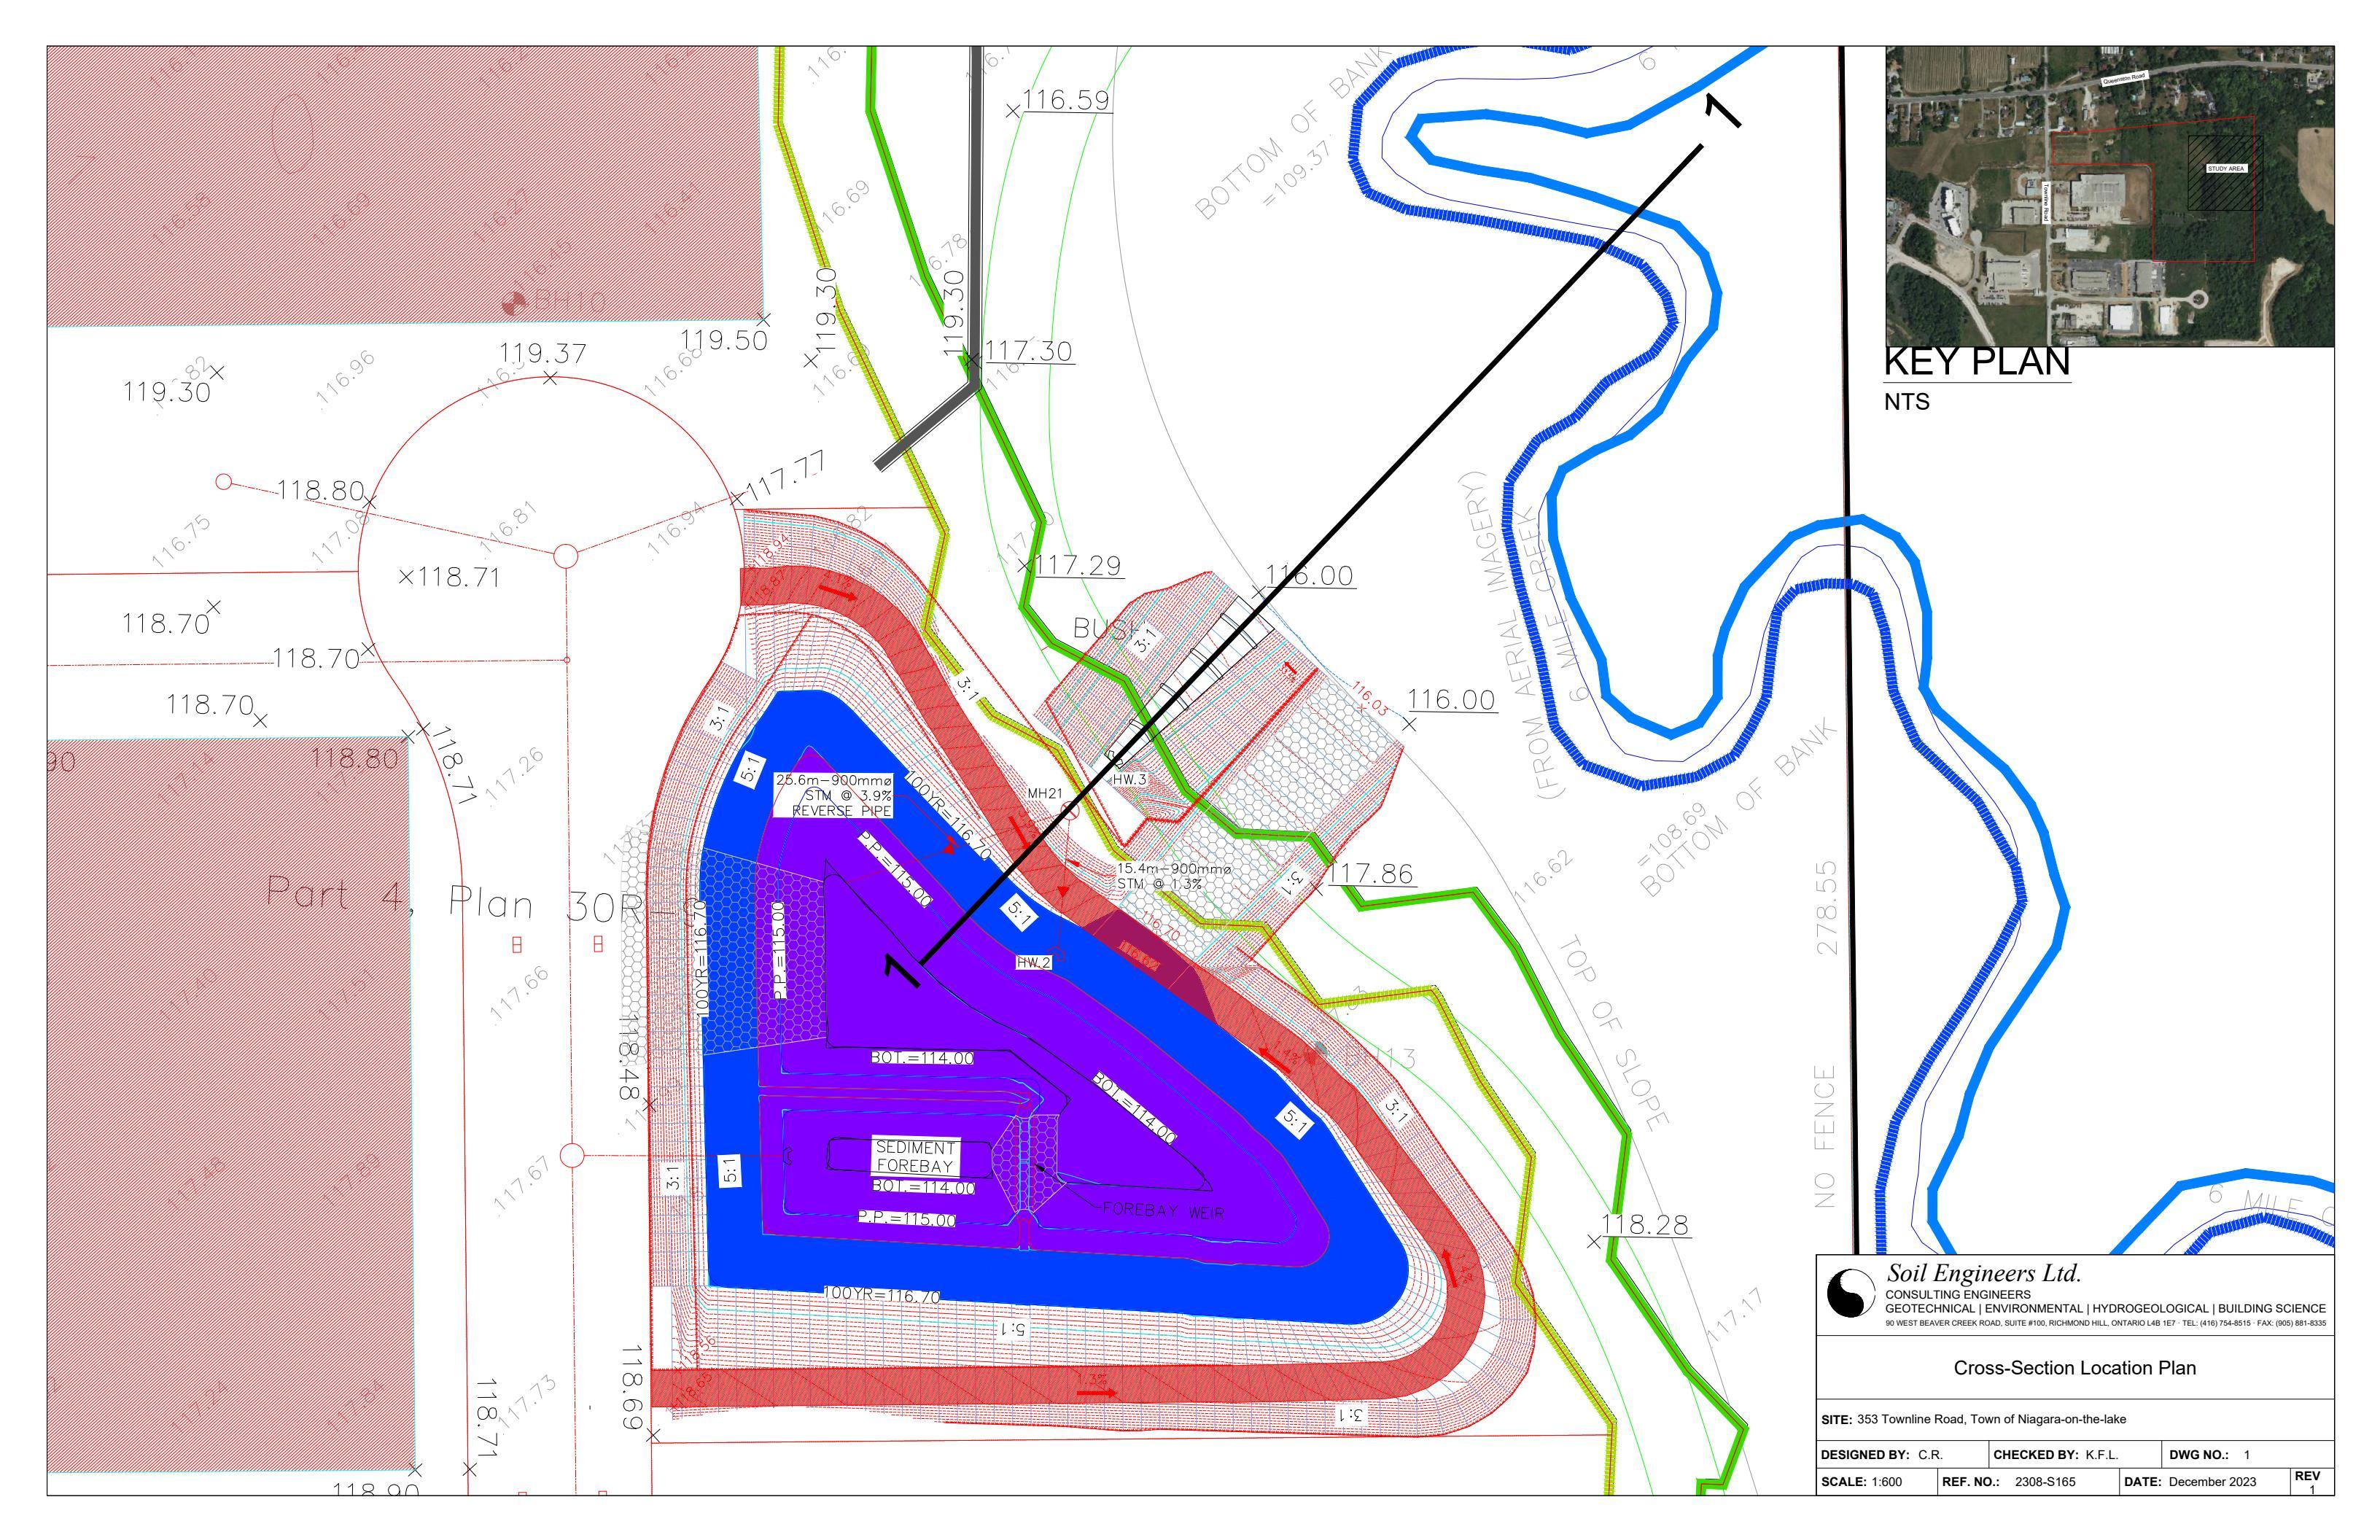
| Cross-Section Location Plan | Drawing No. 1 |

A slope stability analysis was carried out on the proposed grading condition at Cross-Section 1-1. The cross-section was prepared by Crozier Consulting Engineers and location is shown on the enclosed Drawing No.1. Details of the slope section are shown on Drawing No. 2.

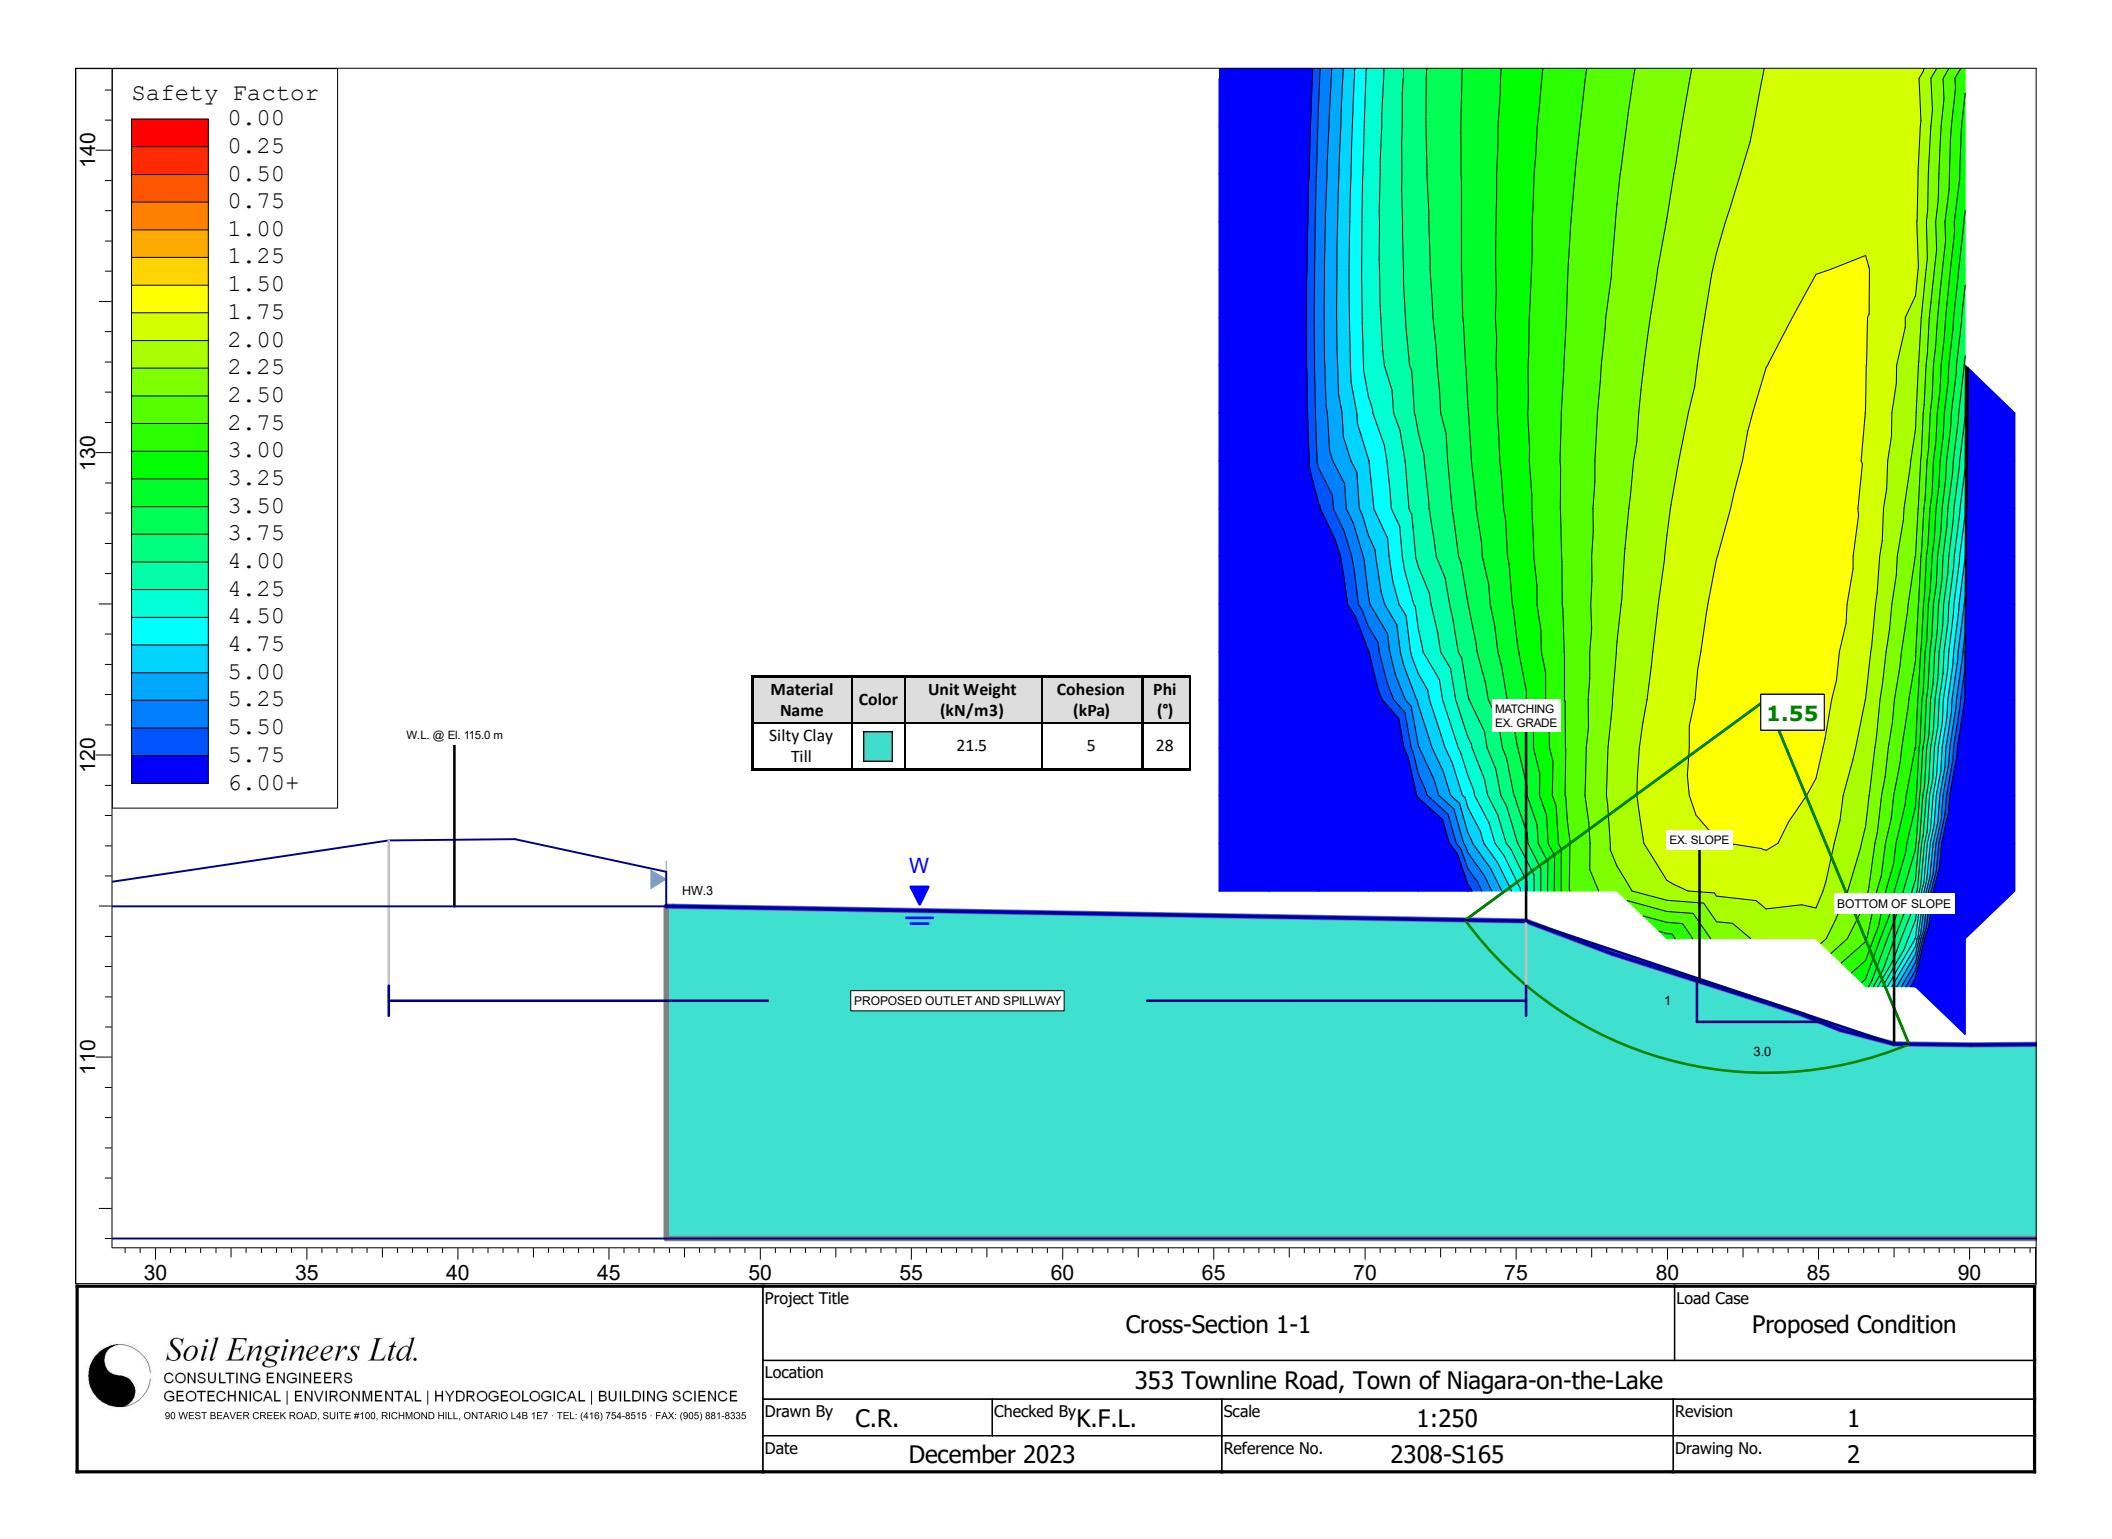
| Cross-Section Location Plan | Drawing No. 1 |
|---|---|
| Slope Stability Analysis | Drawing No. 2 |

Where the pond water exceeds the Permanent Pool Level, the excess water will be discharged through the outlet onto the spillway. As such, the flow path and the existing slope will be modeled under submerged condition for the slope stability analysis. In order to satisfy the stability requirement for slope under submerged condition, the resulting factor of safety (FOS) should meet a minimum of 1.30.

The analysis at Cross-Section 1-1 yielded a FOS of 1.55, which meets the minimum FOS of 1.30 and is considered acceptable. The result is presented on Drawing No. 2.

In order to prevent further disturbance of the existing slope beyond the spillway, the following geotechnical constraints should be stipulated:

- The prevailing vegetative cover must be maintained, since its extraction would deprive the slope of the rooting system that is reinforcement against soil erosion by weathering. If for any reason the vegetation cover is stripped during construction, it must be reinstated to its original, or better than its original, protective condition.

- 2. The topsoil cover on the slope face should not be disturbed, since this provides insulation and screen against frost wedging and rainwash erosion.

- 3. Grading of the land adjacent to the slope must be such that concentrated runoff is not allowed to drain onto the slope face. Landscaping features which may cause runoff to pond at the top of the slope, as well as saturation of the crown of the slope, must not be permitted.

- 4. Where the construction is carried out near the top of the slope, dumping of loose fill over the slope from topsoil stripping or vegetation removal activities must be prohibited. Topsoil stripping and vegetation removal along the slope are also prohibited.

- 5. In case of any removal of vegetation during the course of construction, restoration with selective native plantings, including deep rooting systems which would penetrate the original topsoil, shall be carried out after the development to ensure slope stability.
