# SOIL-MAT ENGINEERS & CONSULTANTS LTD.

PROJECT NO.: SM 166999-G

**PRELIMINARY HYDROGEOLOGICAL ASSESSMENT  
PROPOSED RESIDENTIAL DEVELOPMENT  
FIRELANE 13B ROAD  
NIAGARA-ON-THE-LAKE, ONTARIO**

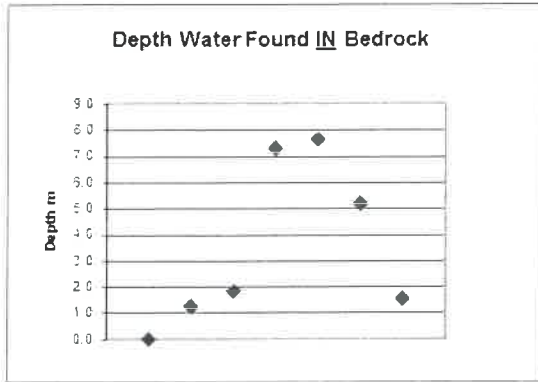
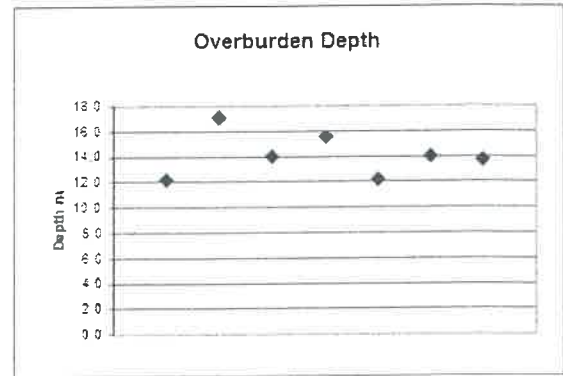
The water well record data, considered statistically and viewed in scatter plots of depth water found and static elevation, suggest that one predominant aquifer is in use in the study area, as illustrated below:

The apparent dominant aquifer in use in the study area is situated an estimated 20 metres below the surface elevation of the study area.

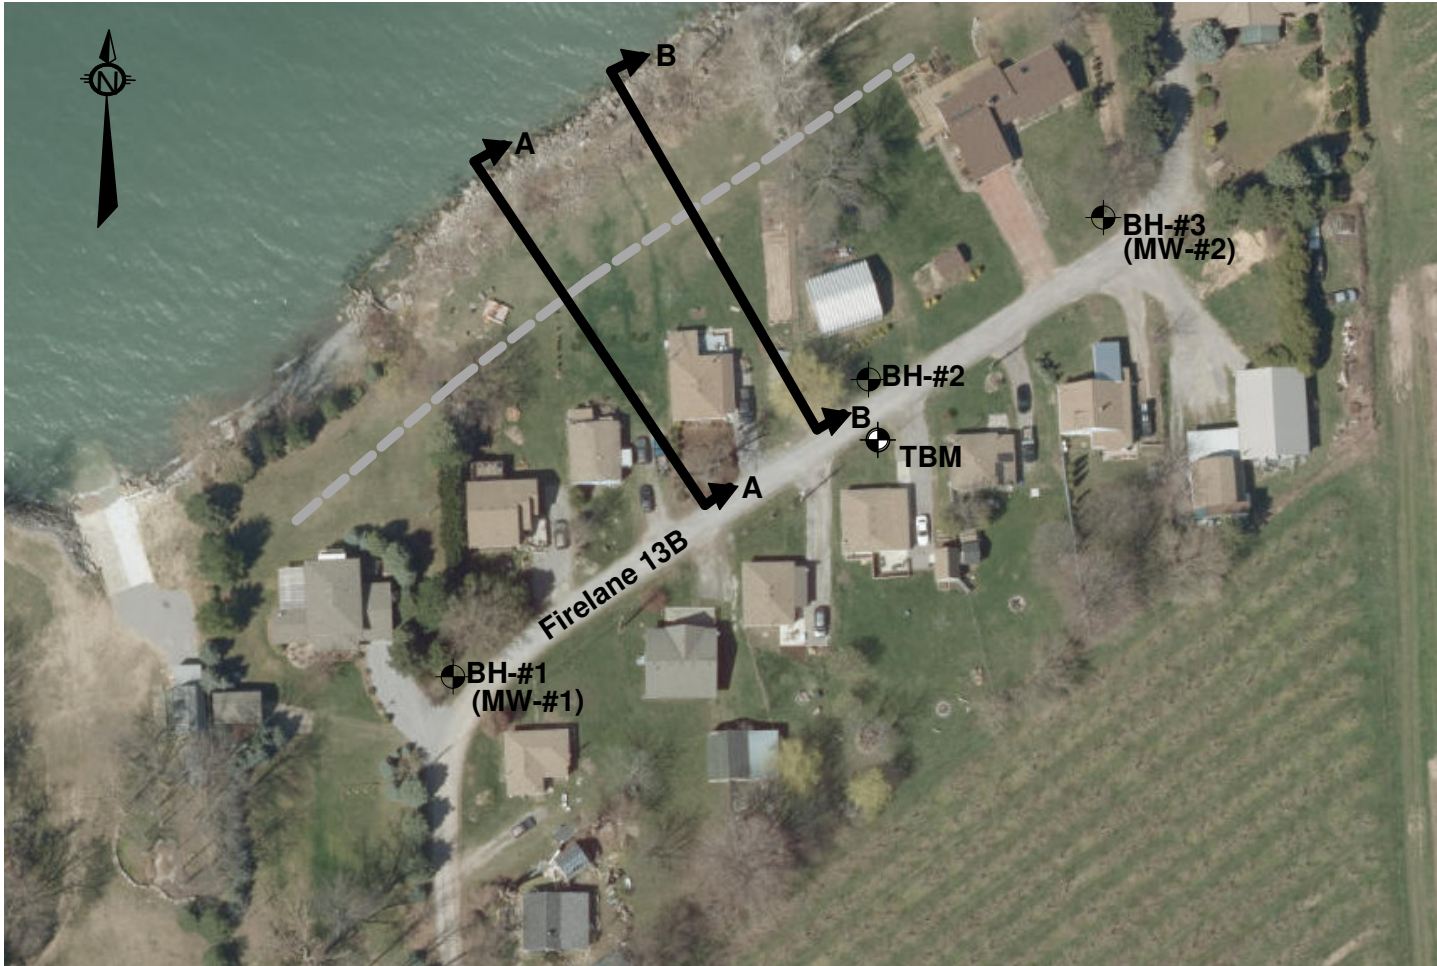
# DRAWING No. 1

A total of three [3] sampled boreholes were advanced at the locations illustrated in the attached Drawing No. 1, Slope Profile and Borehole Location Plan. The boreholes were advanced using solid stem continuous flight auger equipment on October 11, 2016, under the direction and supervision of a staff member of SOIL-MAT ENGINEERS & CONSULTANTS LTD. The boreholes were advanced to depths of between approximately 8.1 to 12.2 metres beneath the existing ground surface. Upon completion of drilling, Borehole Nos. 1 and 3 were fitted with a monitoring well to allow for measurement of the static groundwater level, while Borehole No. 2 was backfilled in general accordance with Ontario Regulation 903. The monitoring wells consisted of 50-millimetre diameter PVC pipe, screened in the lower 3 metres, backfilled with filter sand to approximately 0.3 metres above the screened portion, and with bentonite clay 'hole plug' medium to ground surface. Each monitoring well was outfitted with a 'monument' protective steel casing, flush with the existing ground surface.

Slopes" indicates stable slope inclinations through sands and gravels from 1.5 to 2.0 horizontal to 1.0 vertical, and through the clays and silts as steep as 2.0 to 4.0 horizontal to 1.0 vertical. In this case, given the borehole information indicating compact to dense sandy silt and stiff cohesive soil conditions, a conservative stable slope inclination of 2.0 horizontal to 1 vertical has been applied through both the sandy silt and clayey silt soils. Applying the appropriate erosion and stable slope inclinations as outlined above results in a top of stable slope location at each profile. For Profiles A-A and B-B, the determined top of stable slope is approximately 36.7 and 38.3 metres from the existing roadway, respectively. An interpolated line of the top of stable slope has been illustrated on Drawing No. 1.

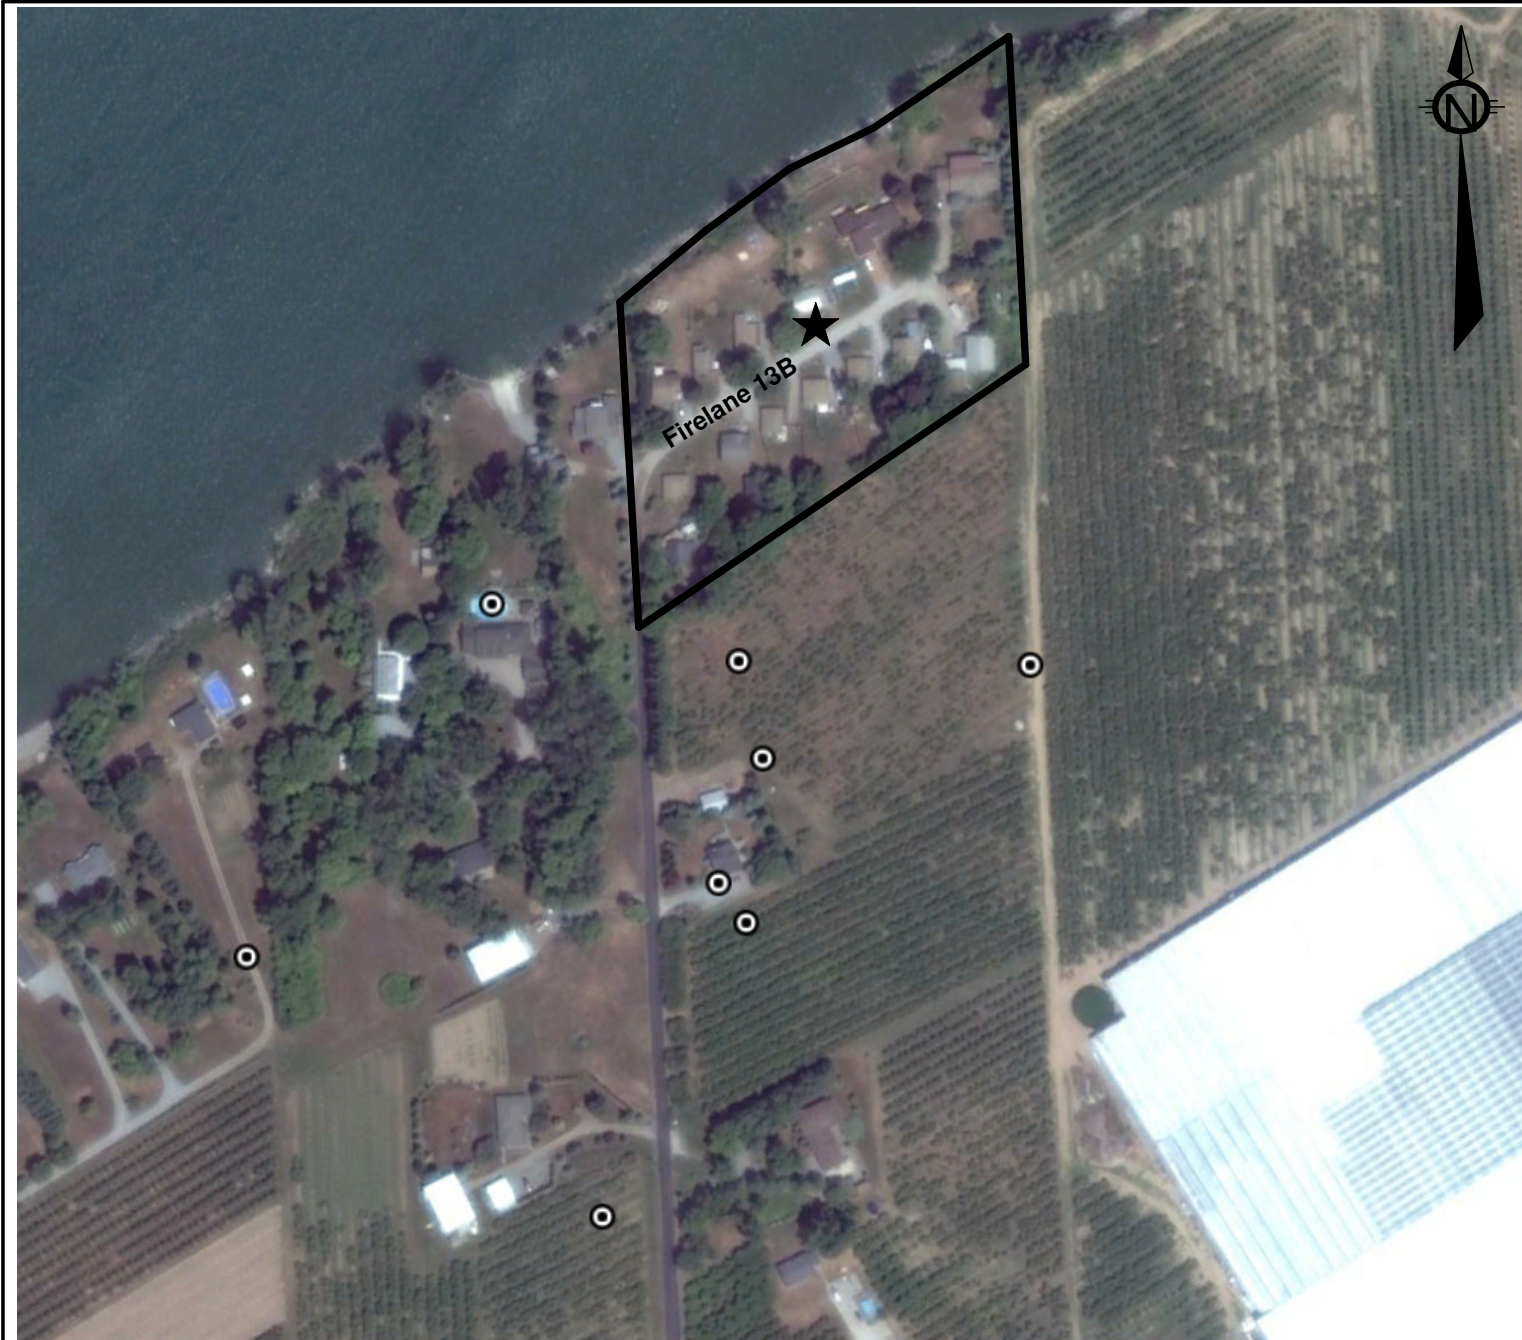
SM 166999-G Slope Profile and Borehole Location Plan.kcw

Enclosures: Drawing No.1, Slope Profile and Borehole Location Plan  
Borehole Log Nos. 1 to 3, inclusive  
Drawing Nos. 2 and 3, Slope Profiles A-A and B-B  
Grain Size Analysis Nos. 1 to 4, inclusive  
Slope Stability Rating Chart  
Slope/W analyses results

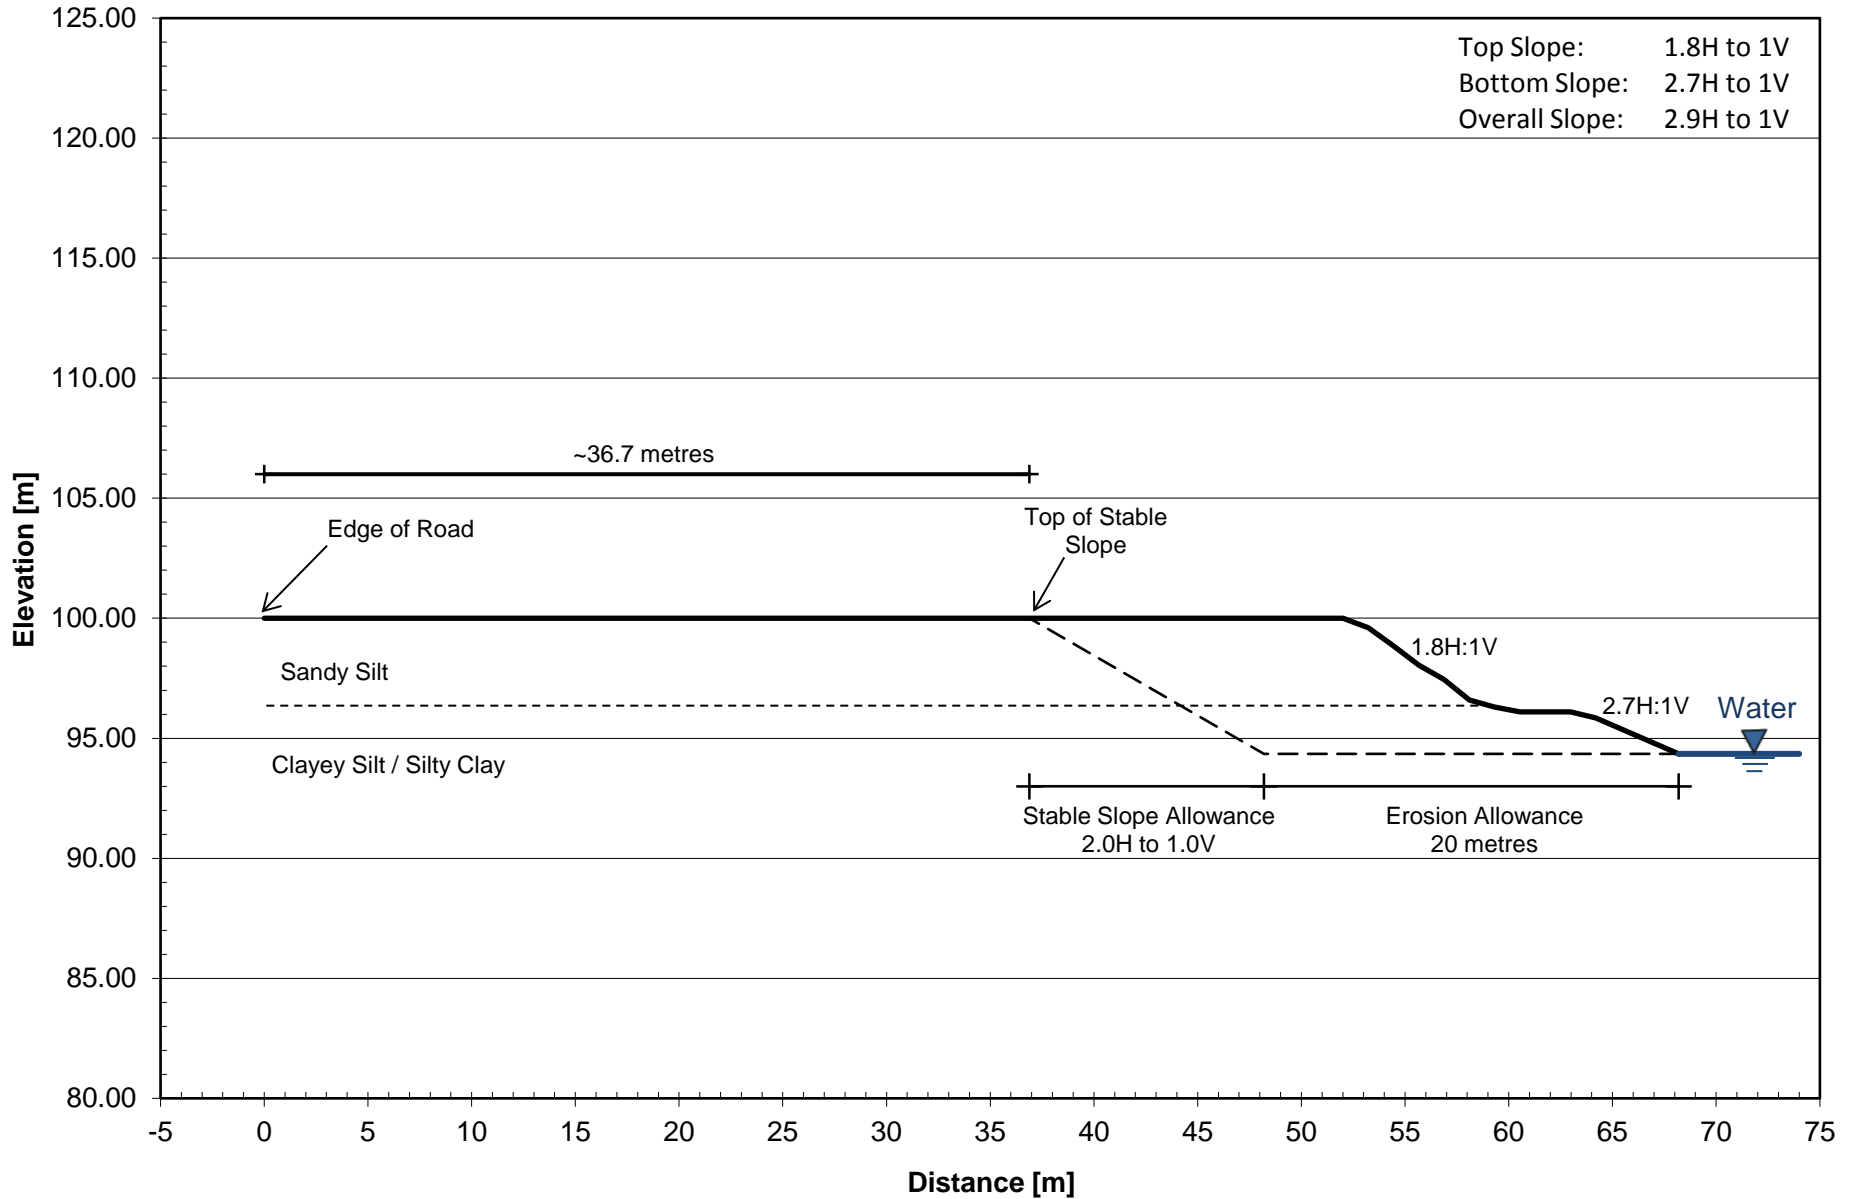
**Slope Profile Section A-A  
Firelane 13B Road  
St. Catharines, Ontario**

As noted above, two [2] representative slope profiles were measured from the existing roadway down to the water level of Lake Ontario. The subject slope was noted to be approximately 5 to 6 metres in height, and to be as steep as approximately 1.5 to 1.9 horizontal to 1 vertical, with overall inclinations of approximately 2.4 to 2.9 horizontal to 1 vertical. The slope consisted of large irregular armour stone, with a terrace at roughly the mid-height of the slope. The large armour stone appeared to be in sound condition with no evidence of slope instability or previous failures. Evidently the existing armour stone shoreline protection have been performing adequately to protect the slope from ongoing erosion.

Stability analyses yielded minimum factors of safety on the order of approximately 1.51 and 1.57 with respect to global stability, for the two profiles measured, profiles A-A and B-B respectively, and in excess of 3.1 with respect to the long-term top of stable slope location for both slope profiles. It is noted that these stability analyses do not account for the stabilising effect of the existing armour stone, and would suggest the stability of the slope to be higher than that calculated. Sample results of these analyses are appended to this report.

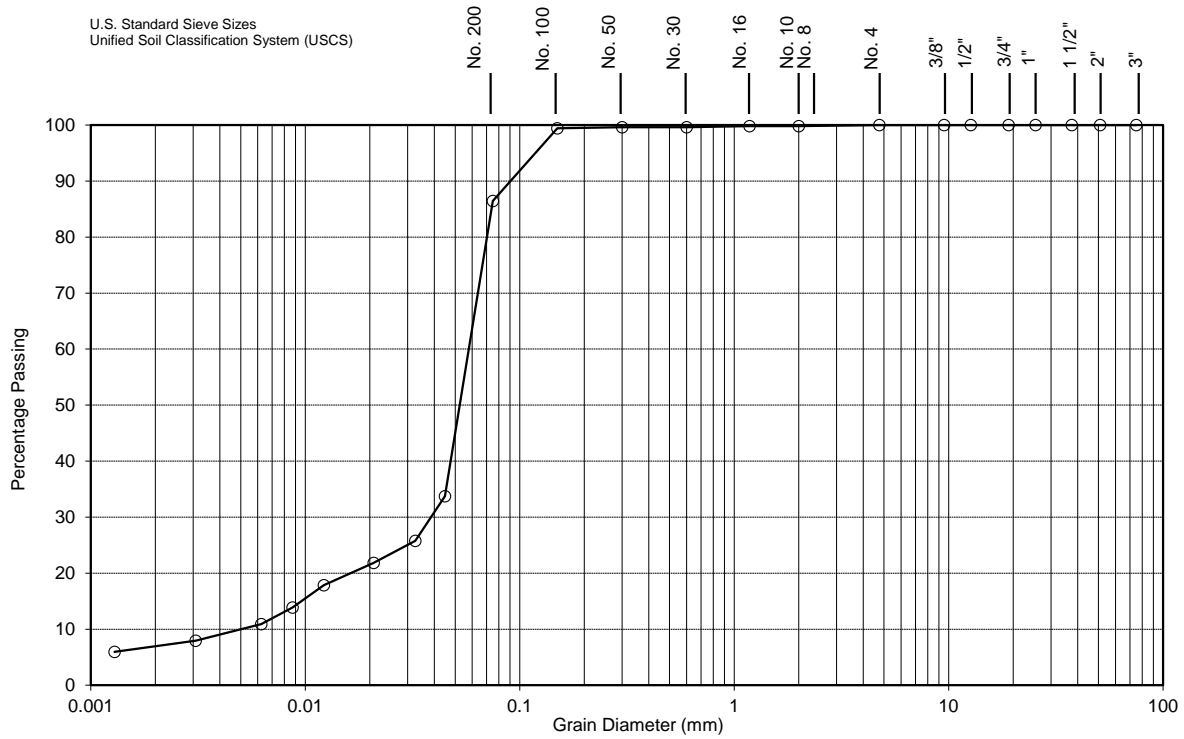
## Mechanical & Hydrometer Analyses

Lab No.	<b>107-16</b>	Notes: Sample retrieved by Soil-Mat Engineers & Consultants Ltd. laboratory on October 11, 2016.					
Borehole No.:	1	Soil Description: <b>Brown SILT with some Sand and trace Clay</b> <b>ML - Inorganic silts and very fine sands</b>					
Sample No.:	2						
CLAY [%]:	<b>7</b>	Estimated <i>T</i> Time [min/cm] :		<b>18 to 20</b>	Estimated Permeability, <i>k</i> [cm/s]	<b>10<sup>-5</sup></b>	
SILT [%]:	<b>80</b>	Coefficient of Uniformity <i>C<sub>u</sub></i> :		<b>12.0</b>	Coefficient of Curvature <i>C<sub>c</sub></i> :		<b>5.3</b>
SAND [%]:	<b>13</b>						
GRAVEL [%]:	<b>0</b>	D <sub>10</sub> (Effective Diam. in mm):		<b>0.005</b>

As noted above four [4] selected samples of the subsurface soils were subjected to laboratory grain size analyses. The results of this testing are summarised in Table A below. The grain size analyses confirm the material as a sandy silt, with silt content in the range of approximately 59 to 80 per cent, and traces of clay. One sample, BH2-SS1, was noted to have a clay content of 16 per cent, however the clay content was shown to reduce with depth in sample BH2-SS4. These fine grained granular soils would afford a moderately permeable overburden.

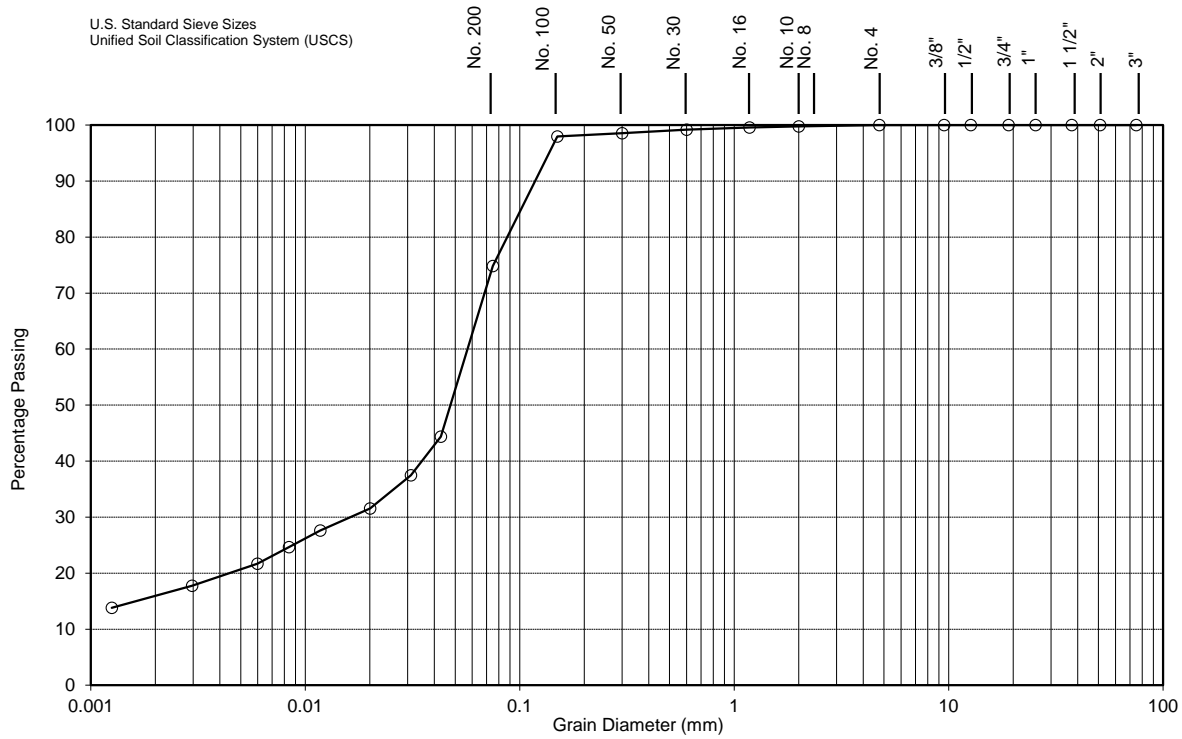
## Mechanical & Hydrometer Analyses

Lab No.	<b>108-16</b>	Notes: Sample retrieved by Soil-Mat Engineers & Consultants Ltd. laboratory on October 11, 2016.			
Borehole No.:	2				
Sample No.:	1				
CLAY [%]:	<b>16</b>	Soil Description: <b>Brown Sandy SILT with some Clay</b> <b>ML - Inorganic silts and very fine sands, clayey silts with slight plasticity</b>			
SILT [%]:	<b>59</b>				
SAND [%]:	<b>25</b>	Estimated T Time [min/cm] : <b>Greater than 50</b>			
GRAVEL [%]:	<b>0</b>	Estimated Permeability, k [cm/s]		<b>10<sup>-7</sup></b>	
D <sub>10</sub> (Effective Diam. in mm):	<b>&lt;0.001</b>	Coefficient of Uniformity C <sub>u</sub> :		<b>68.8</b>	
		Coefficient of Curvature C <sub>c</sub> :		<b>5.1</b>

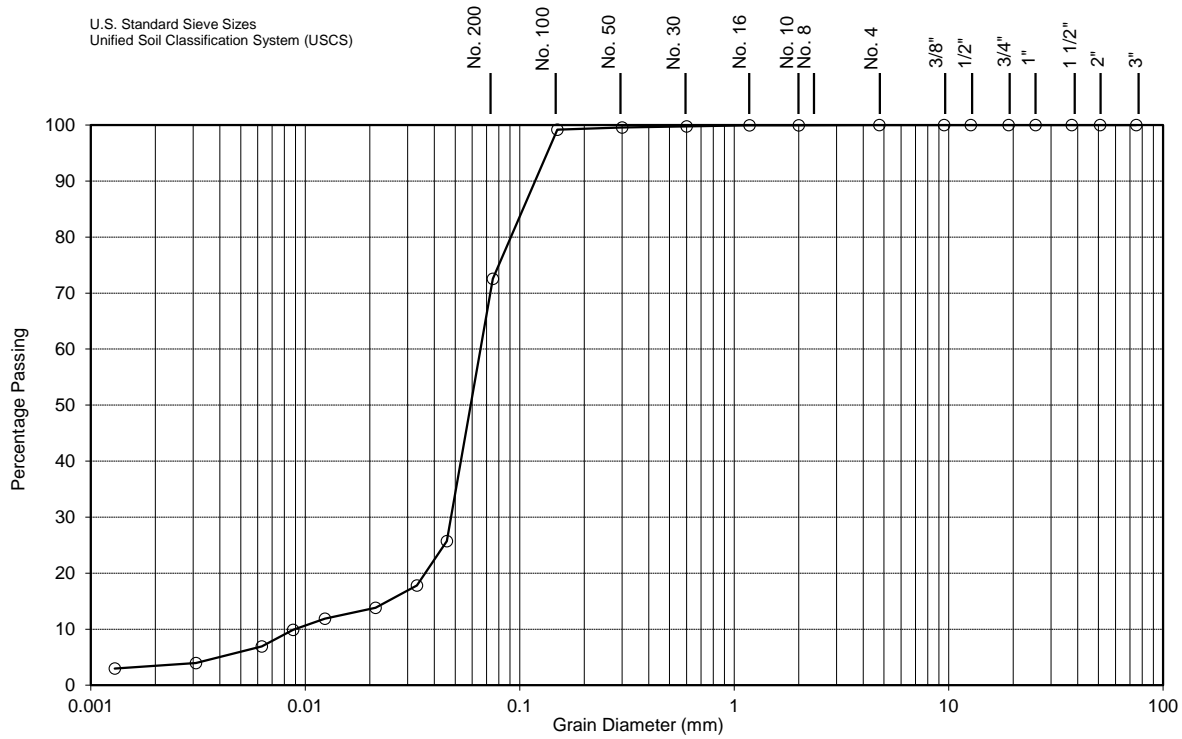
## Mechanical & Hydrometer Analyses

Lab No.	<b>109-16</b>	Notes: Sample retrieved by Soil-Mat Engineers & Consultants Ltd. laboratory on October 11, 2016.			
Borehole No.:	2	Soil Description: <b>Brown Sandy SILT with trace Clay</b> ML - Inorganic silts and very fine sands, to; SM - silty sands, sand-silt mixtures			
Sample No.:	4				
CLAY [%]:	<b>3</b>	Estimated T Time [min/cm] :		Estimated Permeability, k [cm/s]	
SILT [%]:	<b>70</b>	14 to 18		10 <sup>-5</sup>	
SAND [%]:	<b>27</b>	Coefficient of Curvature C <sub>c</sub> : <b>3.5</b>			
GRAVEL [%]:	<b>0</b>				
D <sub>10</sub> (Effective Diam. in mm):	<b>0.009</b>	Coefficient of Uniformity C <sub>u</sub> : <b>7.2</b>

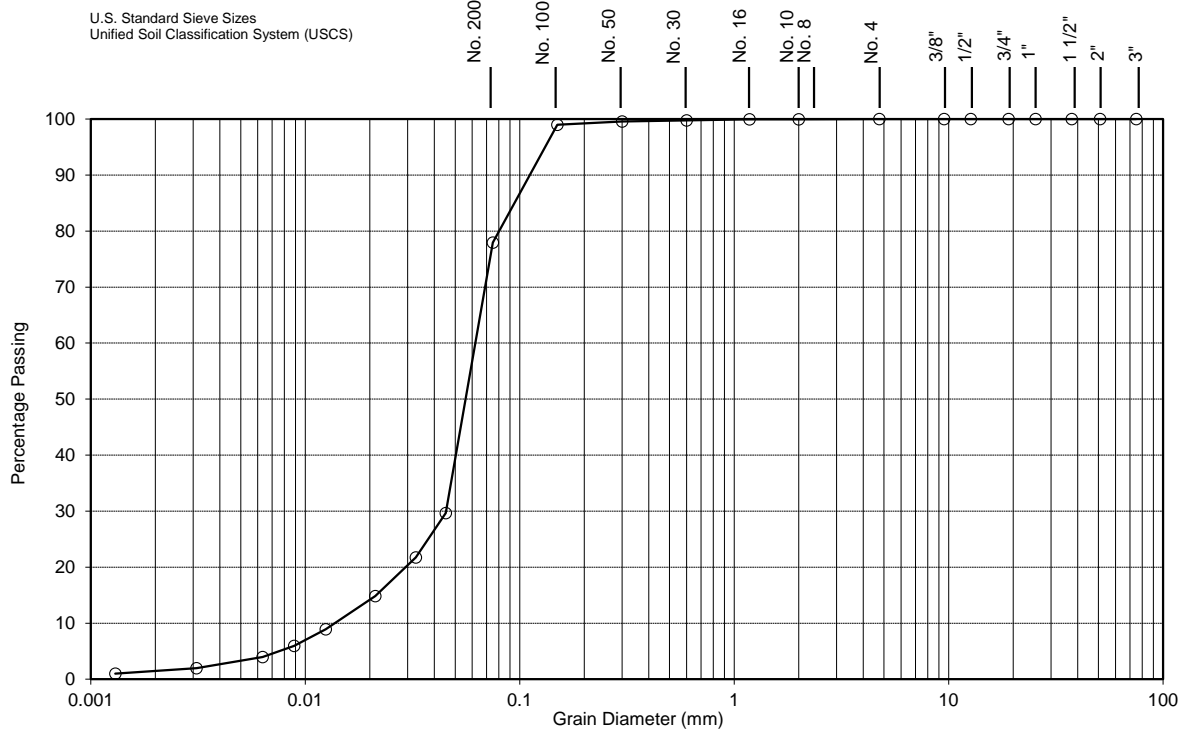
## Mechanical & Hydrometer Analyses

Lab No.	<b>110-16</b>	Notes: Sample retrieved by Soil-Mat Engineers & Consultants Ltd. laboratory on October 11, 2016.			
Borehole No.:	3	Soil Description: <b>Brown Sandy SILT with trace Clay</b> ML - Inorganic silts and very fine sands, to; SM - silty sands, sand-silt mixtures			
Sample No.:	2				
CLAY [%]:	<b>1</b>	Estimated T Time [min/cm] : <b>10 to 12</b>			
SILT [%]:	<b>77</b>	Estimated Permeability, k [cm/s] <b>10<sup>-4</sup></b>			
SAND [%]:	<b>22</b>	Coefficient of Uniformity C <sub>u</sub> : <b>4.0</b>			
GRAVEL [%]:	<b>0</b>				
D <sub>10</sub> (Effective Diam. in mm):	<b>0.015</b>	Coefficient of Curvature C <sub>c</sub> : <b>2.3</b>

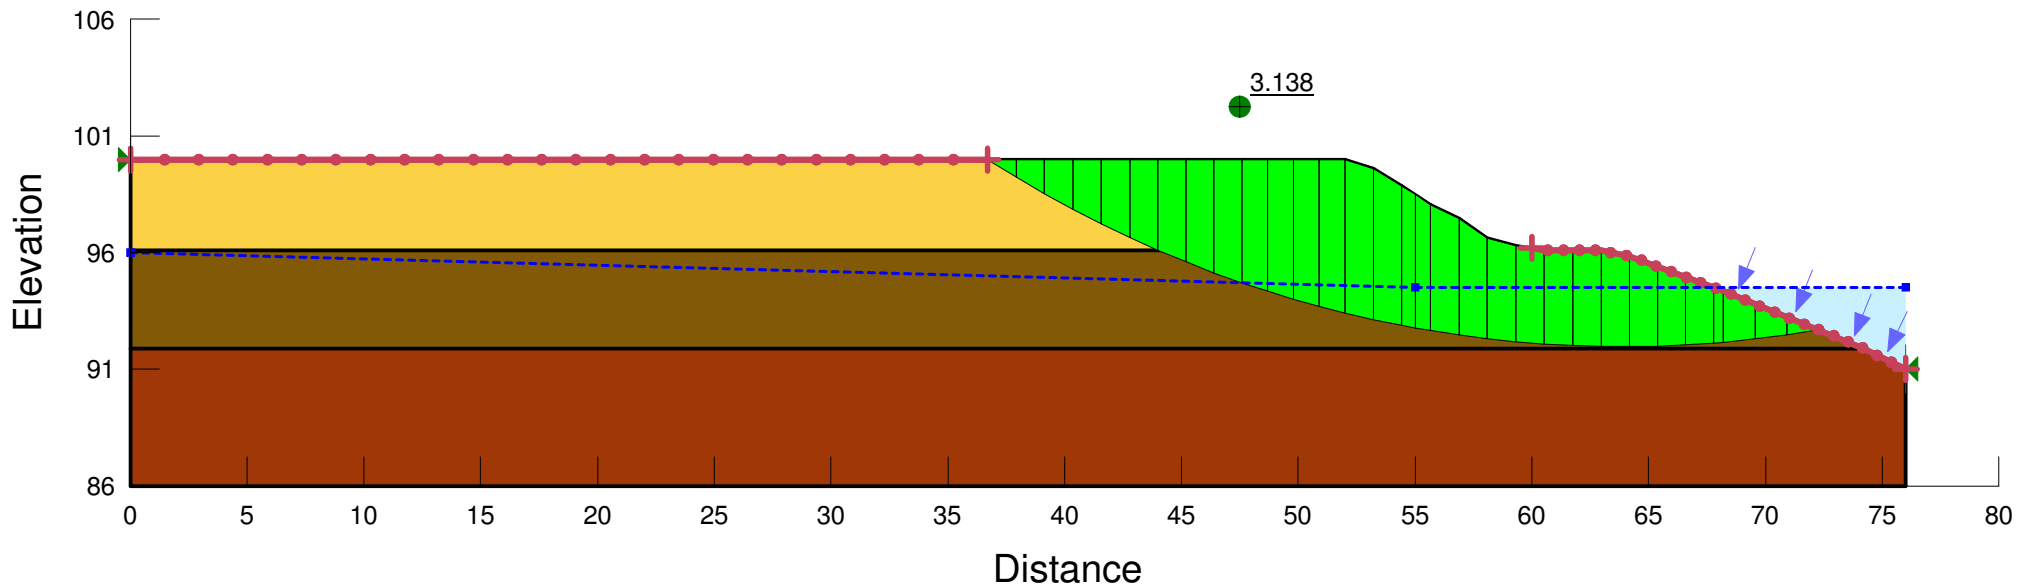
Slope Stability Assessment  
Firelane 13B Road  
St. Catharines, Ontario  
Profile A-A

Name: Sandy Silt  
Unit Weight: 19.5 kN/m<sup>3</sup>  
Cohesion: 0 kPa  
Phi: 36 °

Name: Silty Clay/Clayey Silt  
Unit Weight: 19 kN/m<sup>3</sup>  
Cohesion: 5 kPa  
Phi: 34 °

Name: Queenston Shale  
Unit Weight: 20 kN/m<sup>3</sup>  
Cohesion: 10 kPa  
Phi: 40 °

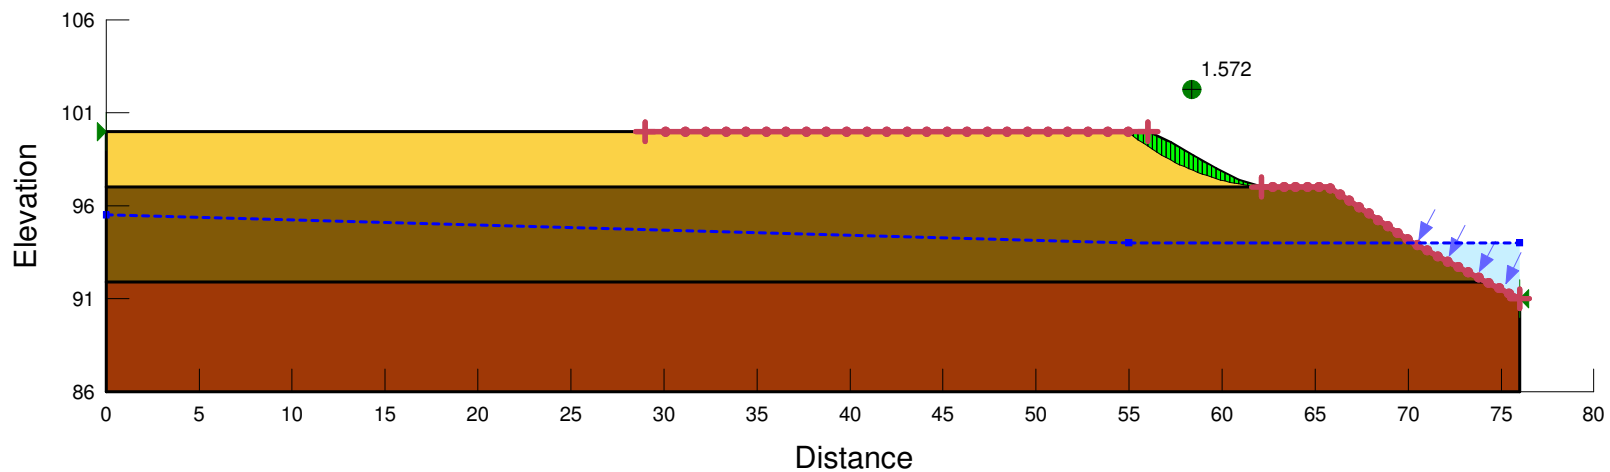
Slope Stability Assessment  
Firelane 13B Road  
St. Catharines, Ontario  
Profile B-B

Name: Sandy Silt  
Unit Weight: 19.5 kN/m<sup>3</sup>  
Cohesion: 0 kPa  
Phi: 36 °

Name: Silty Clay/Clayey Silt  
Unit Weight: 19 kN/m<sup>3</sup>  
Cohesion: 5 kPa  
Phi: 34 °

Name: Queenston Shale  
Unit Weight: 20 kN/m<sup>3</sup>  
Cohesion: 10 kPa  
Phi: 40 °

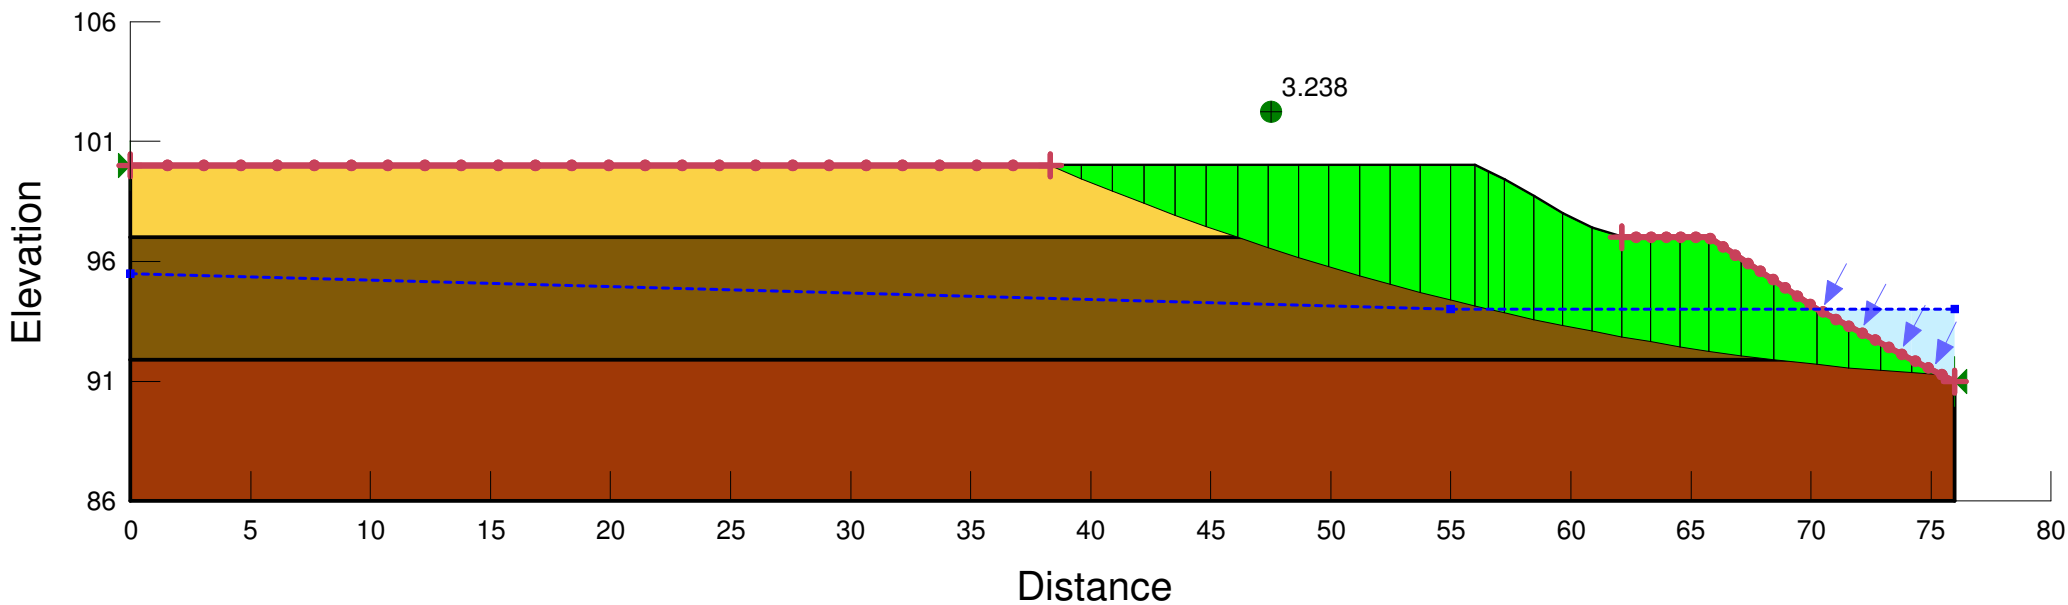
Name: Silty Clay/Clayey Silt  
 Unit Weight: 19 kN/m<sup>3</sup>  
 Cohesion: 5 kPa  
 Phi: 34 °

Name: Queenston Shale  
 Unit Weight: 20 kN/m<sup>3</sup>  
 Cohesion: 10 kPa  
 Phi: 40 °
