Geotechnical Investigation Report

Proposed Mixed-Use Development
1544 & 1546 Four Mile Creek Road
Niagara-on-the-Lake, Ontario

HAM-24000672-A0

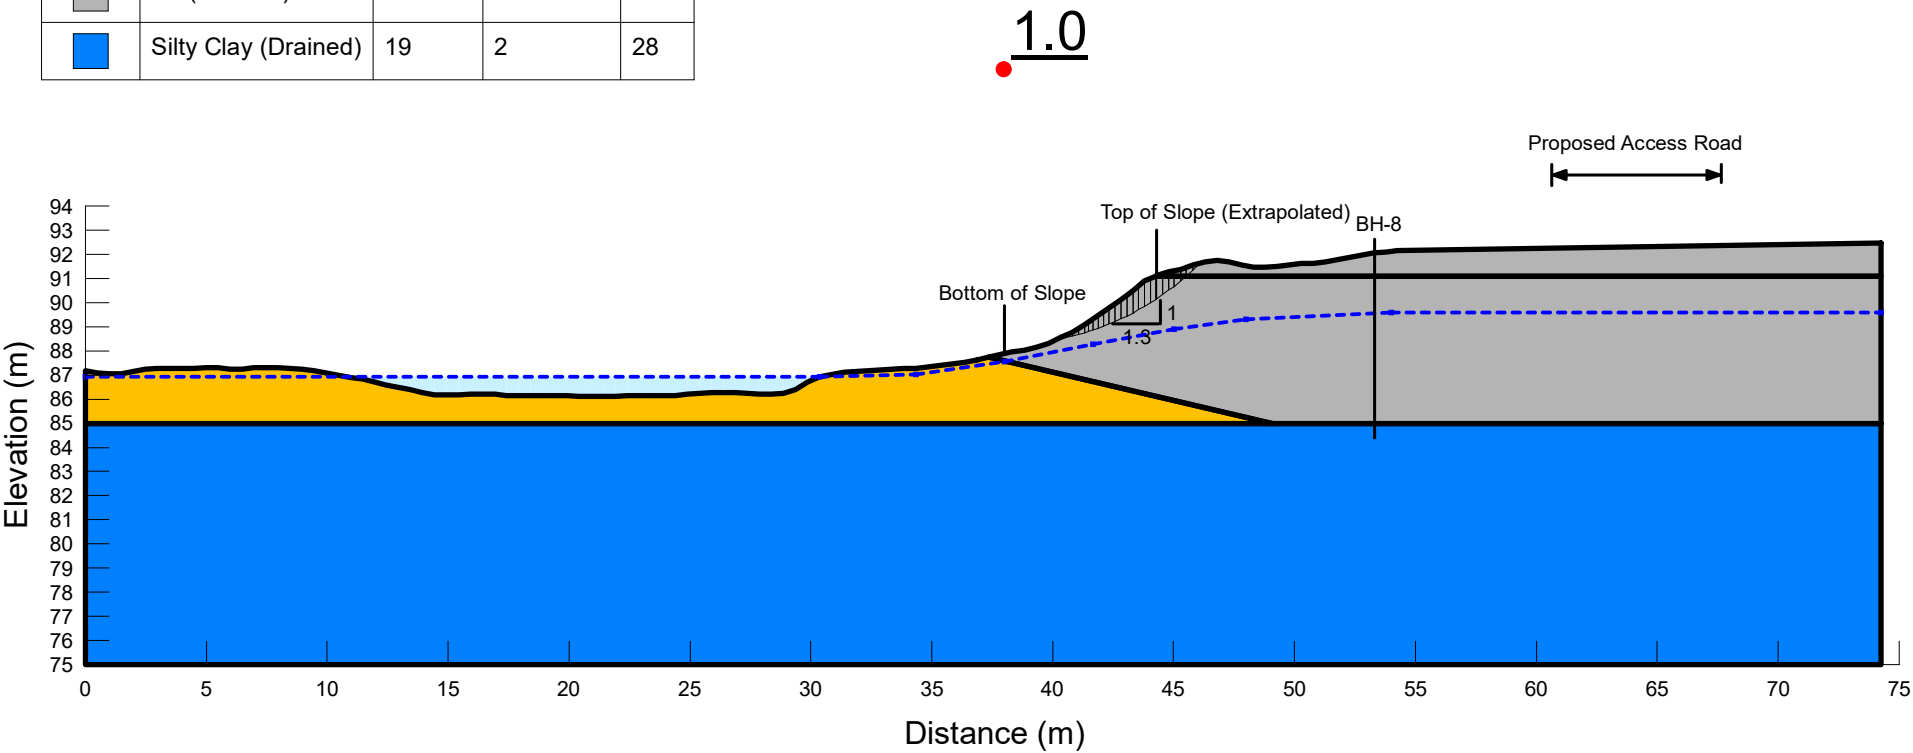
Figure B1

Color	Name	Unit Weight (kN/m³)	Cohesion' (kPa)	Phi' (°)
<div></div>	Creek Bank	20	0	28
<div></div>	Fill (Drained)	18	0	28
<div></div>	Silty Clay (Drained)	19	2	28

Section : 1-1
Slope Height : 3.2
Slope Gradient : 2.0 : 1
Drained / Undrained Condition : Drained
Static / Seismic Scenario : Static
Analysis Method : Morgenstern - Price
Surcharge : Nil

For Section 1-1, the calculated minimum FS under static drained condition is 1.0 (Figure B1), which is less than the requirement minimum FS for long-term stability. Additional analysis was carried out to determine the location of failure slip surface where FS of 1.5 is achieved. This point, shown in Figure B4, is located at about 7.2 m behind the physical top of bank.
