I agreed with you that the answer to this question would be of great assistance to Town Engineering staff regarding clearance of Condition No. 1.1.5 of the decision of the Committee of Adjustment re: the Consent to Sever for 479 Butler Street. As we know, this is the last condition that needs to be fulfilled.

Subject: Sewer dig

Subject: Sewer Cap

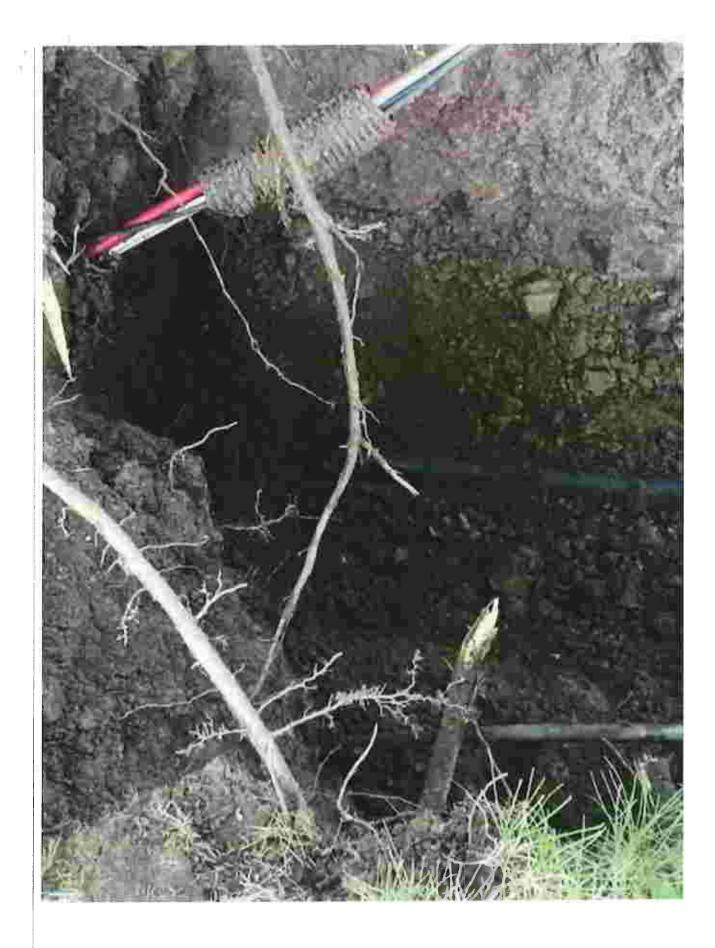
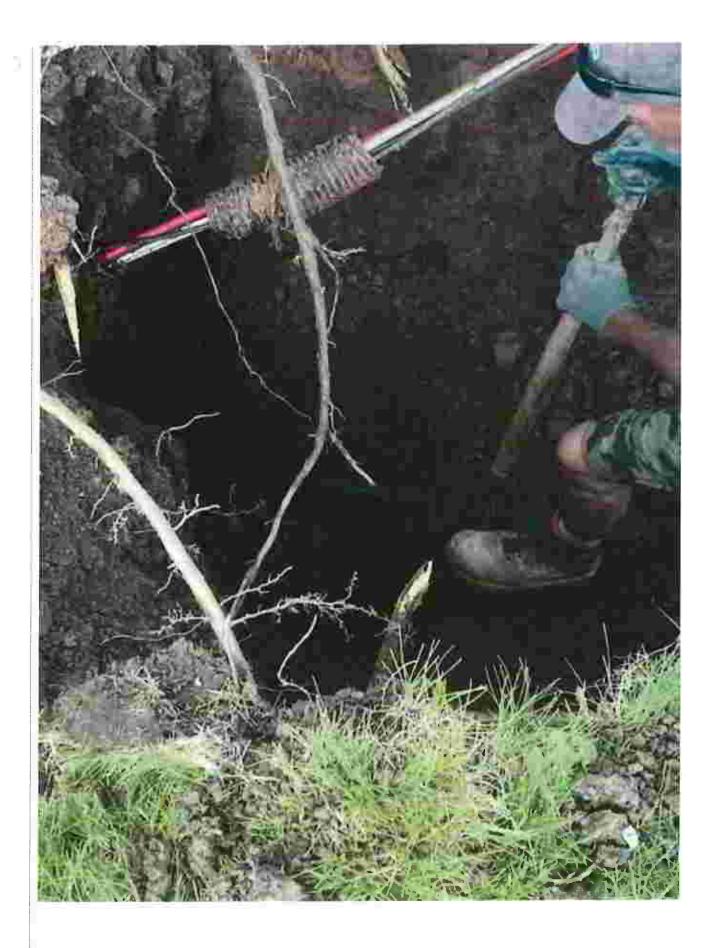
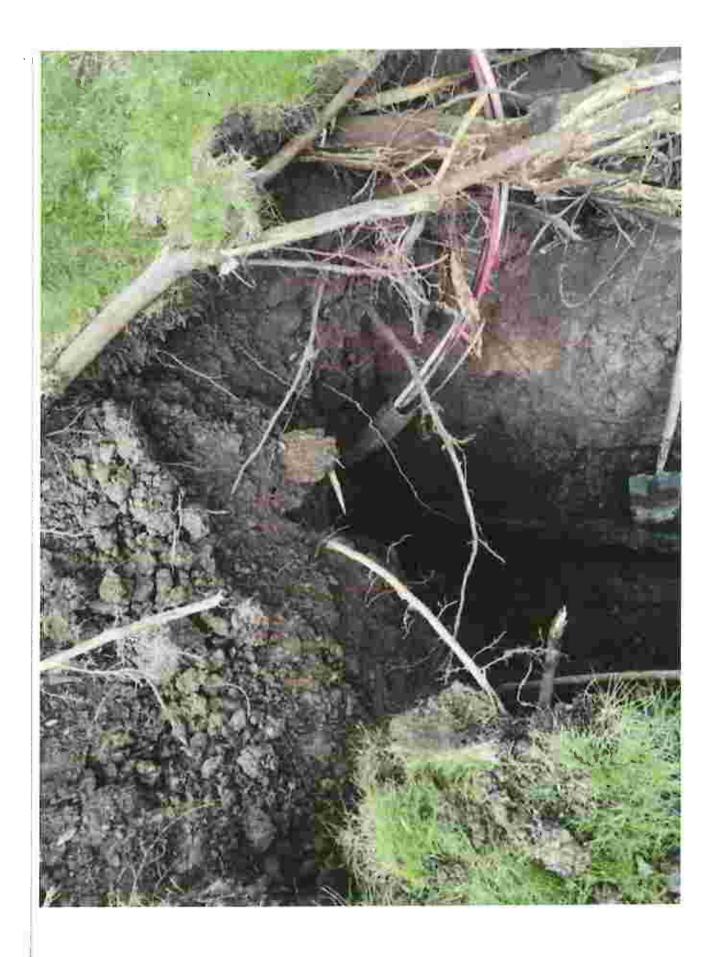
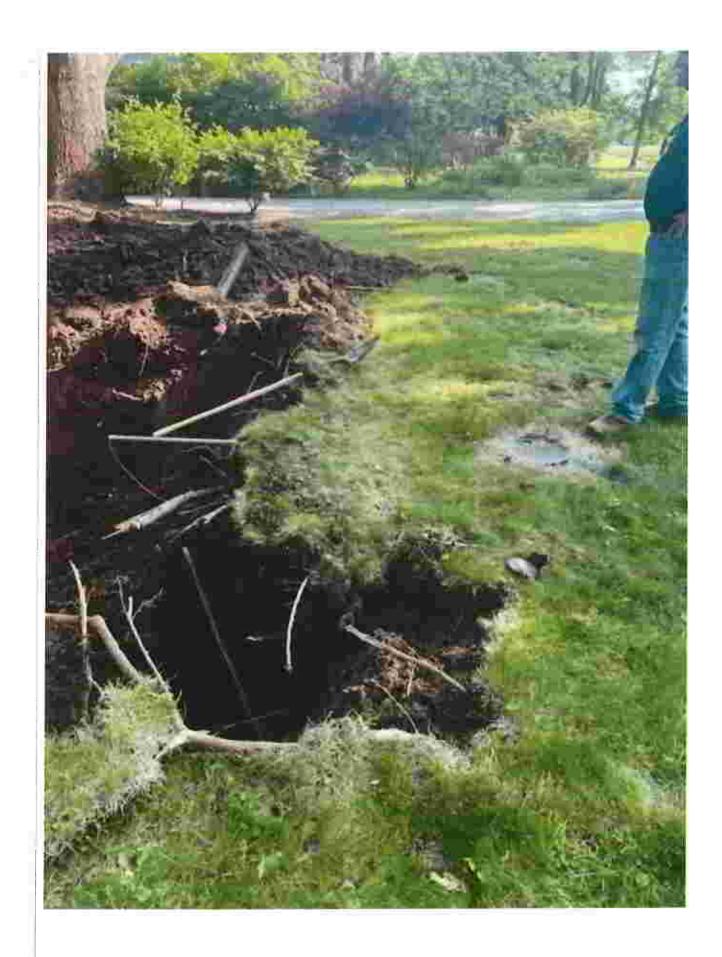
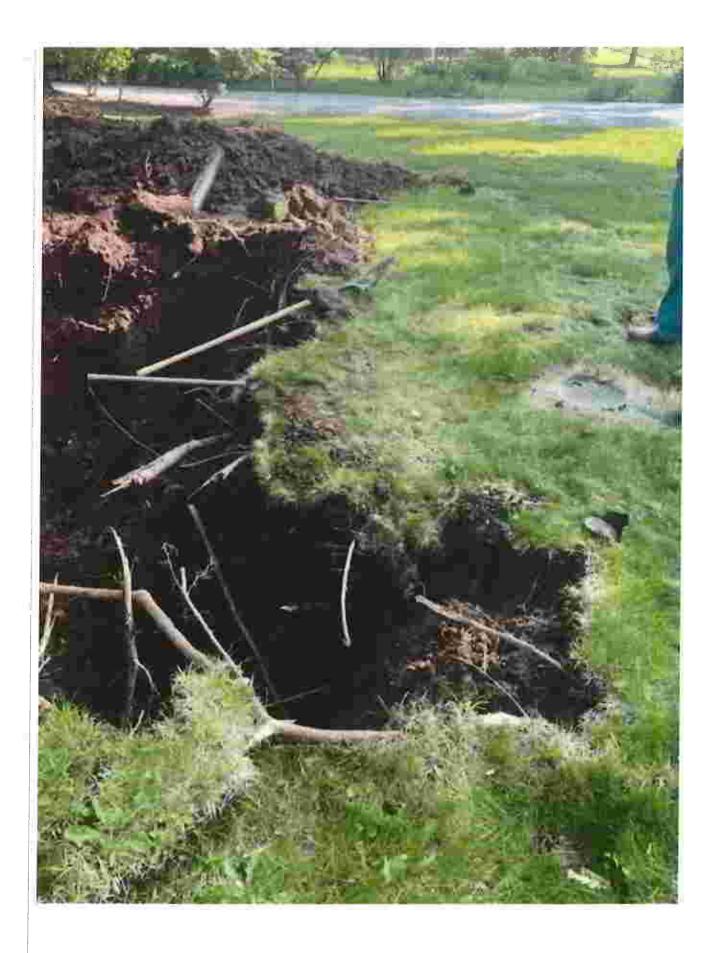
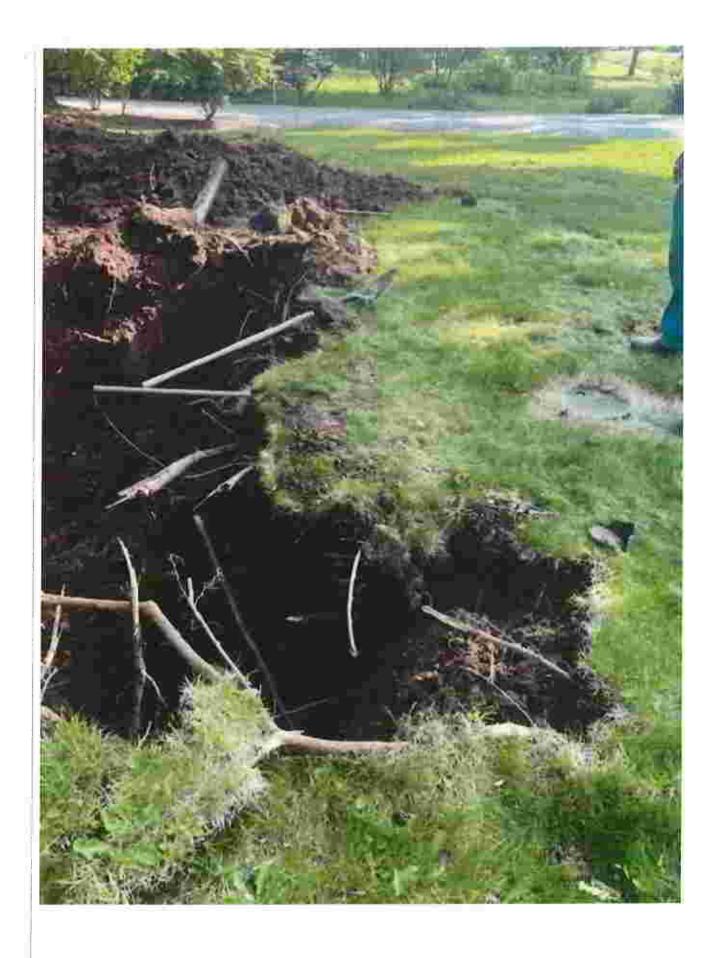
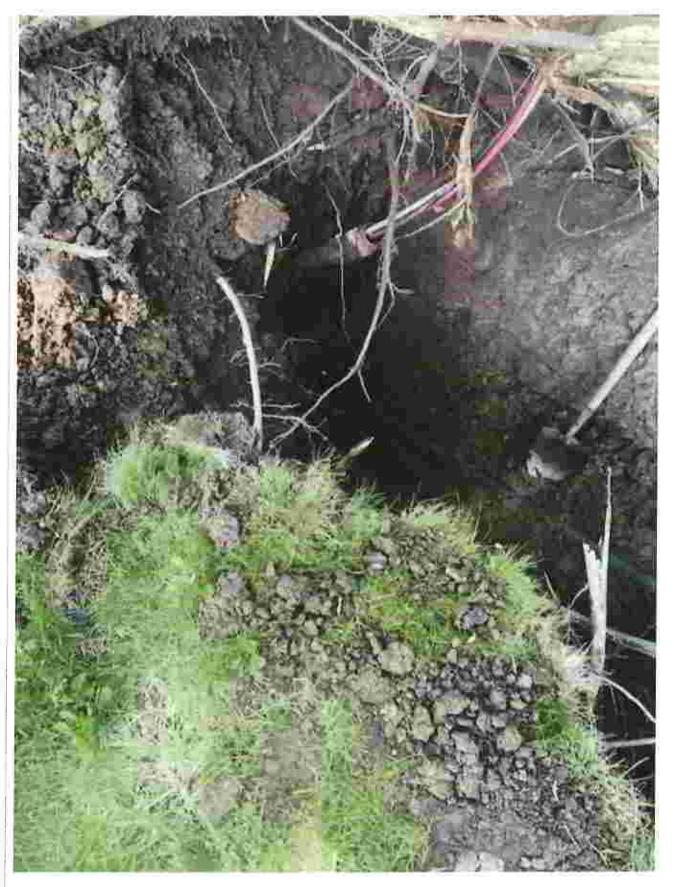
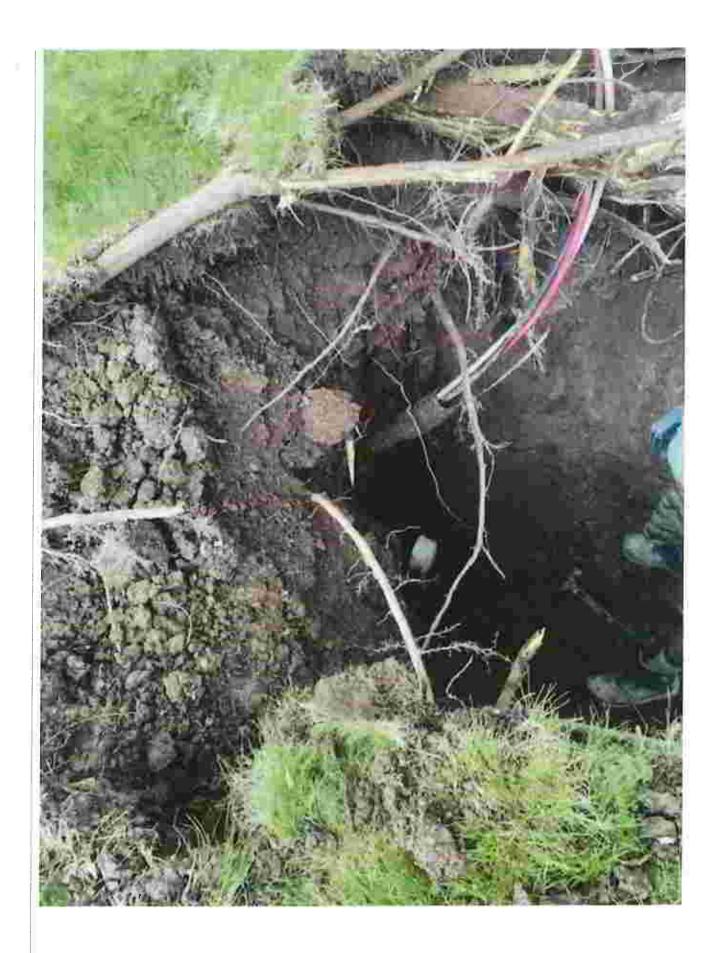
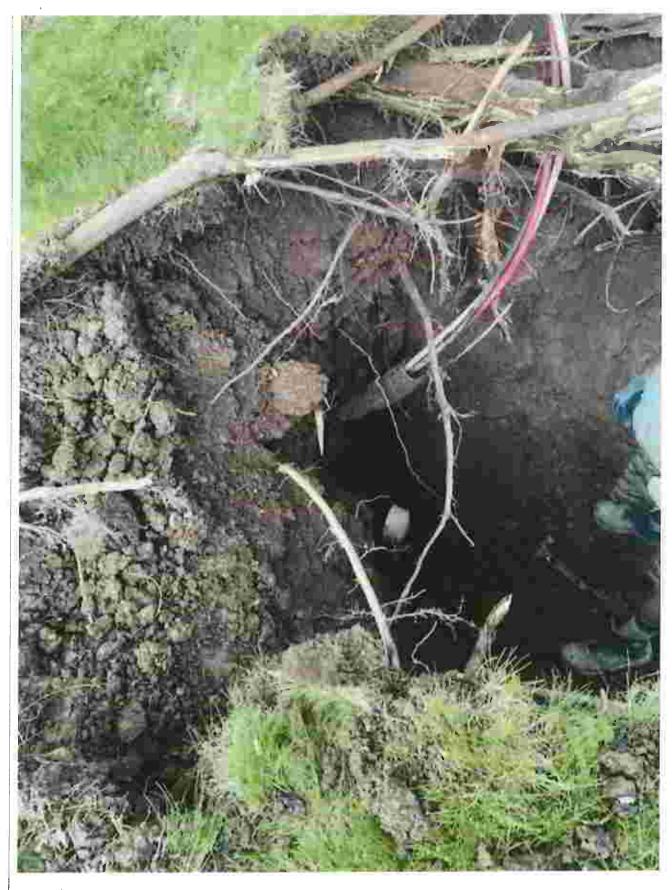
Finally, a series of photos showing various aspects of the excavation. Of particular note are the photos which show the laterals for the water and hydro (white and pink in colour) proceeding towards Butler in what would generally be a west to east direction. The sanitary sewer lateral is the black one at the bottom of the trench. Unlike the water and hydro laterals, the sanitary sewer lateral is proceeding in a roughly north to south direction.

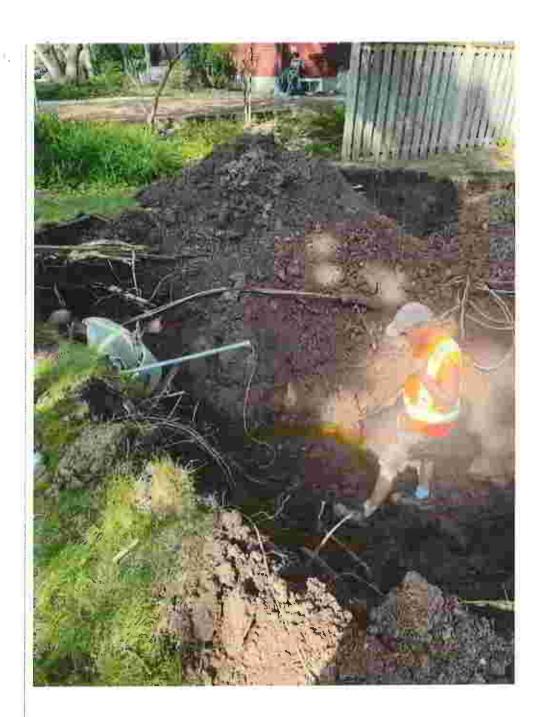
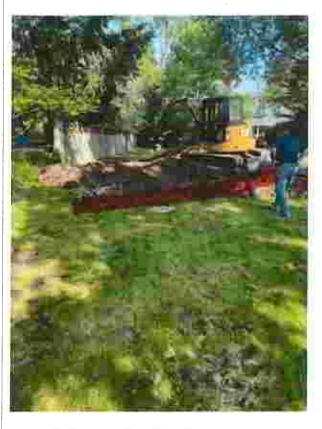
- 7. Based upon what is shown in the highlighted portion of one of the photos, it is clear that the lateral does not go to the street (to the east) but rather it goes to the south and onto the property at 485 Butler Street. Based upon its experience with these matters, Sacco believes that the sanitary sewer lateral most likely connected with the sanitary sewer lateral for 485 Butler Street. Indeed, one of the photos clearly shows that the sanitary sewer lateral crosses underneath the water and hydro lateral which proceed to the street, while the sanitary sewer lateral does not go in that direction;

Further to my previous message, please see below two photos which show the location of the sanitary sewer lateral as it meets the boundary line with 485 Butler (my house). The brick structure you see in the upper left of the photo is my home at 485 Butler, together with my fence.

The pipe, you will see from the highlighted area, ran from Igor's house sideways, under a big tree, toward your property. Sacco figures it is not even connected to the main but to your pipe.

- 6. Sacco proceeded to cap the sanitary sewer lateral at the property line. The Town building inspector John [whose last name no one seems to know, but I understand that John has been the inspector for the Town for some time] was contacted and he attended the site and verified that the sanitary sewer lateral had been properly capped at the property line. John advised that he would report this to the Town and try to find any documentation as to how the sanitary sewer connection had originally been installed;

Ok it's done and signed off by the Town. John the inspector came and signed off.

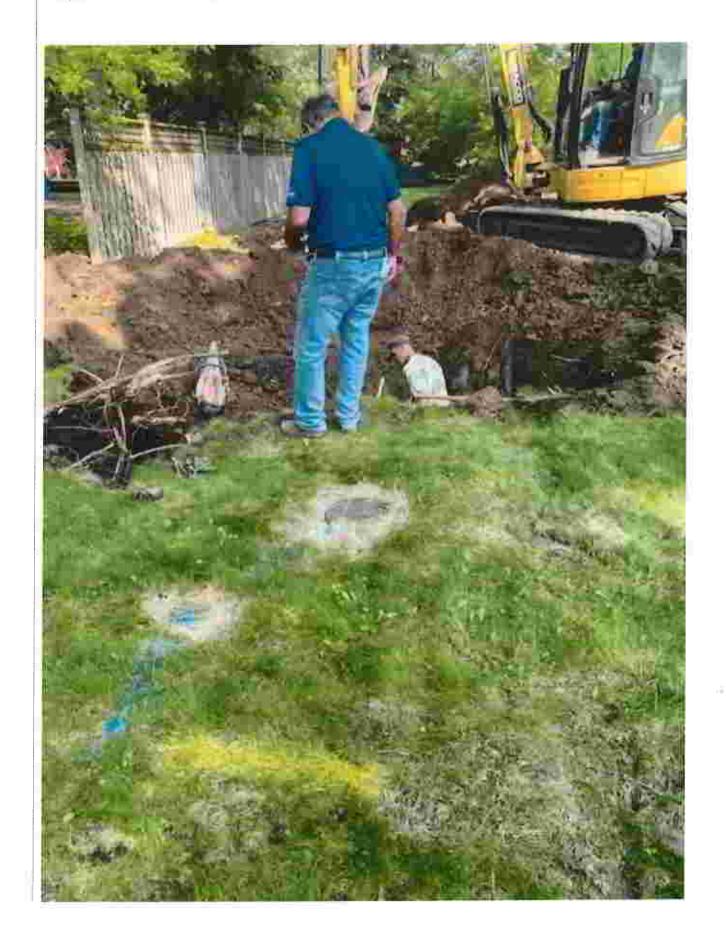
This a photo of the trench taken from a different angle but showing, once again, my fence and my house. I would estimate that this location is approximately 50 feet from the street (i.e. Butler)
