Terms of Reference
Hydrogeological Investigation
144, 176, 200 John Street and 588 Charlotte Street,
Niagara-on-the-Lake, Ontario

Client Name: Solmar Development Corp.
Date: March 30, 2026
File: 86891

200 John Street and 588 Charlotte Street,
Niagara-on-the-Lake, Ontario

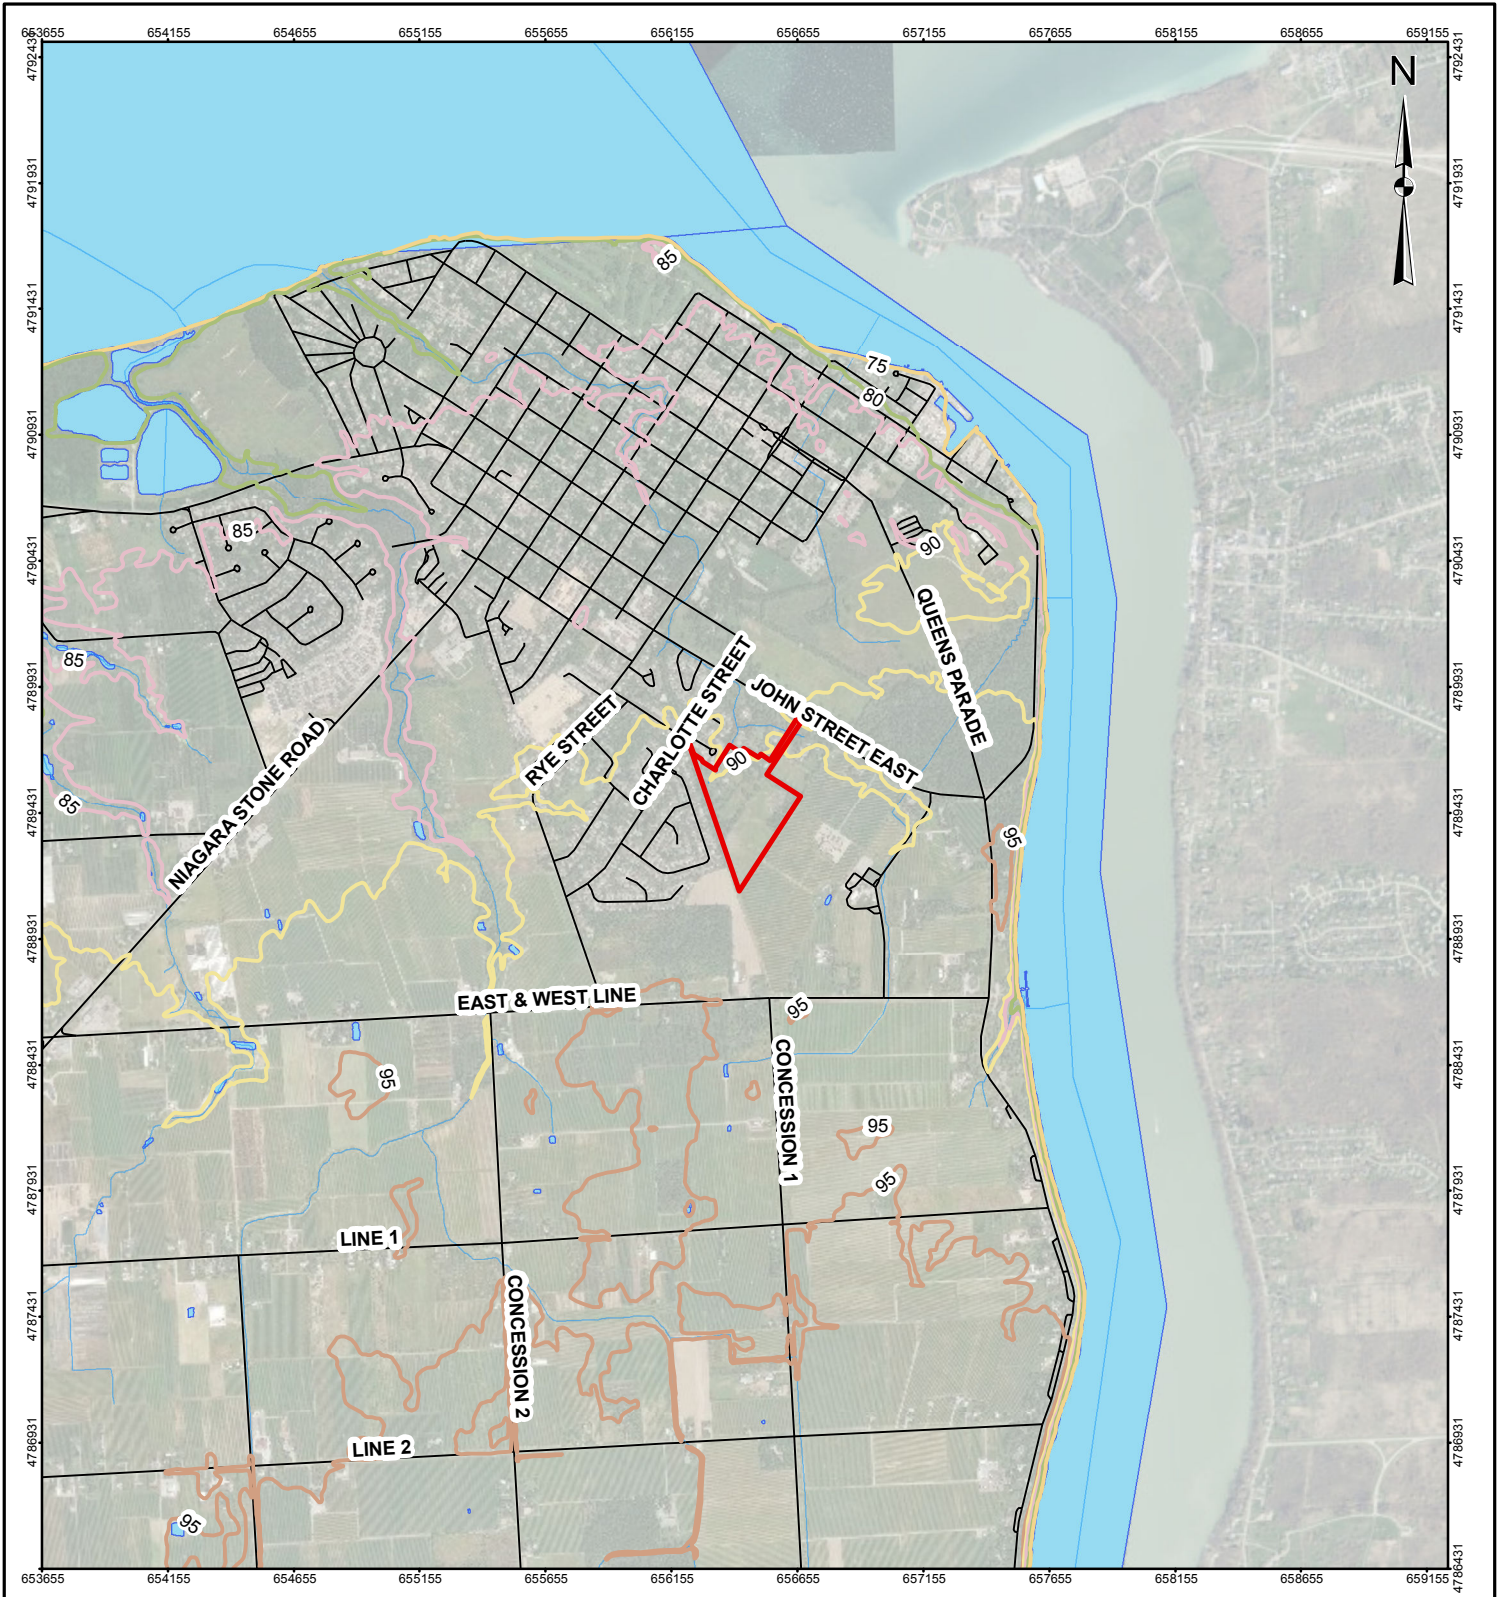
TITLE
TOPOGRAPHY

- Site Boundary
 - Arterial Road
 - Watercourse
 - Waterbody
- Elevation (masl)**
- 75
 - 80
 - 85
 - 90
 - 95

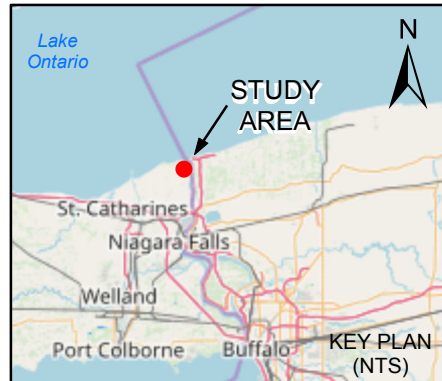
TITLE
PHYSIOGRAPHY

- ▭ Site Boundary
 - Arterial Road
 - Watercourse
 - Waterbody
- Region**
- Iroquois Plain

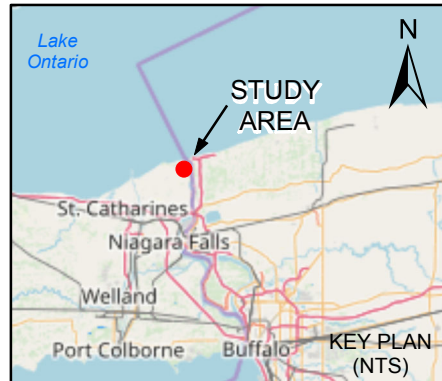
TITLE
BEDROCK GEOLOGY

Queenston Fm.

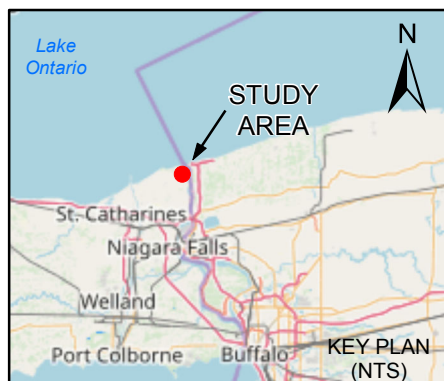
FIGURE 6

- Site Boundary
- Road
- ~ Watercourse
- + Monitoring Well
- + Borehole
- ▲ Piezometer Station

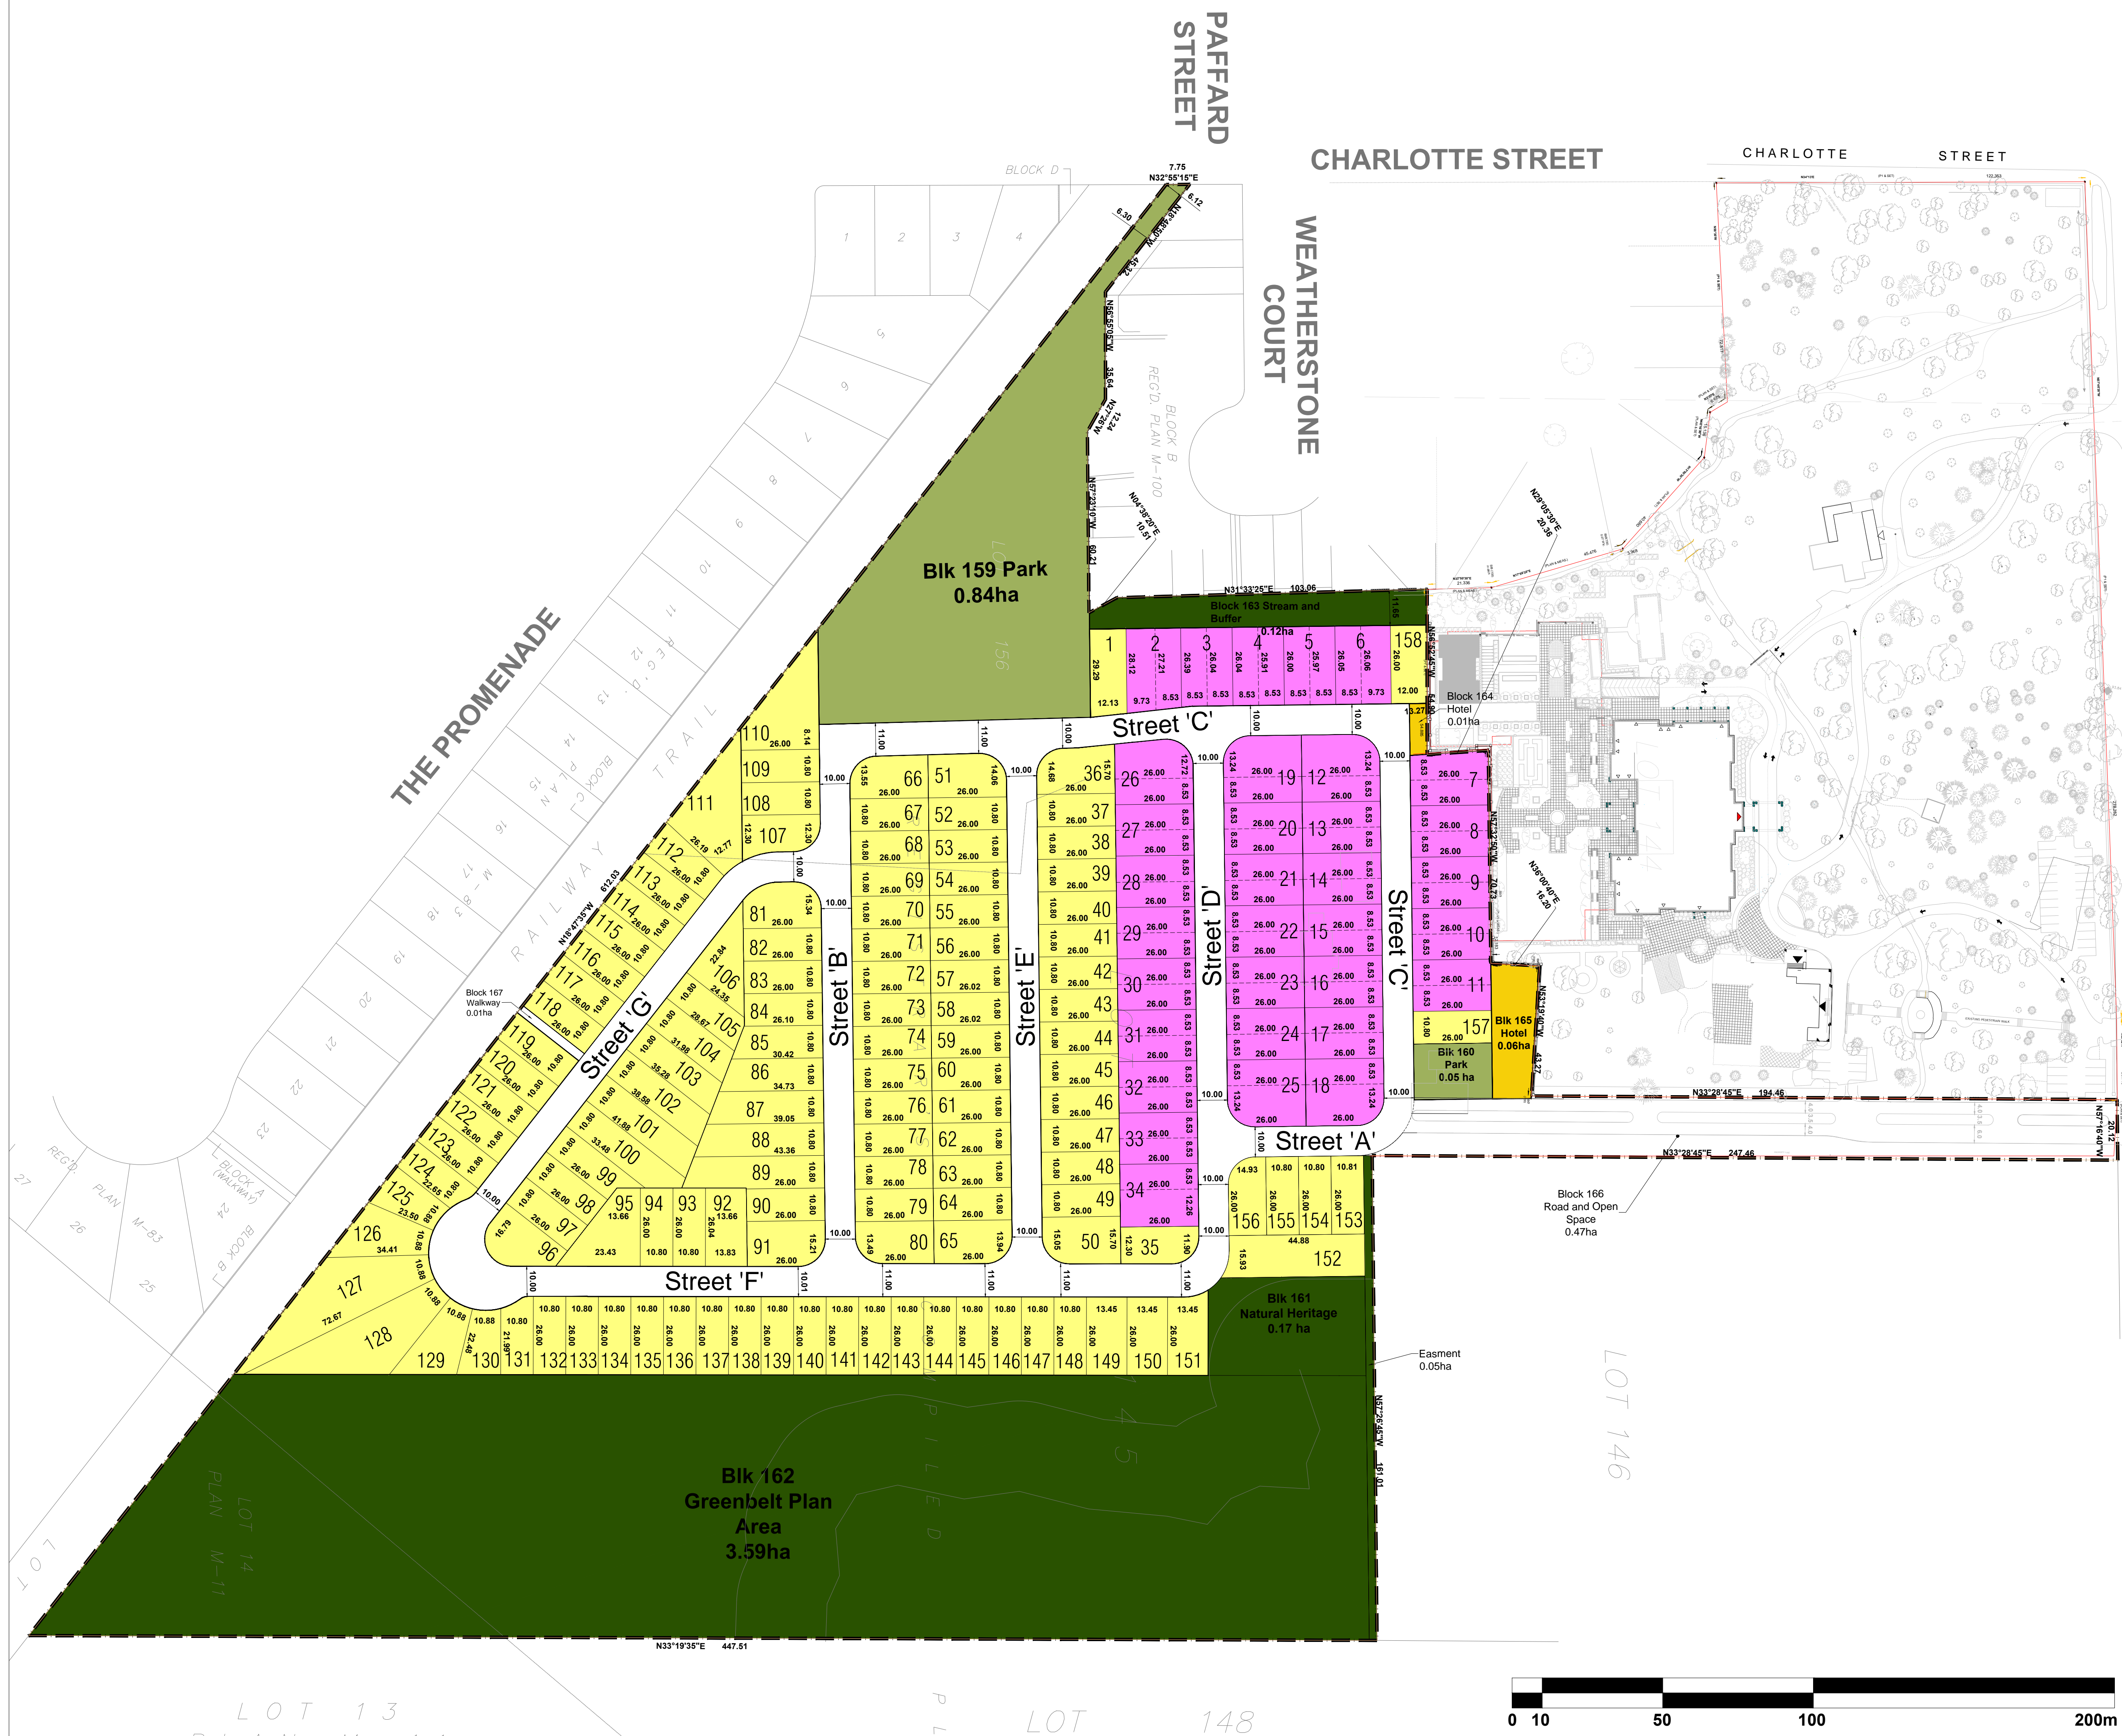
DRAFT PLAN OF SUBDIVISION
SOLMAR
 FILE #
 LOTS 145 and 156
 REGISTRAR'S COMPILED PLAN 692 and LOT 14
 PLAN M-11
 TOWN OF NIAGARA-ON-THE-LAKE
 REGIONAL MUNICIPALITY OF NIAGARA

- H) MUNICIPAL AND PIPED WATER TO BE PROVIDED
- I) SILTY CLAY, SILTY CLAY TILL, SANDY SILT, SANDY SILT TILL
- K) SANITARY AND STORM SEWERS TO BE PROVIDED

LAND USE	LOT / BLOCK #	AREA (ha)	AREA (ac)	UNITS
RESIDENTIAL SEMI DETACHED HOMES	2-34	1.54	3.81	66
RESIDENTIAL SINGLE DETACHED HOMES	1,35-158	4.03	9.96	125
PARK	159 - 160	0.89	2.20	
NATURAL HERITAGE	161	0.17	0.42	
GREENBELT PLAN AREA & EASEMENT	162	3.63	8.97	
STREAM & BUFFER	163	0.12	0.30	
HOTEL	164-165	0.07	0.17	
ROAD & OPEN SPACE	166	0.47	1.16	
WALKWAY	167	0.01	0.02	
ROAD R.O.W.		1.41	3.48	
TOTAL	167	12.34	30.49	191
