228 Queen Street
Niagara-on-the-Lake, ON

Van Riesen Hotel Group Inc.
PO Box 612
St. Davids, ON L0S 1P0

Tree Preservation Plan

JACKSON ARBORICULTURE INC.

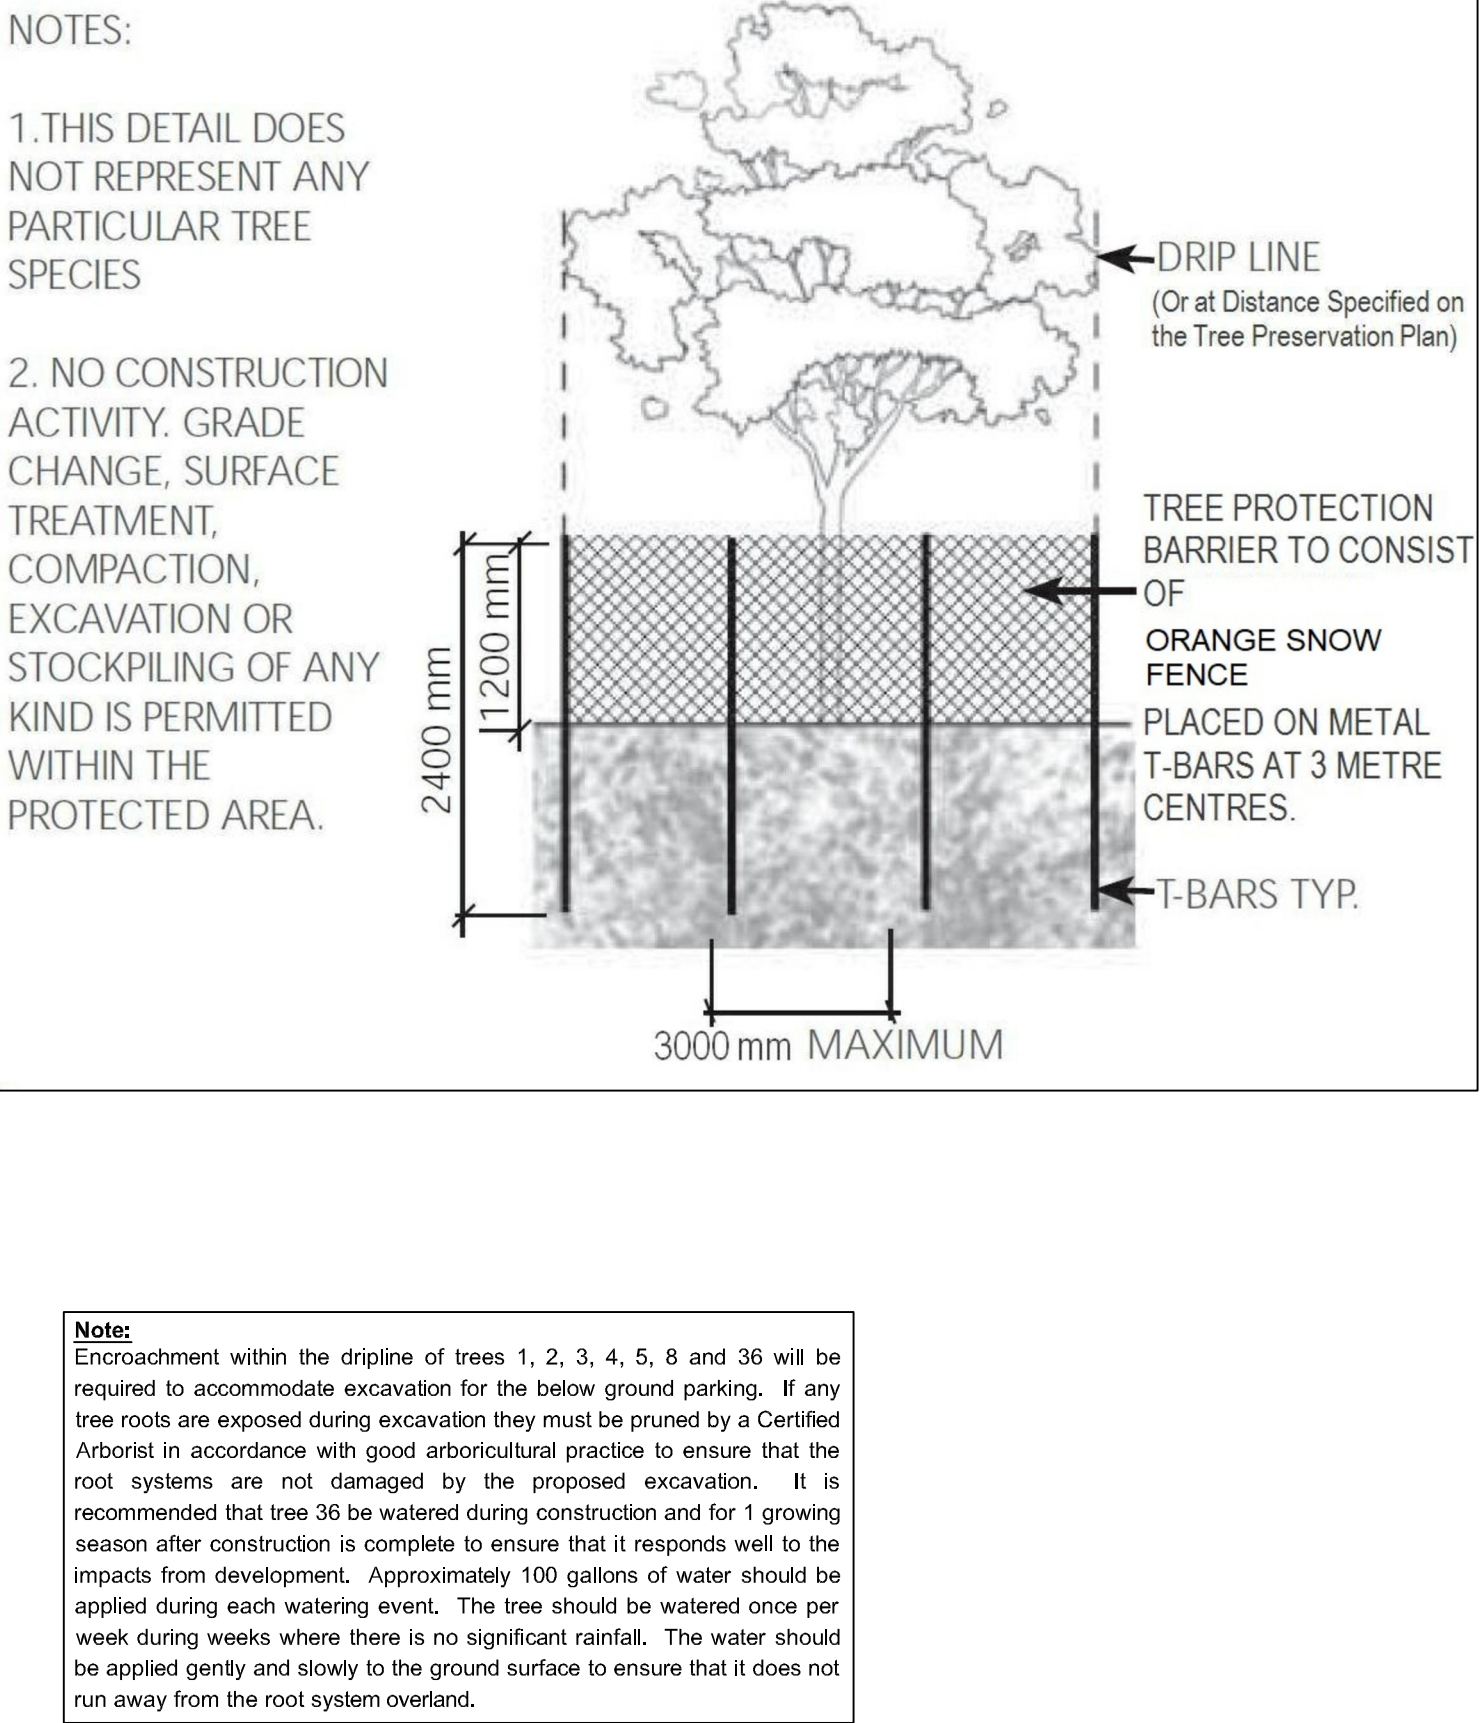
Note:
Encroachment within the driplines of Trees 10, 11 and 29 will be required to accommodate the proposed concrete driveway. A gravel driveway already exists adjacent to tree 29 and it is anticipated that few tree roots reside below the existing driveway. Where the curb is proposed within the driplines of Trees 10 and 11, air spade excavation will be required to excavate the limit of the proposed curb to gently expose any tree roots that reside within the area of encroachment. If any roots are exposed they must be pruned by a Certified Arborist in accordance with good arboricultural practice to ensure that the root systems are not damaged by construction.

Note:
Encroachment within the dripline of tree 24 will be required to accommodate the proposed patio stone walkway and parking spaces. If any roots are exposed by construction they must be pruned by a Certified Arborist in accordance with good arboricultural practice to ensure that the root system is not damaged. It is recommended that tree 24 be watered during construction and for 1 growing season after construction is complete to ensure that it responds well to the impacts from development. Approximately 100 gallons of water should be applied during each watering event. The tree should be watered once per week during weeks where there is no significant rainfall. The water should be applied gently and slowly to the ground surface to ensure that it does not run away from the root system overland.

- Tree Protection Recommendations**
The following recommendations are made in attempts to reduce the impacts to trees identified for preservation:
- Tree protection fence must be installed at the dripline for trees identified for preservation prior to the commencement of demolition, unless noted otherwise in this report and on Sheet 1.

- Trees 24 and 36 will require watering as outlined in the note on this drawing.
 - Tree protection fencing should be inspected by a Certified Arborist prior to and during construction to ensure that the fencing remains intact and in good repair throughout the stages of development.
